Contract #: 04-0120F4Cty: SF/ALA Rte: 80 PM: 13.2/13.9File #: 69.25B**QUALITY ASSURANCE -- NON-CONFORMANCE REPORT****Location:** Changxing Island, Shanghai, P.R. China**Report No:** NCR-000884**Prime Contractor:** American Bridge/Fluor Enterprises, a JV**Date:** 01-Nov-2010**Submitting Contractor:** Zhenhua Port Machinery Company, Ltd (ZPMC), Changxing Island**NCR #:** ZPMC-0846**Type of problem:**

Reference Description: ZPMC performed weld repair without following the WRR for bikepath BK004A2-054; subsequently, alternating the weld detail from the approved shop drawings

Job Name: SAS Superstructure
Document No: 05.03.06-000842

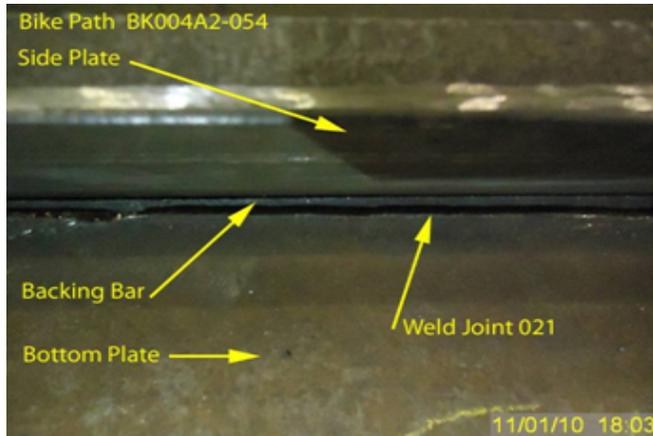
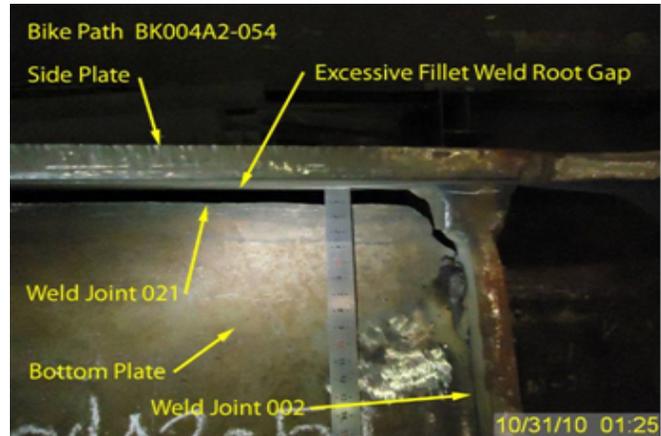
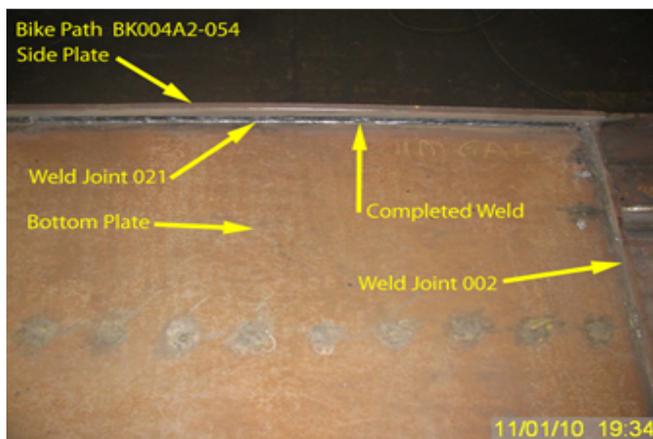
During Quality Assurance (QA) random in-process observations of the fabrication of Bike Path Segment BK004A2-054, this Caltrans QA inspector discovered the following issues:

- The bottom cover plate is distorted
- At 2 corner sections of the cover plate (1500mm and 2000mm sections), there exist root gaps of maximum 11mm.
- ZPMC personnel had a WRR# is B-WR 15580, which is for the weld build up.

- According to the approved shop drawing this weld is 6 mm fillet weld.
- ZPMC proceeded with fabrication by changing the joint detail to complete joint penetration (CJP) with backing bar to be remained rather than what it is in the WRR.

- These 2 CJP weld only cover the 1500mm and 2000mm sections, thus not a continuous CJP weld.
- Excessive root gap of more than 5mm at fit-up of CJP were measured at the bottom plate to side.

- The added tack welds on the CJP backing bar was not inspected by MT.
- The member is identified as Bike Path Segment BK004A2-054.
- The weld is fillet weld identified as BK004A2-054-021, joining BKPL4B to BKPL3B.

- The weld joins the bottom plate edge to side plate.
- OBG Bike Path is located in Bay-8.

-AWS D1.5 2002 section 3.3.1 "The parts to be joined by fillet welds shall be brought into as close contact as practicable. The root opening shall not exceed 5 mm [3/16 in.] except in cases involving either shapes or plates 75 mm [3 in.] or greater in thickness if, after straightening and in assembly, the root opening cannot be closed sufficiently to meet this tolerance. In such cases, a maximum root opening of 8 mm [3/16 in.] may be used, with a backing weld or suitable backing."

ZPMC acknowledges that the fillet weld was changed to a CJP, they have issued an internal NCR and discussed this matter with their production crews to prevent future occurrences. In this case the CJP was welded between 6mm plates so ZPMC is providing MT results to show that the welds is acceptable as well as NDT of the base metal repair. Based on this ZPMC requests closure of this NCR.

Provide joint change detail to document a section of the weld that was partially performed without following the approved shop drawings.

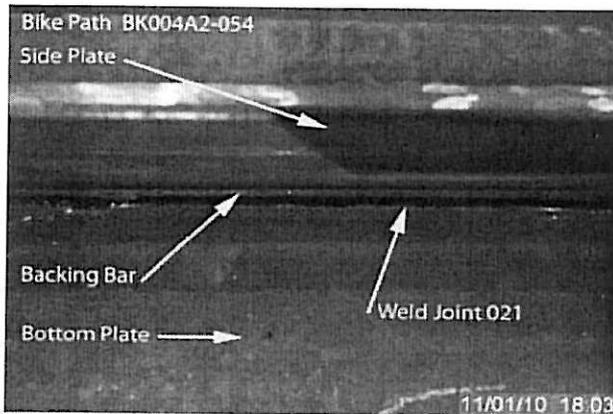
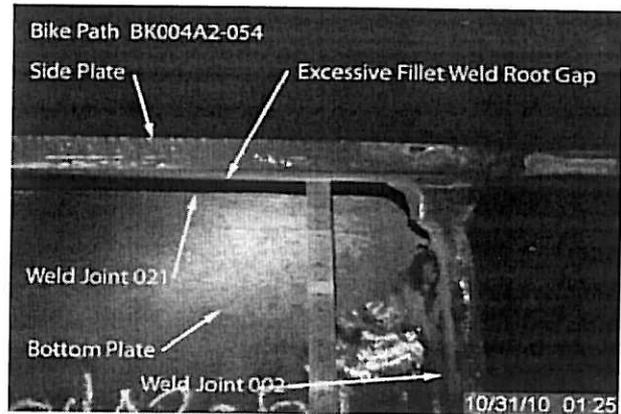
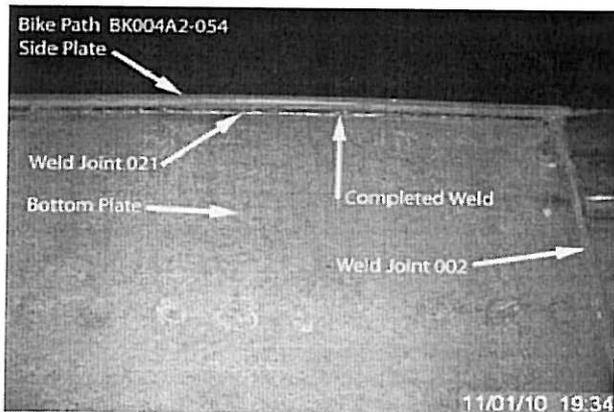
During Quality Assurance (QA) random in-process observations of the fabrication of Bike Path Segment BK004A2-054, this Caltrans QA inspector discovered the following issues:

- The bottom cover plate is distorted
- At 2 corner sections of the cover plate (1500mm and 2000mm sections), there exist root gaps of maximum 1mm.
- ZPMC personnel had a WRR# is B-WR 15580, which is for the weld build up.

- According to the approved shop drawing this weld is 6 mm fillet weld.
- ZPMC proceeded with fabrication by changing the joint detail to complete joint penetration (CJP) with backing bar to be remained rather than what it is in the WRR.

- These 2 CJP weld only cover the 1500mm and 2000mm sections, thus not a continuous CJP weld.
- Excessive root gap of more than 5mm at fit-up of CJP were measured at the bottom plate to side.

- The added tack welds on the CJP backing bar was not inspected by MT.
- The member is identified as Bike Path Segment BK004A2-054.
- The weld is fillet weld identified as BK004A2-054-021, joining BKPL4B to BKPL3B.

- The weld joins the bottom plate edge to side plate.
- OBG Bike Path is located in Bay-8.

-AWS D1.5 2002 section 3.3.1 "The parts to be joined by fillet welds shall be brought into as close contact as practicable. The root opening shall not exceed 5 mm [3/16 in.] except in cases involving either shapes or plates 75 mm [3 in.] or greater in thickness if, after straightening and in assembly, the root opening cannot be closed sufficiently to meet this tolerance. In such cases, a maximum root opening of 8 mm [3/16 in.] may be used, with a backing weld or suitable backing."

ZPMC is submitting the NDT of the CJP weld which shows it is acceptable as well as the revised weld map to show the addition of the weld joint. ZPMC QA has discussed this incident with the CWI responsible for the area to ensure in the future the WRRs are followed and prior approval is received before changing weld joints. Based on this ZPMC requests closure of this NCR.

This proposed resolution is acceptable. The documentation received is sufficient and the Department concurs that Non-Conformance ZPMC-0846 is closed.

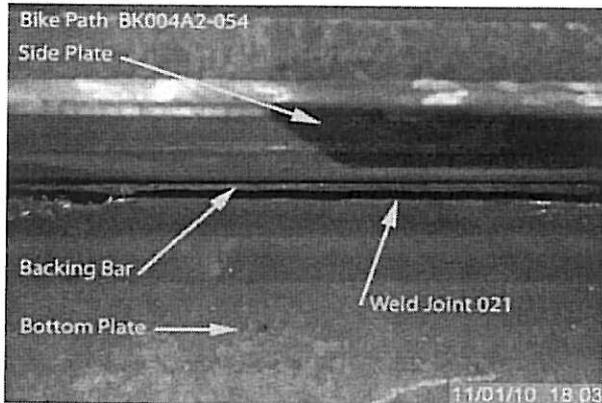
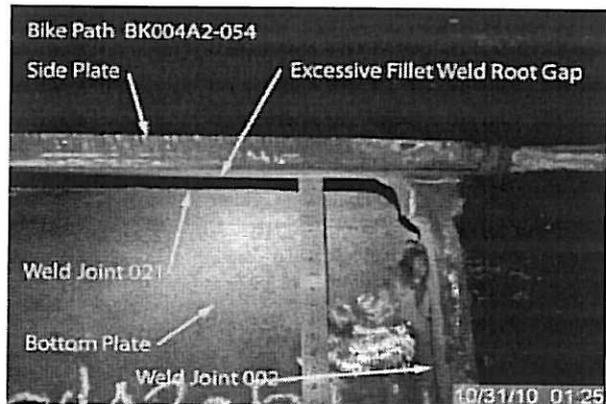
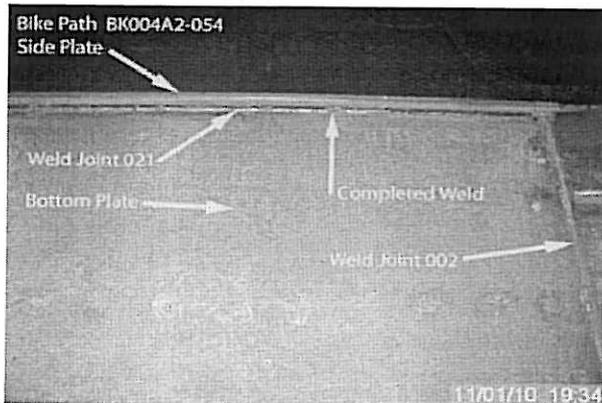
Reference Description: ZPMC performed weld repair without following the WRR for bikepath BK004A2-054; subsequently, alternating the weld detail from the approved shop drawings

-AWS D1.5 2002 section 3.3.1 "The parts to be joined by fillet welds shall be brought into as close contact as practicable. The root opening shall not exceed 5 mm [3/16 in.] except in cases involving either shapes or plates 75 mm [3 in.] or greater in thickness if, after straightening and in assembly, the root opening cannot be closed sufficiently to meet this tolerance. In such cases, a maximum root opening of 8 mm [3/16 in.] may be used, with a backing weld or suitable backing."
