Contract #: 04-0120F4
 Cty: SF/ALA Rte: 80 PM: 13.2/13.9
 File #: 69.25B

QUALITY ASSURANCE -- NON-CONFORMANCE REPORT

Report No: NCR-000885

Reference Description: Longitudinal Diaphragm on 13AE E4 Line Cut beyond dimensions shown on approved shop drawings

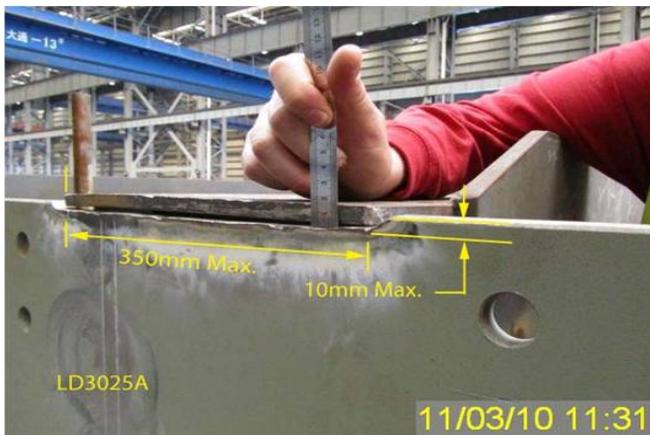
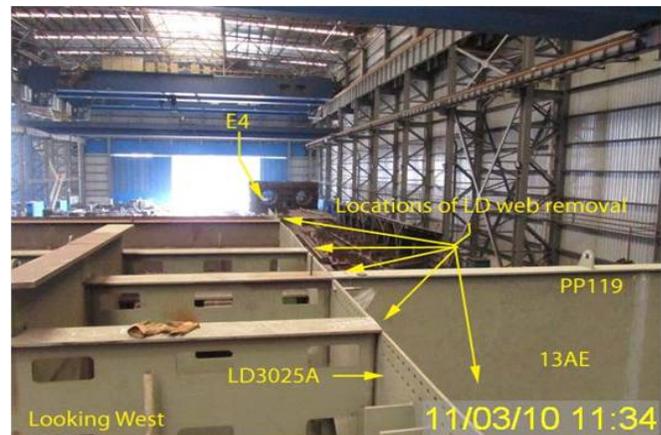
- ZPMC personnel cut out the upper leading edge of the longitudinal diaphragm LD3025A web at a total of five (5) locations to facilitate fit up at the floor beam intersections.
- The Floor beams in way of LD3025A at E4 are identified as FB3106A, FB3123A, FB3110A, FB3126A and FB3119A.
- Maximum dimension of the longitudinal diaphragm web plate removal was 10mm x 350mm.
- Segment 13AE is in the OBG Fabrication bay 14.

See attached photographs for additional detail:

Contractor will perform the work based on TC-RFI 225R0. Contractor will taper the cut out in the noted locations in the LD to a 1:2.5 slope

Contractor has tapered the cut out in the noted location in the LD to a 1:2.5 slope and completed the repair.
