QUALITY ASSURANCE -- NON-CONFORMANCE REPORT

Location: Changxing Island, Shanghai, P.R. China**Report No:** NCR-000886**Prime Contractor:** American Bridge/Fluor Enterprises, a JV**Date:** 03-Nov-2010**Submitting Contractor:** Zhenhua Port Machinery Company, Ltd (ZPMC), Changxing Island**NCR #:** ZPMC-0848**Type of problem:**

Reference Description: ZPMC performed weld repair without MT on the excavation for bikepath BK004A2-054

Job Name: SAS Superstructure
Document No: 05.03.06-000843

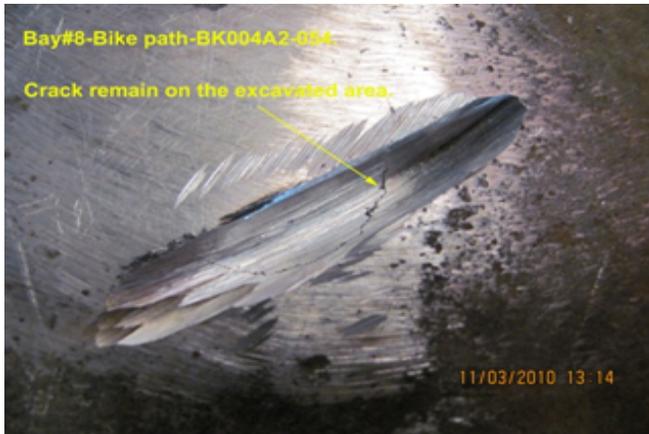
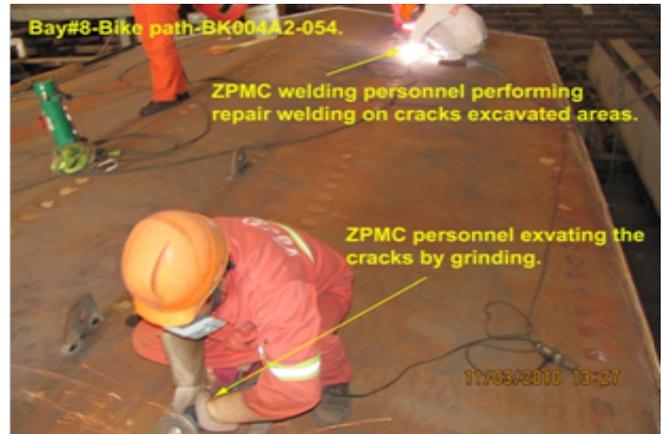
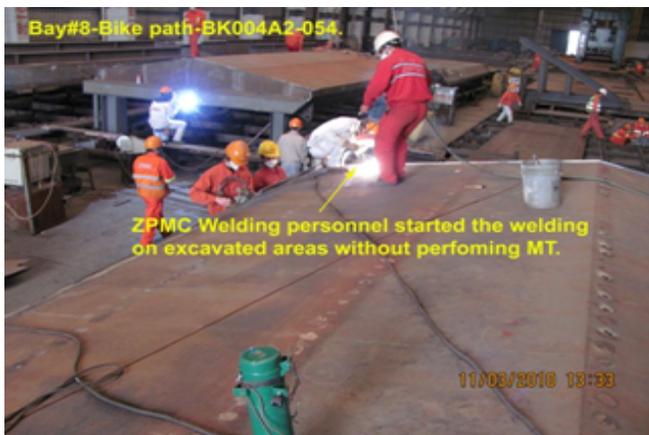
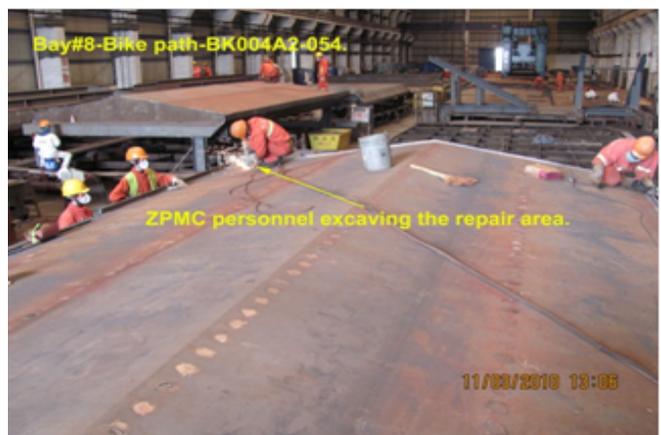
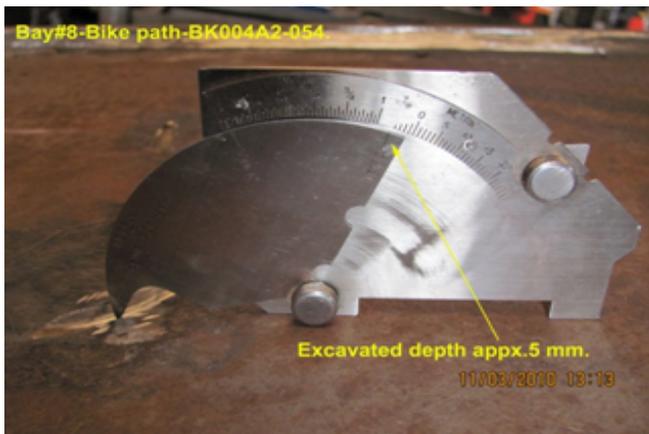
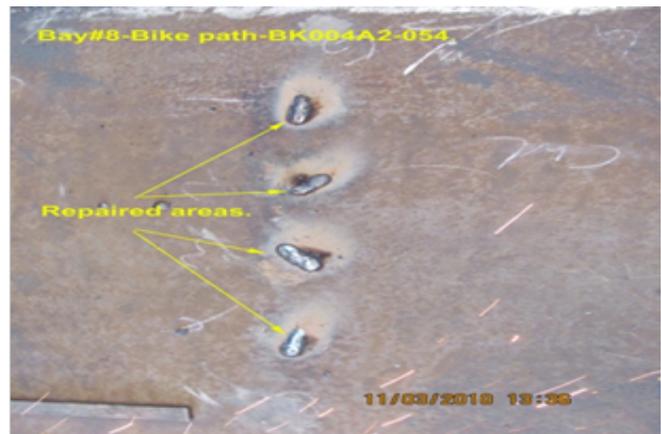
During the Quality Assurance (QA) random visual inspection of the Bike path bottom plate of BK004A2-054, this QA Inspector discovered the following issues:

- ZPMC welding personnel were performing weld repair on the excavated cracked plug welds areas not according to the approved Critical Welding Repair (CWR) report No.B-CWR-2102.

- The approved CWR 2102 specifies that before welding, the excavated areas shall be verified with Visual Testing (VT) and MT to ensure that they are free of defect.

- The excavation depth is approximately 5 mm in depth.
- ZPMC personnel did not verify the excavated area by MT prior to welding.
- QA noted that the excavated area has a crack and reminded ZPMC that MT shall be performed prior to weld repair.

- The weld with the VT crack is BK004A2-054-020 (3rd hole from BKPL6B)
- ZPMC proceeded with welding without MT.
- The Bike path number is identified as BK004A2-054.

- The welds are identified as BK004A2-054-014,015,017,019,020.
- The thickness of the bottom plate is 6 mm.
- This Bike Path is located in Sub assembly Bay#8.

ZPMC has removed the weld observed with the indication, performed the MT after excavation and MT after the repair. ZPMC has issued an internal NCR to document this non conformance and is providing the NDT after to show the weld is acceptable. ZPMC requests closure of this NCR.

The weld in question was removed and the affected area including the location where original defects found was inspected by MT. MT was also performed after the subsequent repair. NDT report showed that the original defects have been removed and the repair was acceptable. Internal NCR was issued by ZPMC to the welder and QC involved.

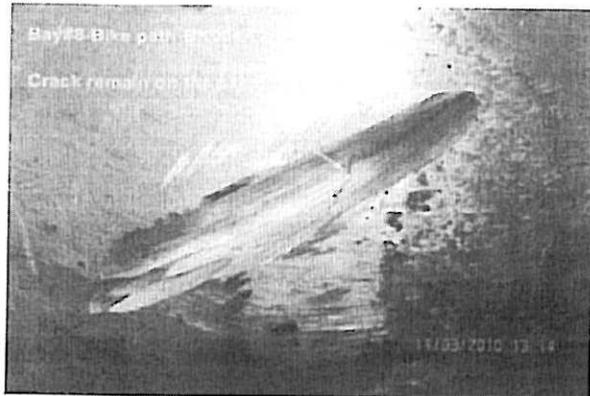
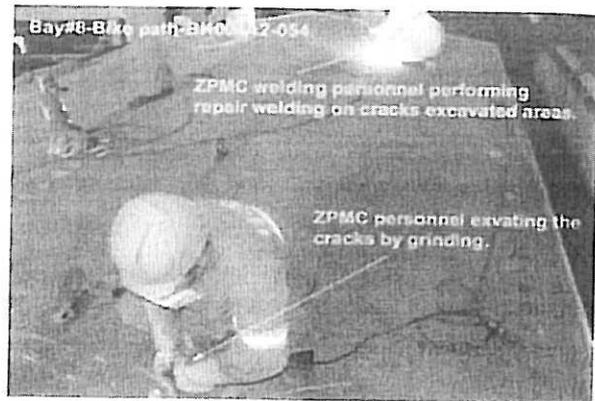
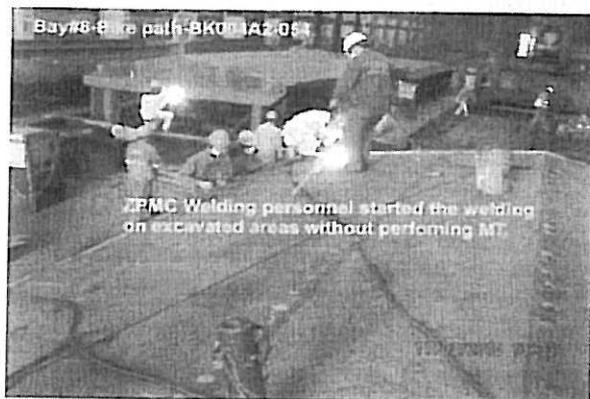
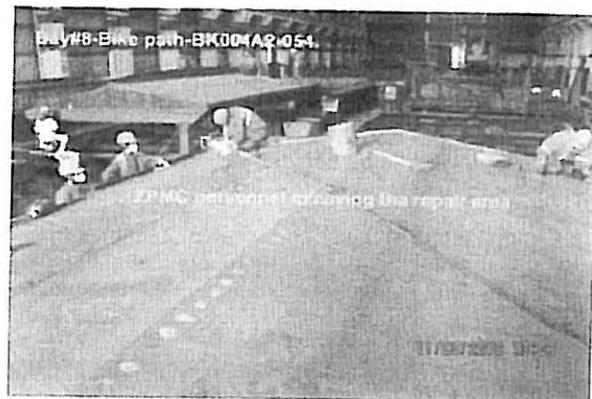
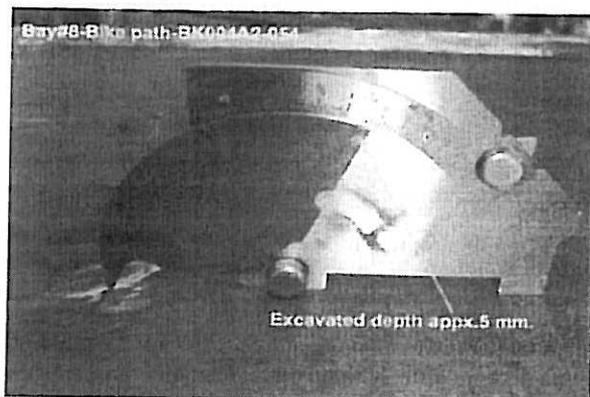
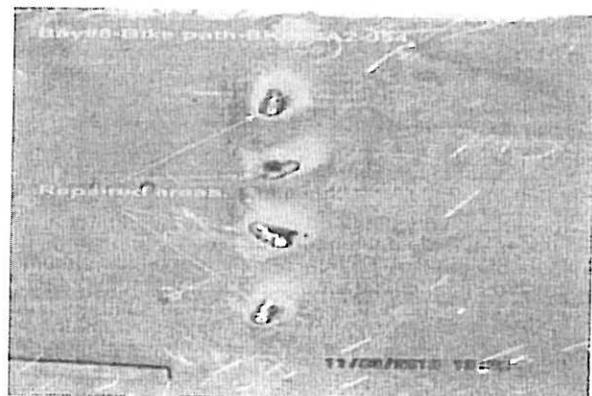
During the Quality Assurance (QA) random visual inspection of the Bike path bottom plate of BK004A2-054, this QA Inspector discovered the following issues:

- ZPMC welding personnel were performing weld repair on the excavated cracked plug welds areas not according to the approved Critical Welding Repair (CWR) report No.B-CWR-2102.

- The approved CWR 2102 specifies that before welding, the excavated areas shall be verified with Visual Testing (VT) and MT to ensure that they are free of defect.

- The excavation depth is approximately 5 mm in depth.
- ZPMC personnel did not verify the excavated area by MT prior to welding.
- QA noted that the excavated area has a crack and reminded ZPMC that MT shall be performed prior to weld repair.

- The weld with the VT crack is BK004A2-054-020 (3rd hole from BKPL6B)
- ZPMC proceeded with welding without MT.
- The Bike path number is identified as BK004A2-054.

- The welds are identified as BK004A2-054-014,015,017,019,020.
- The thickness of the bottom plate is 6 mm.
- This Bike Path is located in Sub assembly Bay#8.

ZPMC to remove the weld in question, identify the indications found and perform MT after the excavation and before reweld. Perform MT after the weld repair. ZPMC to issue internal NCR to the parties involved.
