Contract #: 04-0120F4Cty: SF/ALA Rte: 80 PM: 13.2/13.9File #: 69.25B**QUALITY ASSURANCE -- NON-CONFORMANCE REPORT****Location:** Changxing Island, Shanghai, P.R. China**Report No:** NCR-000891**Prime Contractor:** American Bridge/Fluor Enterprises, a JV**Date:** 12-Nov-2010**Submitting Contractor:** Zhenhua Port Machinery Company, Ltd (ZPMC), Changxing Island**NCR #:** ZPMC-0853**Type of problem:**

Welding	Concrete	Other	
Welding	Curing	Procedural	Bridge No: 34-0006
Joint fit-up	Coating	Other	Component: Bikepath BK004A-025
Procedural	Procedural	Description: Reduced Plate Thickness

Reference Description: QA found the thickness of a plate is reduced in the bikepath after ZPMC had tested and accepted the weld visually

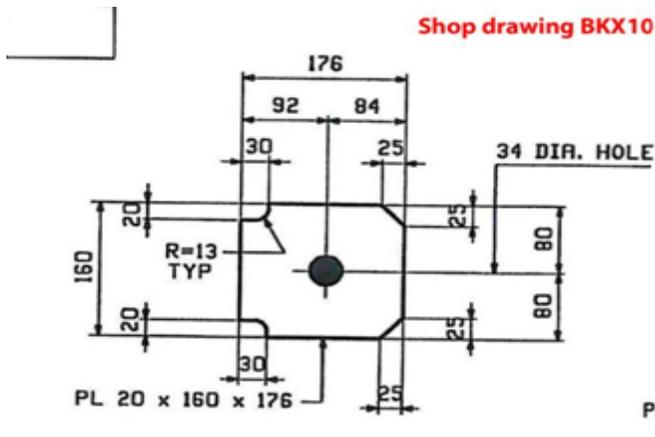
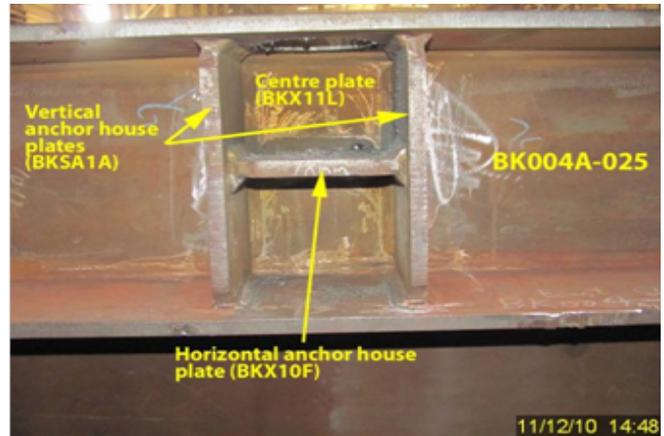
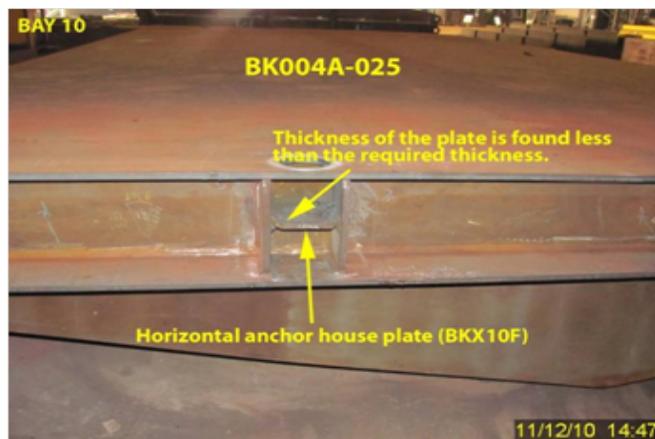
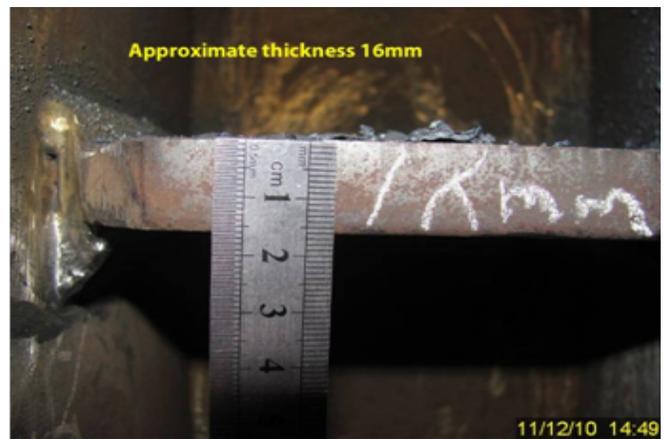
During the Quality Assurance (QA) Visual Testing (VT) verification of welds located on the vertical and horizontal anchor house plate of OBG bike path BK004A-025, this QA Inspector discovered the following issues:

- The thickness of an already welded horizontal anchor house plate (BKX10F) is found 4mm reduced uniformly in comparison to the approved shop drawings.
- As per shop drawing the required nominal thickness of the horizontal anchor house plate (BKX10F) is 20mm.
- The actual thickness of the BKX10F plate welded was found approximately 16mm.
- The material grade for the 16mm horizontal plate is unknown.
- This plate is located at east side of stringer plate 9C.
- The horizontal anchor house plate (BKX10F) joining the vertical anchor house plates and centre plate (BKX11L).
- The weld numbers are identified as; BK004A4-025-080, 100, 082, 101 and BK004A4-025-083, 102 respectively.
- The member is located in Bay 10.

The Notice of Witness Inspection Number (NWIT) is 07326 for visual inspection. These areas have been previously tested and accepted by ZPMC Quality Control (QC) personnel.

Reference Resolution: The plate with incorrect thickness has been replaced with a plate of the correct thickness. ZPMC has issued an internal NCR to document this incident.

The plate with incorrect thickness has been replaced with a plate of the correct thickness. ZPMC has issued an internal NCR to document this incident. This has been verified by the Department's inspectors see the attached notification for the date verified. Based on this ZPMC requests closure of this NCR.

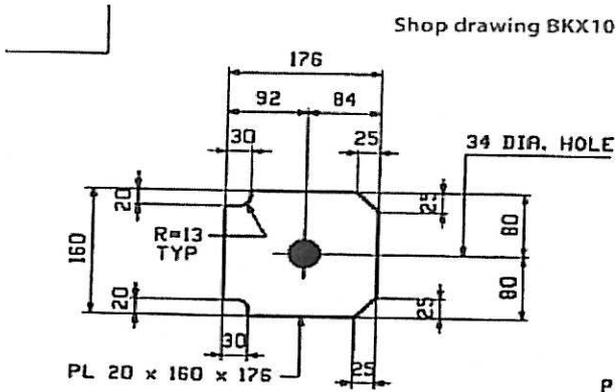
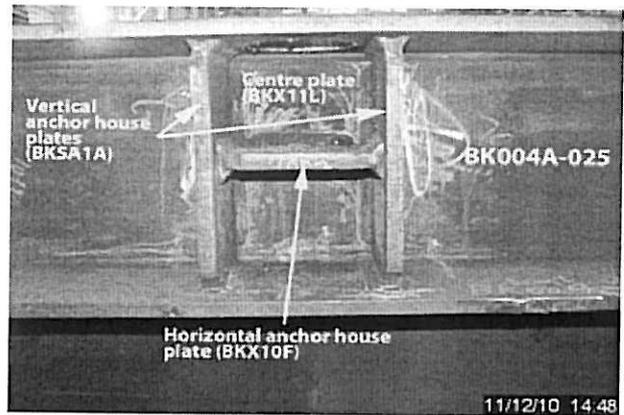
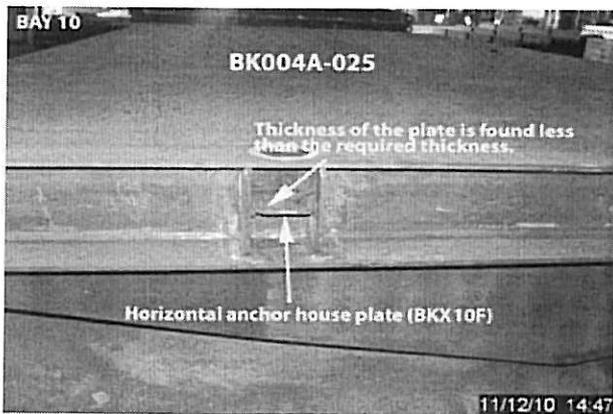
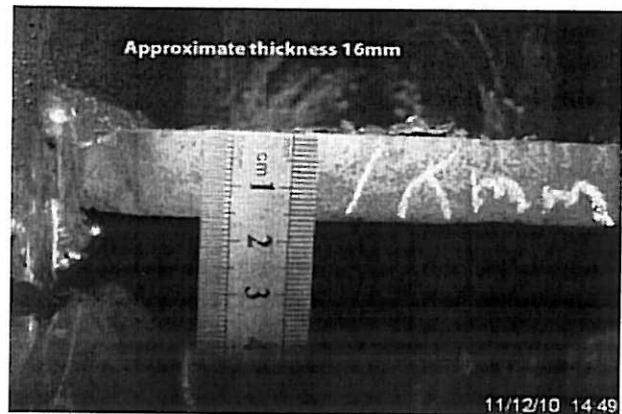
During the Quality Assurance (QA) Visual Testing (VT) verification of welds located on the vertical and horizontal anchor house plate of OBG bike path BK004A-025, this QA Inspector discovered the following issues:

- The thickness of an already welded horizontal anchor house plate (BKX10F) is found 4mm reduced uniformly in comparison to the approved shop drawings.
- As per shop drawing the required nominal thickness of the horizontal anchor house plate (BKX10F) is 20mm.
- The actual thickness of the BKX10F plate welded was found approximately 16mm.
- The material grade for the 16mm horizontal plate is unknown.
- This plate is located at east side of stringer plate 9C.
- The horizontal anchor house plate (BKX10F) joining the vertical anchor house plates and centre plate (BKX11L).
- The weld numbers are identified as; BK004A4-025-080, 100, 082, 101 and BK004A4-025-083, 102 respectively.
- The member is located in Bay 10.

The Notice of Witness Inspection Number (NWIT) is 07326 for visual inspection. These areas have been previously tested and accepted by ZPMC Quality Control (QC) personnel.

Replace the non-conforming plate with a plate of correct thickness. Issue internal NCR to the parties involved.

The under thickness plate was replaced, verified by QA inspectors. Internal NCR was issued by ZPMC.
