Contract #: 04-0120F4Cty: SF/ALA Rte: 80 PM: 13.2/13.9File #: 69.25B**QUALITY ASSURANCE -- NON-CONFORMANCE REPORT****Location:** Changxing Island, Shanghai, P.R. China**Report No:** NCR-000892**Prime Contractor:** American Bridge/Fluor Enterprises, a JV**Date:** 13-Nov-2010**Submitting Contractor:** Zhenhua Port Machinery Company, Ltd (ZPMC), Changxing Island**NCR #:** ZPMC-0854**Type of problem:**

Welding	Concrete	Other	
Welding	Curing	Procedural	Bridge No: 34-0006
Joint fit-up	Coating	Other	Component: Segment 11AW Counterweight connection plate
Procedural	Procedural	Description: QA found 2 missed UT indications

Reference Description: QA found 2 missed UT indications after ZPMC had tested and accepted the weld at Segment 11AW countweight connection plate

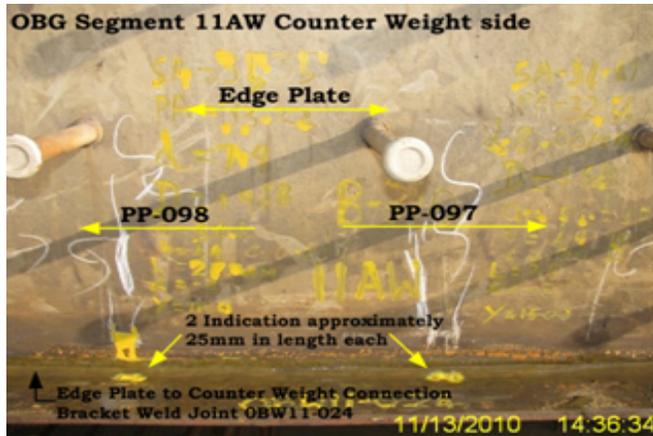
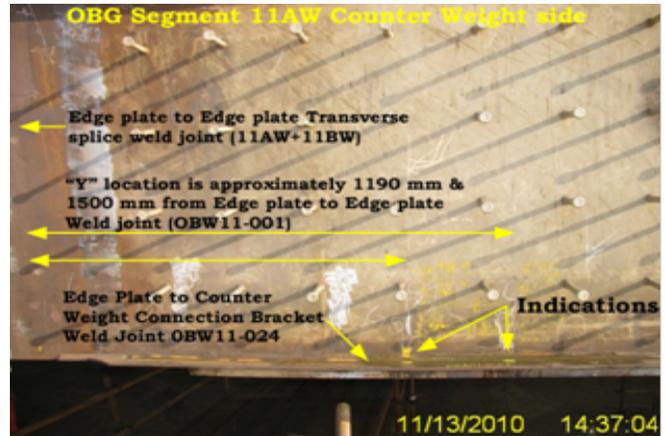
During the Quality Assurance (QA) Ultrasonic Testing (UT) review of welds located on Orthotropic Box Girder (OBG) Segment 11AW, this QA Inspector discovered the following issues:

- Two (2) Class "A" longitudinal linear indication measuring approximately 25mm in length each.
- The indications dB rating are +9dB, and +6dB.
- The thickness of the plate is 10 mm; the depth of both of the indications is approximately 8 mm.

- Both indications are located on the weld joint identified as OBW11-024.
- The weld is a Complete Joint Penetration (CJP) corner joint joining Edge Plate to Counter Weight Connection Bracket.

- The weld is designated as Non Seismic Performance Critical Material (Non SPCM).
- These indications are clearly marked on or near the weld.
- OBG Segment 11AW is located on Trial Assembly Yard.

- The "Y" location for these indications is approximately 1190 mm & 1500 mm from Edge plate to Edge plate Transverse splice Weld joint (OBW11-001).
- The Notice of Witness Inspection (NWIT) No. is 007333. The indication is located within the area previously tested and accepted by ZPMC Quality Control (QC) personnel. As per the contract documents, ZPMC's QC personnel are required to 100% UT inspection of this weld.

-AWS D1.5-02 Section 6; Table 6.3 specifies a class "A" indication as having a rating of 10dbs and under for material thicknesses 8mm through 20mm.

Contractor will perform weld repair accordance with CWR. NDT will be performed after repair. NDT report will prove the weld is free of indications.

Contractor repaired the weld according to CWR. NDT performed after repair. NDT results show the weld is acceptable.

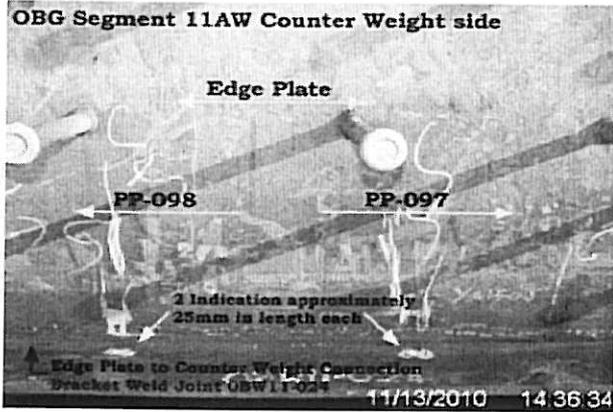
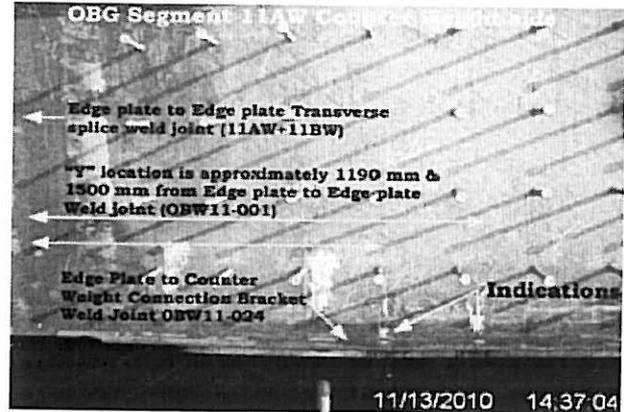
During the Quality Assurance (QA) Ultrasonic Testing (UT) review of welds located on Orthotropic Box Girder (OBG) Segment 11AW, this QA Inspector discovered the following issues:

- Two (2) Class "A" longitudinal linear indication measuring approximately 25mm in length each.
- The indications dB rating are +9dB, and +6dB.
- The thickness of the plate is 10 mm; the depth of both of the indications is approximately 8 mm.

- Both indications are located on the weld joint identified as OBW11-024.
- The weld is a Complete Joint Penetration (CJP) corner joint joining Edge Plate to Counter Weight Connection Bracket.

- The weld is designated as Non Seismic Performance Critical Material (Non SPCM).
- These indications are clearly marked on or near the weld.
- OBG Segment 11AW is located on Trial Assembly Yard.

- The "Y" location for these indications is approximately 1190 mm & 1500 mm from Edge plate to Edge plate Transverse splice Weld joint (OBW11-001).
- The Notice of Witness Inspection (NWIT) No. is 007333. The indication is located within the area previously tested and accepted by ZPMC Quality Control (QC) personnel. As per the contract documents, ZPMC's QC personnel are required to 100% UT inspection of this weld.

-AWS D1.5-02 Section 6; Table 6.3 specifies a class "A" indication as having a rating of 10dbs and under for material thicknesses 8mm through 20mm.
