Contract #: 04-0120F4
 Cty: SF/ALA Rte: 80 PM: 13.2/13.9
 File #: 69.25B

QUALITY ASSURANCE -- NON-CONFORMANCE REPORT

Location: Changxing Island, Shanghai, China **Report No:** NCR-000894
Prime Contractor: American Bridge/Fluor Enterprises, a JV **Date:** 22-Nov-2010
Submitting Contractor: Zhenhua Port Machinery Company, Ltd (ZPMC), Changxing Island **NCR #:** ZPMC-0856

Reference Description: Heat Straightening Performed without Prior Approval From Engineer

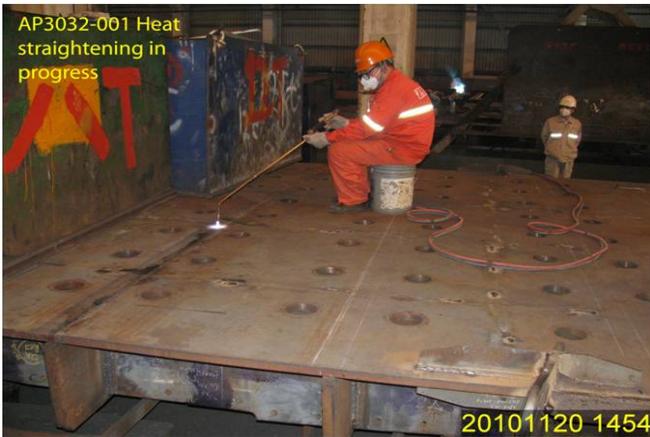
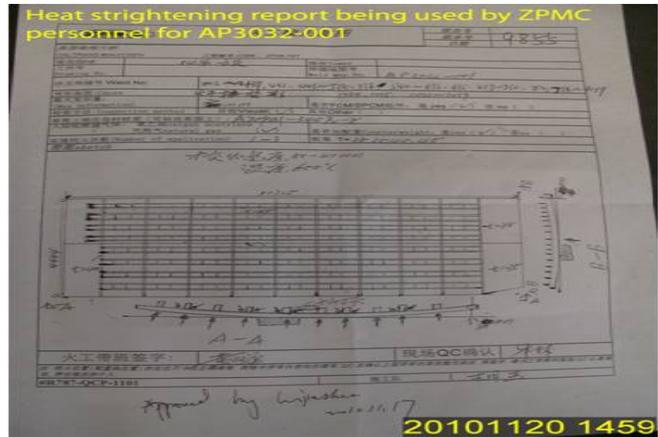
During the Quality Assurance Daily Observation of fabrication heat straightening of AP3032-001 this Quality Assurance Inspector (QA) discovered the following issues:

- ZPMC personnel heat straightening excessive distortion on Seismic Performance Critical Material (SPCM) material distorted by welding without the Engineers approval.
- ZPMC appeared to be following Heat Straightening procedure HSR1-(B)-9855
- The component is identified as AP3032-001.
- The plates that heat was being applied to were X5055A and X5055B.
- The OBG anchorage plate AP3032-001 is located in Bay 2.

- The Material thickness is 35mm.

Special Provisions Section 8.3 – “For material more than 16 mm, the Contractor shall not heat straighten members more than 3 in 1000 without prior approval of the Engineer.”

AWS D1.5M – 2002 section 3.7.3 Repairs – “Members distorted by welding shall be straightened by mechanical means or by carefully supervised application of a limited amount of localized heat as approved by the Engineer.”

According to the Special Provision Clause 10-1.59 'Structural Steel, material greater than 16mm in thickness the ratio of distortion allowed is 3 in 1000 mm before Engineer approval is required. The plate length is 10315 mm and the measured distortion is 30mm which is within the tolerances for using an HSR1. Contractor does not consider this is non-conforming and proposes no corrective action is required.

Following clarification by ZPMC and discussion involved all parties including QA personnel from Department and ABF the misunderstanding on the exact measurements has been resolved. The QA was satisfied that the distortion measurements were within the allowed tolerance as defined in the Contract and accepted that the correction can be performed as per the Correction Procedure. No corrective action is required.
