QUALITY ASSURANCE -- NON-CONFORMANCE REPORT

Location: Changxing Island, Shanghai, China**Report No:** NCR-000895**Prime Contractor:** American Bridge/Fluor Enterprises, a JV**Date:** 23-Nov-2010**Submitting Contractor:** Zhenhua Port Machinery Company, Ltd (ZPMC), Changxing Island**NCR #:** ZPMC-0857**Type of problem:**

Reference Description: Weld Procedure Requirements for New Welds Not Followed**Description of Non-Conformance:**

To: AMERICAN BRIDGE/FLUOR, A JV **Date:** 24-Nov-2010
 375 BURMA ROAD
 OAKLAND CA 95607 **Contract No:** 04-0120F4
 04-SF-80-13.2 / 13.9
Dear: Mr. Charles Kanapicki **Job Name:** SAS Superstructure
Attention: Mr. Thomas Nilsson Project/Fabrication Manager **Document No:** 05.03.06-000852
Subject: NCR No. ZPMC-0857
Reference Description: Weld Procedure Requirements for New Welds Not Followed

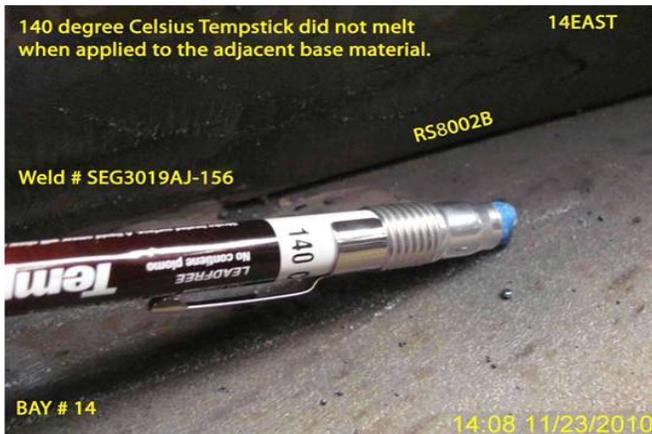
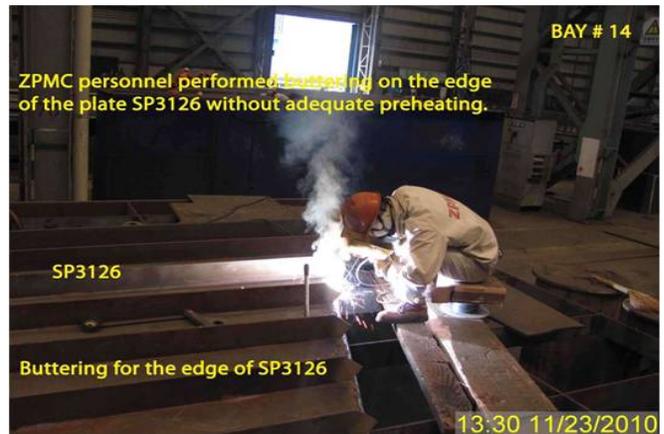
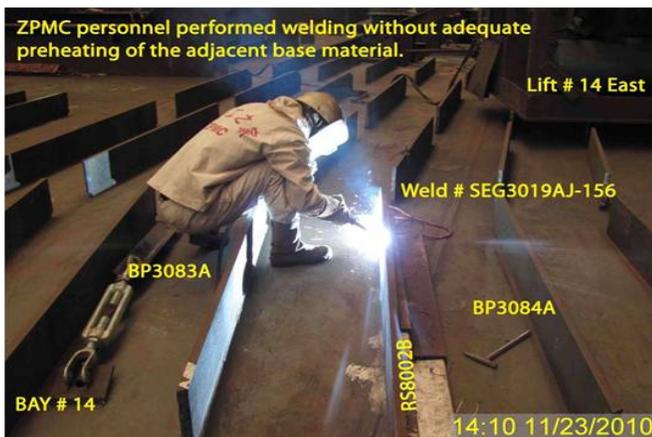
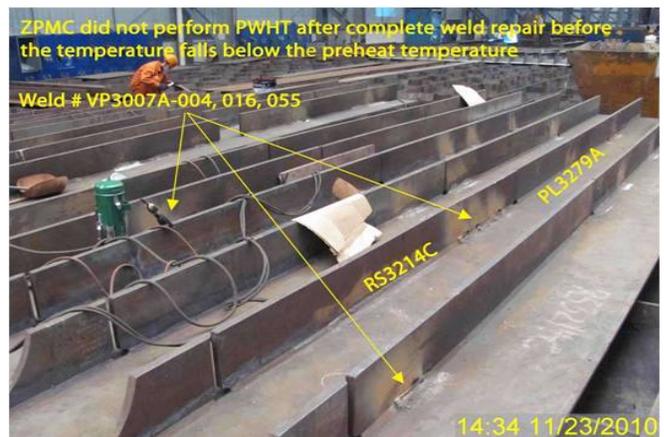
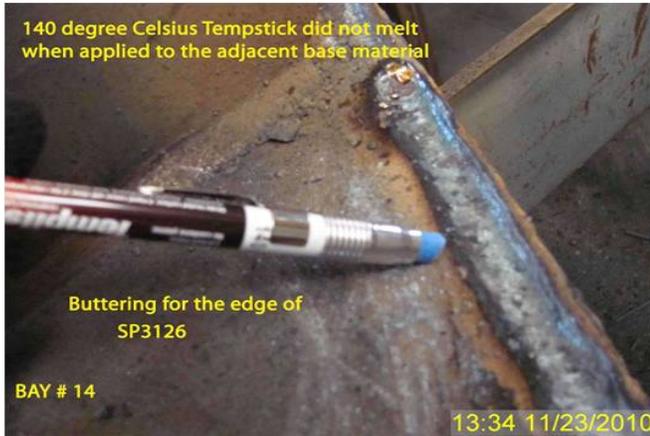
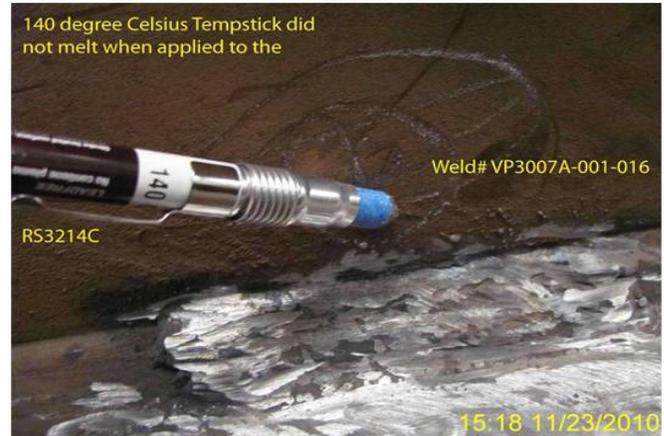
- ZPMC personnel performed welding for the fillet weld between "I" stiffener and bottom panel without adequate preheating of the adjacent base material.
- During the welding This QA Inspector observed a 140 degree Celsius Tempstick did not melt when applied to the adjacent base material.
- Weld number identified as SEG3019AJ-156
- Rib stiffener identified as RS8002B
- Bottom plate identified as BP3084A and BP3083A
- BP3083A and BP3084A are designated on the approved shop drawings as Seismic Performance Critical Members (SPCM).
- The welding performed with Flux Cored Arc Welding (FCAW) process.
- Area was being preheated using electric strip heaters.
- OBG Lift 14 East in bay # 14

- ZPMC did not perform PWHT after complete weld repair before the temperature falls below the preheat temperature on the weld joint between "I" rib stiffeners (RS3214C) to the plate (PL3279A).
- This QA Inspector observed a 140 degree Celsius Tempstick did not melt when applied to the adjacent base material

- Weld number identified as VP3007A-001-016, 004, 055
- PL3279A designated on the approved shop drawings as Seismic Performance Critical Members SPCM)
- The welding performed with Shielded Metal Arc Welding (SMAW) process
- This welds are detailed as a complete joint penetration (CJP), Fracture critical weld (FCW)

- ZPMC personnel performed buttering on the edge of the plate SP3126 without adequate preheating of the adjacent base material.
- This QA Inspector observed a 140 degree Celsius Tempstick did not melt when applied to the adjacent base material
- The welding performed with Shielded Metal Arc Welding (SMAW) process
- Did not appear any electric strip heaters or torch

Contractor provided the NDT report. The NDT report shows the welds are acceptable.

The repaired area on plate SP3126 has been inspected and green tagged. Green tag no.:14479.
