QUALITY ASSURANCE -- NON-CONFORMANCE REPORT

Report No: NCR-000896

NCR #: ZPMC-0858

Reference Description: Weld Procedure Requirements for New Welds Not Followed

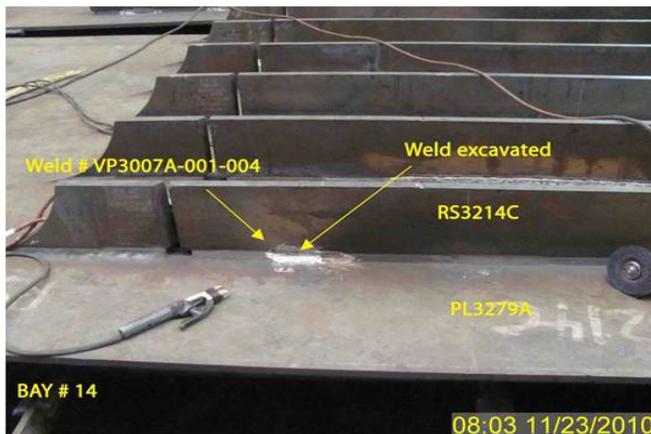
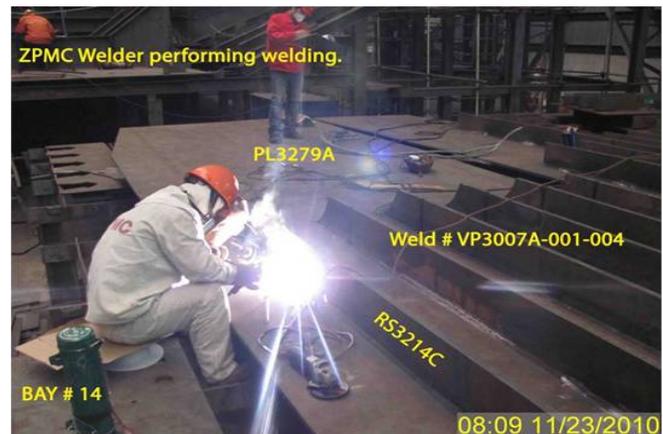
- ZPMC personnel performed weld repair for the weld between "I" rib stiffener (RS3214C) and plate (PL3279A) without performing NDT (Magnetic Particle testing) on the excavated area.
- Weld number identified as VP3007A-001-004
- Weld details as complete joint penetration(CJP) , Fracture critical weld (FCW)
- PL3279A designated on the approved shop drawings as Seismic Performance Critical Members (SPCM).
- The welding performed with Shielded Metal Arc Welding (SMAW) process.

See attached photographs for additional detail.

6A Non Destructive Testing: All back gouged groove welds are to have their gouged areas ground to bright metal and inspected 100% by VT and MT examination before welding may begin from the second side.

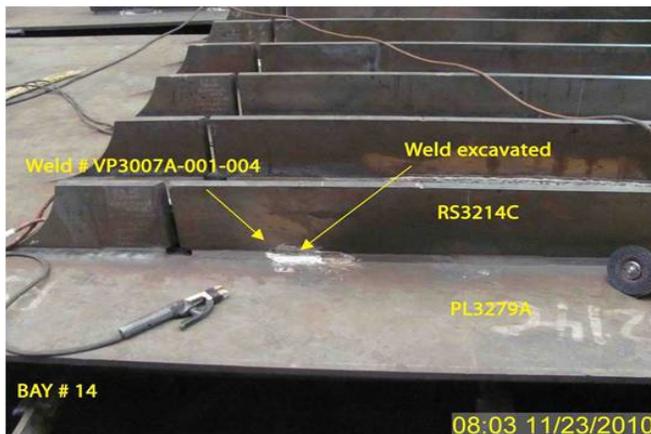
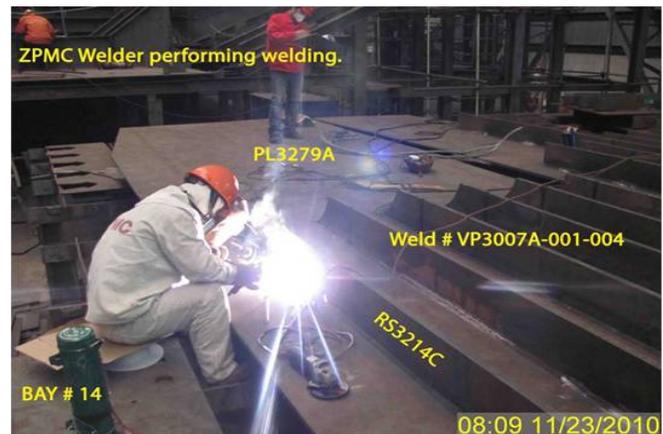
- ZPMC personnel performed weld repair for the weld between "I" rib stiffener (RS3214C) and plate (PL3279A) without performing NDT (Magnetic Particle testing) on the excavated area.
- Weld number identified as VP3007A-001-004
- Weld details as complete joint penetration(CJP) , Fracture critical weld (FCW)
- PL3279A designated on the approved shop drawings as Seismic Performance Critical Members (SPCM).
- The welding performed with Shielded Metal Arc Welding (SMAW) process.

See attached photographs for additional detail.

6A Non Destructive Testing: All back gouged groove welds are to have their gouged areas ground to bright metal and inspected 100% by VT and MT examination before welding may begin from the second side.
