Contract #: 04-0120F4Cty: SF/ALA Rte: 80 PM: 13.2/13.9File #: 69.25B

QUALITY ASSURANCE -- NON-CONFORMANCE REPORT

Location: Changxing Island, Shanghai, China**Report No:** NCR-000901**Prime Contractor:** American Bridge/Fluor Enterprises, a JV**Date:** 23-Nov-2010**Submitting Contractor:** Zhenhua Port Machinery Company, Ltd (ZPMC), Changxing Island**NCR #:** ZPMC-0863**Type of problem:**

Reference Description: New Weld Procedure Not Followed (Rager/McQuaid)**Description of Non-Conformance:**

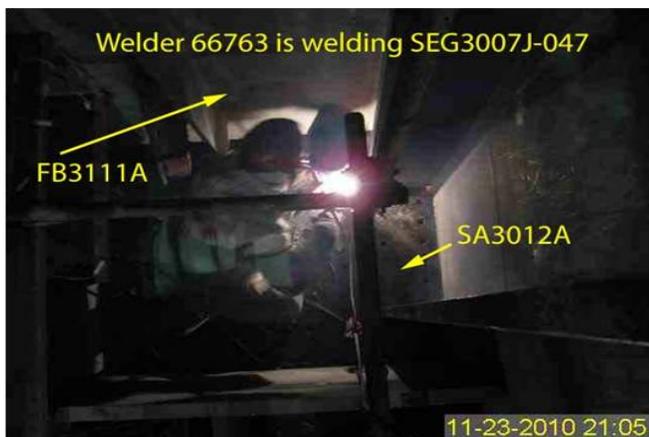
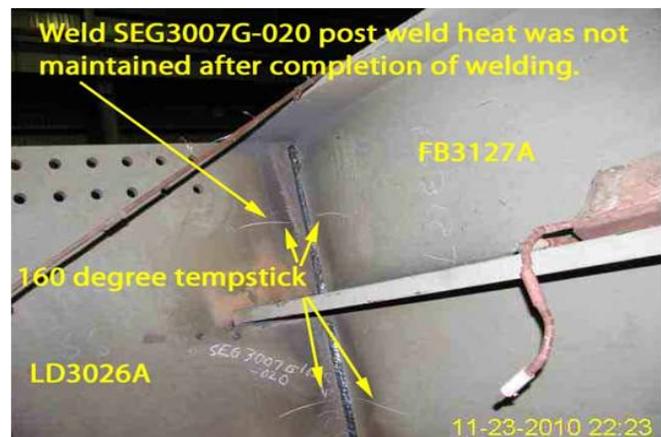
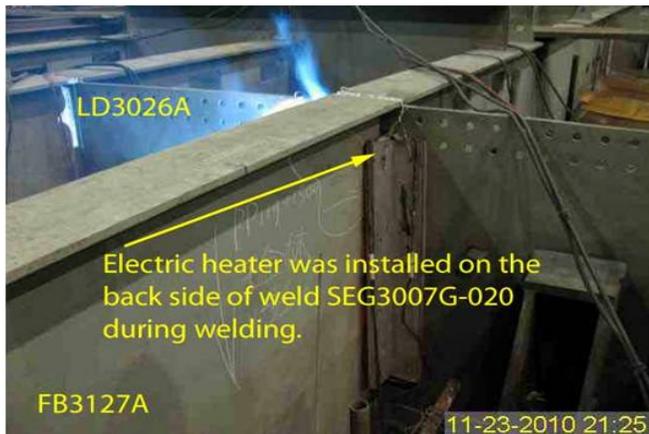
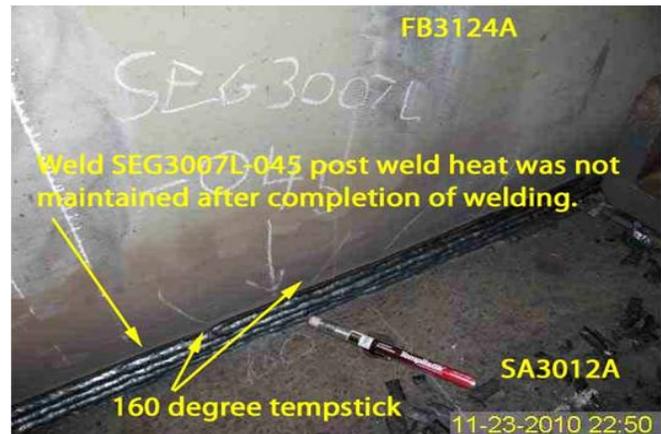
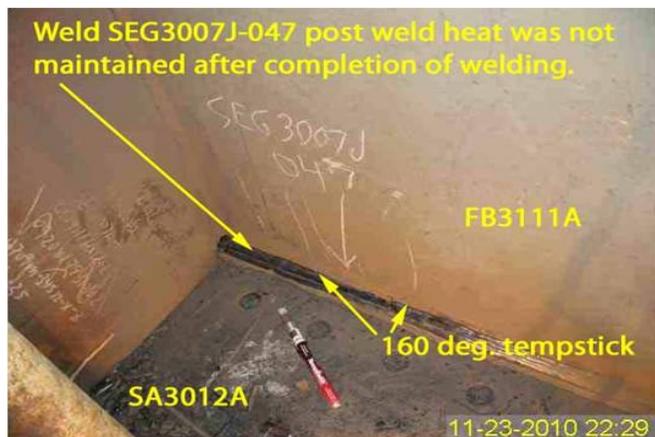
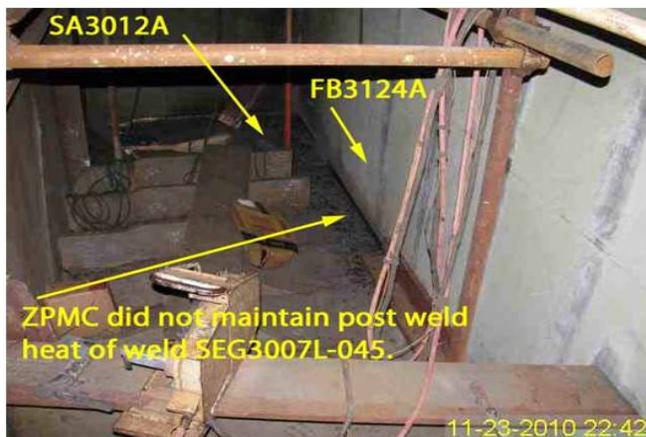
During Caltrans QA in process observations of the fabrication of Orthotropic Box Girder (OBG) 13AE welds SEG3007J-047, SEG3007G-020 and SEG007L-045, QA discovered ZPMC welding personnel did not appear to be following the NEW WELD PROCEDURE (Rager/McQuaid)

The following requirements were not followed:

5. Postweld Thermal Treatment (5A, 5C, 5D)

The weld was identified as SEG3007J-047

The weld is a complete joint penetration weld that joins FB3111A to bottom plate SA3012A

FB3111A and SA3012A are designated on the approved shop drawings as Seismic Performance Critical Members. This OBG segment 13AE weld is located in Bay 14

The weld was identified as SEG3007G-020

The weld is a complete joint penetration weld that joins FB3127A to longitudinal diaphragm LD3026A,

FB3127A and LD3026A are designated on the approved shop drawings as Seismic Performance Critical Members. This OBG segment 13AE weld is located in Bay 14

The weld was identified as SEG3007L-045

The weld is a complete joint penetration weld that joins FB3124A to bottom plate SA3012A

FB3124A and SA3012A are designated on the approved shop drawings as Seismic Performance Critical Members. This OBG segment 13AE weld is located in Bay 14

See attached photographs for additional detail.

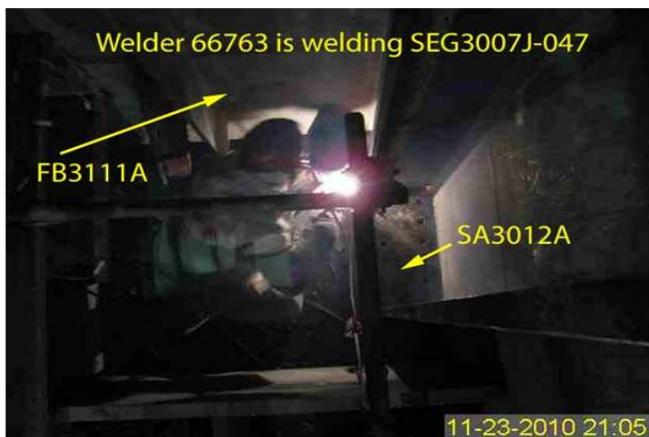
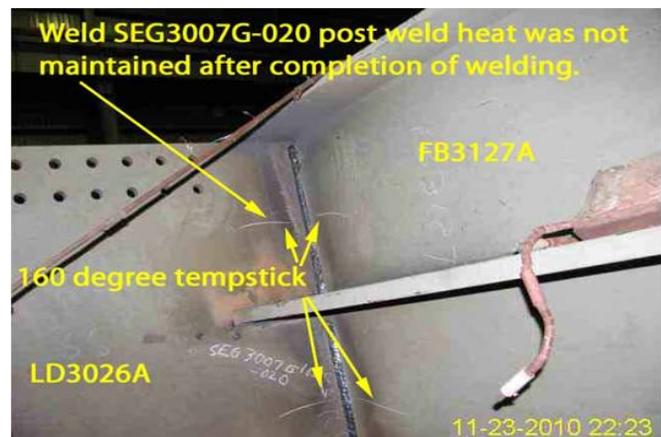
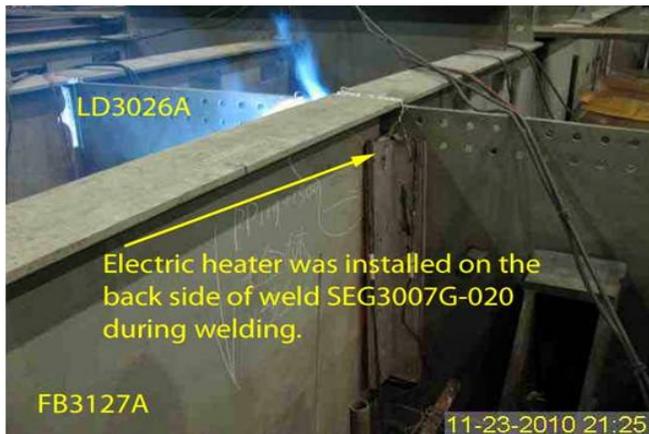
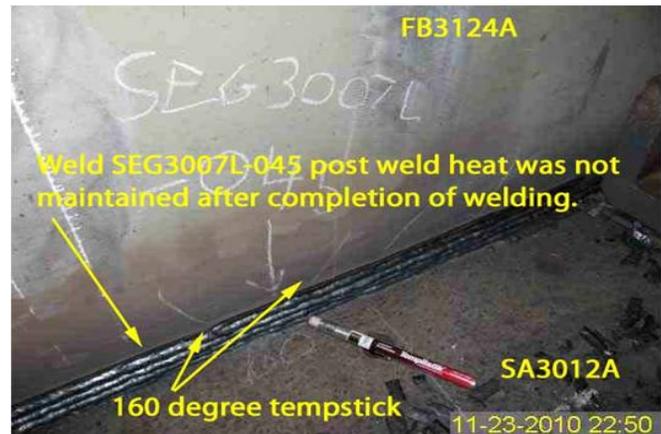
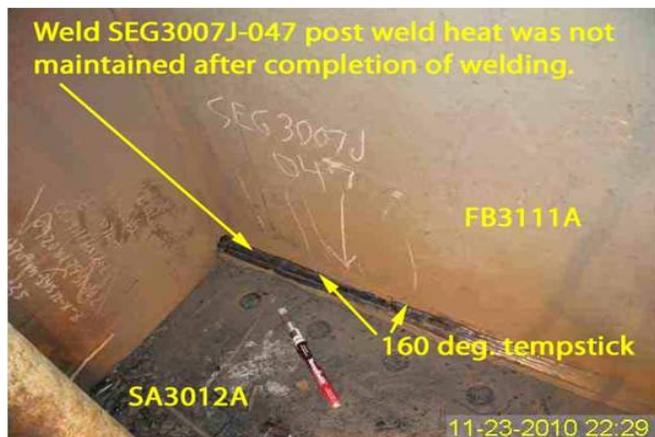
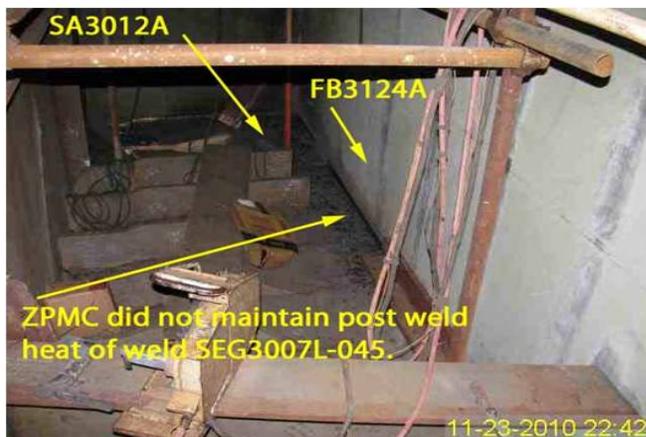
During Caltrans QA in process observations of the fabrication of Orthotropic Box Girder (OBG) 13AE welds SEG3007J-047, SEG3007G-020 and SEG007L-045, QA discovered ZPMC welding personnel did not appear to be following the NEW WELD PROCEDURE (Rager/McQuaid)

The following requirements were not followed:

5. Postweld Thermal Treatment (5A, 5C, 5D)

The weld was identified as SEG3007J-047

The weld is a complete joint penetration weld that joins FB3111A to bottom plate SA3012A

FB3111A and SA3012A are designated on the approved shop drawings as Seismic Performance Critical Members. This OBG segment 13AE weld is located in Bay 14

The weld was identified as SEG3007G-020

The weld is a complete joint penetration weld that joins FB3127A to longitudinal diaphragm LD3026A,

FB3127A and LD3026A are designated on the approved shop drawings as Seismic Performance Critical Members. This OBG segment 13AE weld is located in Bay 14

The weld was identified as SEG3007L-045

The weld is a complete joint penetration weld that joins FB3124A to bottom plate SA3012A

FB3124A and SA3012A are designated on the approved shop drawings as Seismic Performance Critical Members. This OBG segment 13AE weld is located in Bay 14

See attached photographs for additional detail.
