Contract #: 04-0120F4Cty: SF/ALA Rte: 80 PM: 13.2/13.9File #: 69.25B**QUALITY ASSURANCE -- NON-CONFORMANCE REPORT****Location:** Changxing Island, Shanghai, China**Report No:** NCR-000908**Prime Contractor:** American Bridge/Fluor Enterprises, a JV**Date:** 23-Nov-2010**Submitting Contractor:** Zhenhua Port Machinery Company, Ltd (ZPMC), Changxing Island**NCR #:** ZPMC-0870**Type of problem:****Welding****Concrete****Other****Welding****Curing****Procedural****Bridge No:** 34-0006**Joint fit-up****Coating****Other****Component:** Lift 13AE, SEG3007Q-104**Procedural****Procedural****Description:****Reference Description:** New Welding Procedure Not Followed (Rager/McQuaid)**Description of Non-Conformance:**

During the Quality Assurance (QA) random in-process observations of the fabrication of OBG Lift 13 East in Bay # 14, this Caltrans QA Inspector observed the following:

**To:** AMERICAN BRIDGE/FLUOR, A JV  
375 BURMA ROAD  
OAKLAND CA 95607  
**Date:** 25-Nov-2010  
**Contract No:** 04-0120F4  
04-SF-80-13.2 / 13.9  
**Dear:** Mr. Charles Kanapicki  
**Job Name:** SAS Superstructure  
**Attention:** Mr. Thomas Nilsson Project/Fabrication Manager  
**Document No:** 05.03.06-00086

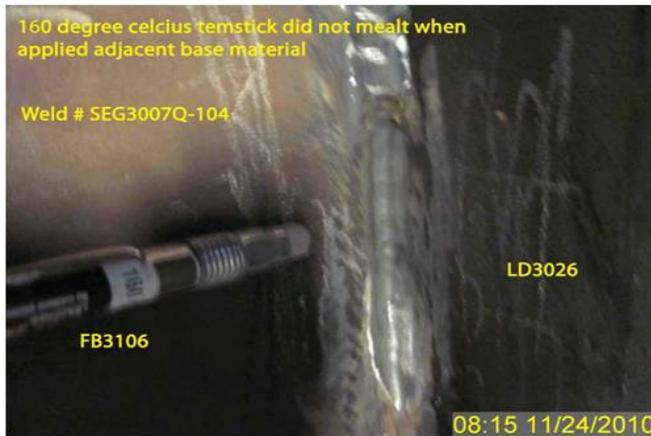
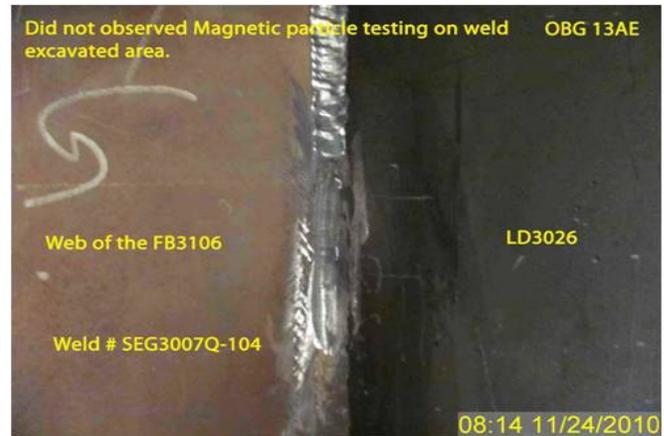
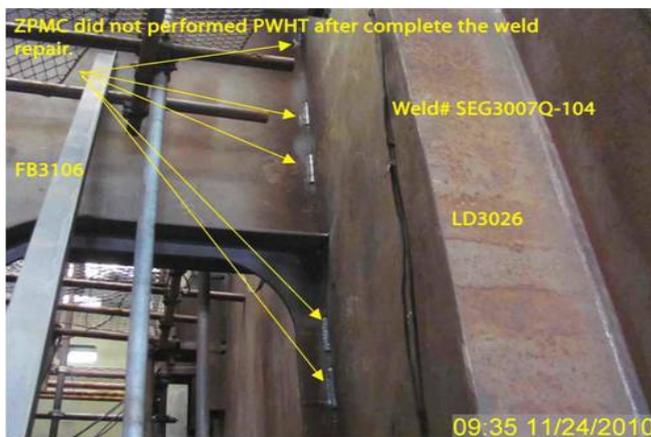
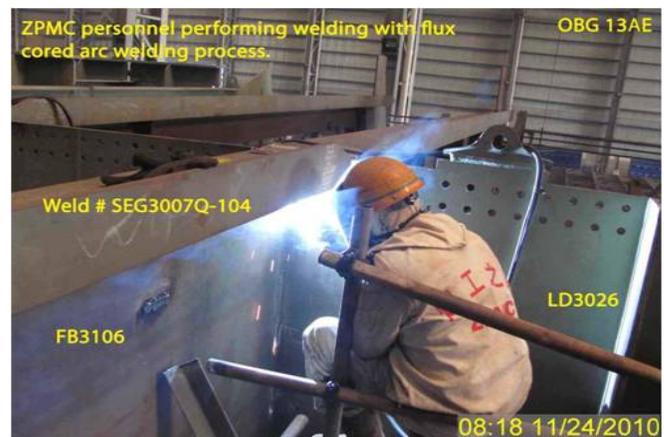
- ZPMC personnel performed weld repair for the weld between longitudinal diaphragm (LD3026) and floor beam web (FB3106) without adequate preheating of the adjacent base material.

- ZPMC did not perform NDT (Magnetic Particle testing) on the weld excavated area.

- ZPMC did not perform PWHT after complete weld repair before the temperature falls below the preheat temperature

-During the welding This QA Inspector observed a 160 degree Celsius Tempstick did not melt when applied to the adjacent base material.

-Weld number identified as SEG3007Q-104

-Did not appear any electric strip heaters or torch

-OBG lift 13 East in bay # 14

Propose a resolution for the identified non-conformance with revised procedures to prevent future occurrences. A response for the resolution of this issue is expected within 7 days.

CT acknowledges contractor's response. However, successful NDT will close this NCR.

This proposed resolution is acceptable. The documentation received is sufficient and the Department concurs that Non-Conformance ZPMC-0870 is closed.

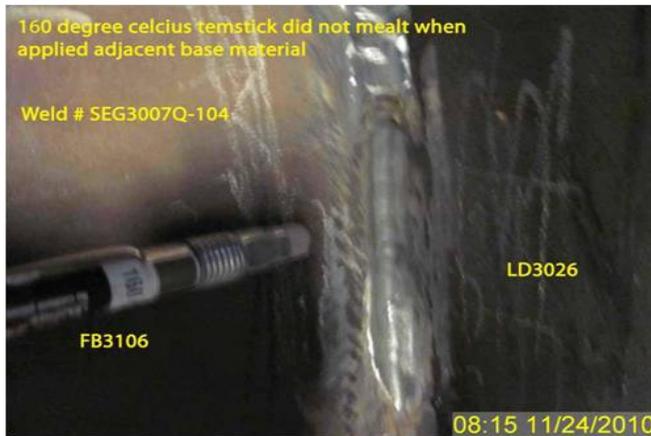
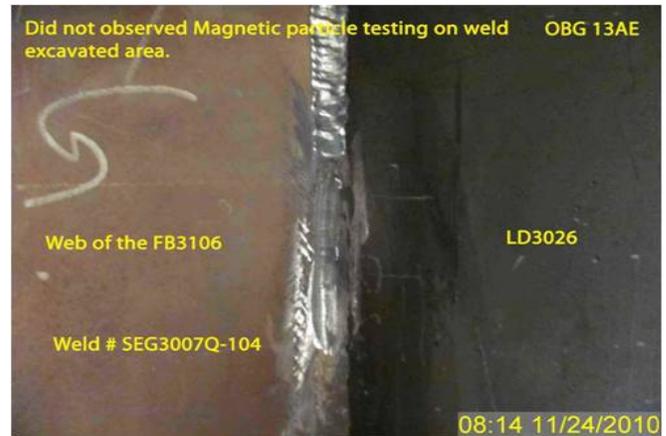
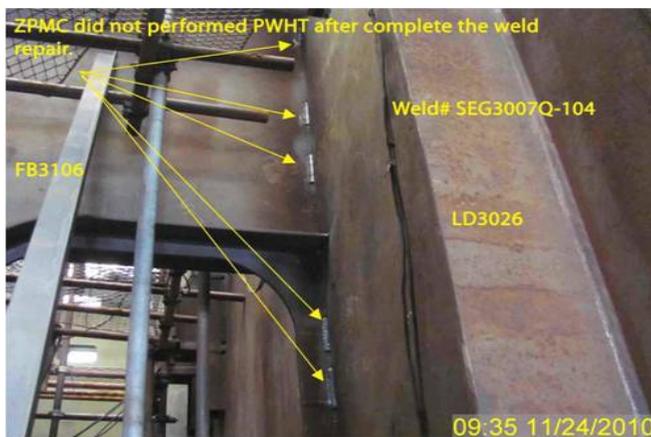
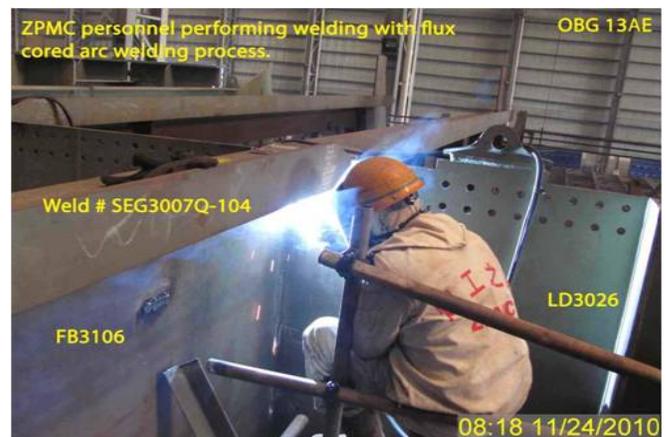
- ZPMC personnel performed weld repair for the weld between longitudinal diaphragm (LD3026) and floor beam web (FB3106) without adequate preheating of the adjacent base material.

- ZPMC did not perform NDT (Magnetic Particle testing) on the weld excavated area.

- ZPMC did not perform PWHT after complete weld repair before the temperature falls below the preheat temperature

-During the welding This QA Inspector observed a 160 degree Celsius Tempstick did not melt when applied to the adjacent base material.

-Weld number identified as SEG3007Q-104

-Did not appear any electric strip heaters or torch

-OBG lift 13 East in bay # 14
