Contract #: 04-0120F4Cty: SF/ALA Rte: 80 PM: 13.2/13.9File #: 69.25B**QUALITY ASSURANCE -- NON-CONFORMANCE REPORT****Location:** Changxing Island, Shanghai, China**Report No:** NCR-000920**Prime Contractor:** American Bridge/Fluor Enterprises, a JV**Date:** 25-Nov-2010**Submitting Contractor:** Zhenhua Port Machinery Company, Ltd (ZPMC), Changxing Island**NCR #:** ZPMC-0882**Type of problem:**

Reference Description: New Welding Procedure Not Being Followed (Rager/McQuaid)**Description of Non-Conformance:**

Job Name: SAS Superstructure
Document No: 05.03.06-000877

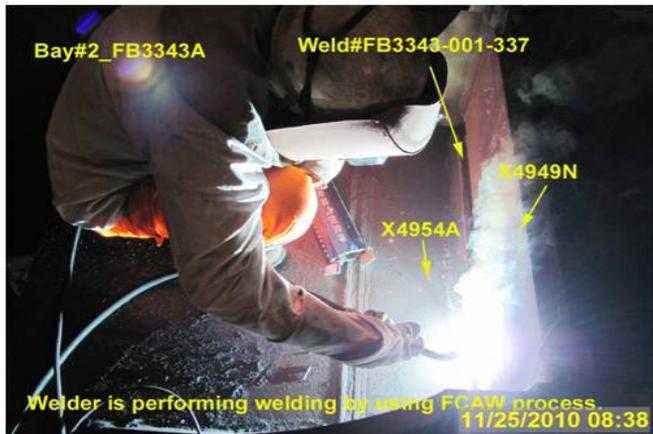
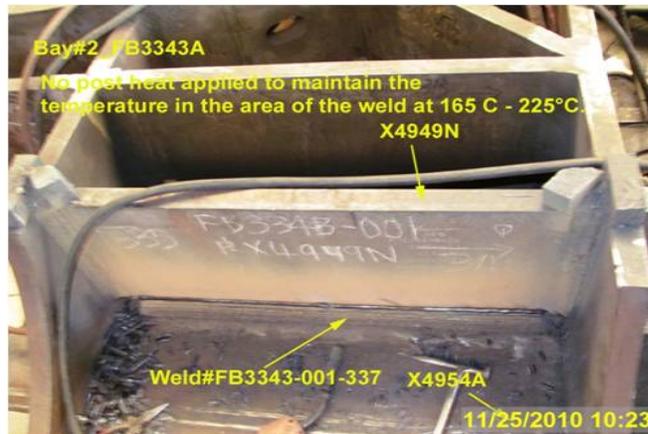
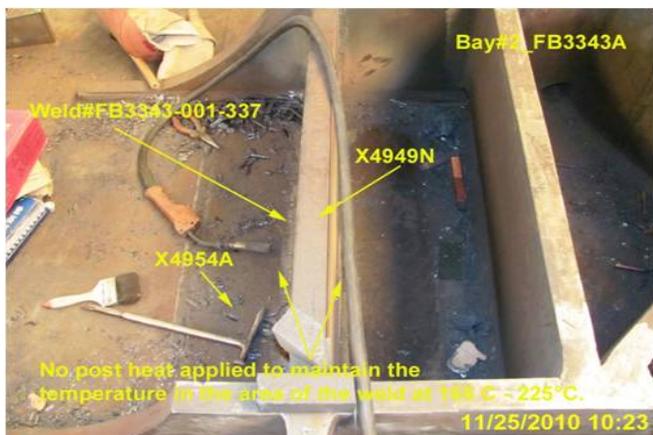
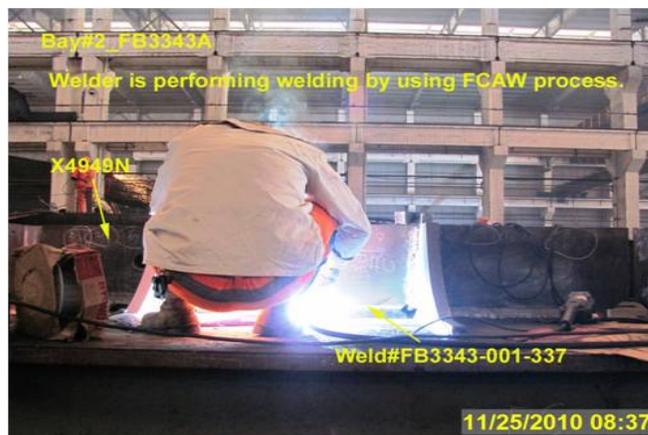
During Caltrans QA in process observations of the fabrication of FB3343A ,this QA discovered ZPMC welding personnel appear to not be following the NEW WELD PROCEDURE (Rager/McQuaid)

5. Postweld Thermal Treatment (5A, 5C, 5D)

The weld is identified as FB3343-001-337

The welding process used was Flux Cored Arc Welding.

The area was being preheated using electric strip heaters.

The weld is a Complete Joint Penetration with steel backing joining FB web plate (X4954A) to Stiffener plate (X4949N).

The FB web base material thickness is 50 mm and stiffener plate is 45 mm.

For further information see the attached photos.

Propose a resolution for the identified non-conformance with revised procedures to prevent future occurrences. A response for the resolution of this issue is expected within 7 days.

See attached NDT results to show the weld is acceptable. Based on this ZPMC requests closure of this NCR.

This proposed resolution is acceptable. The documentation received is sufficient and the Department concurs that Non-Conformance ZPMC-0882 is closed.

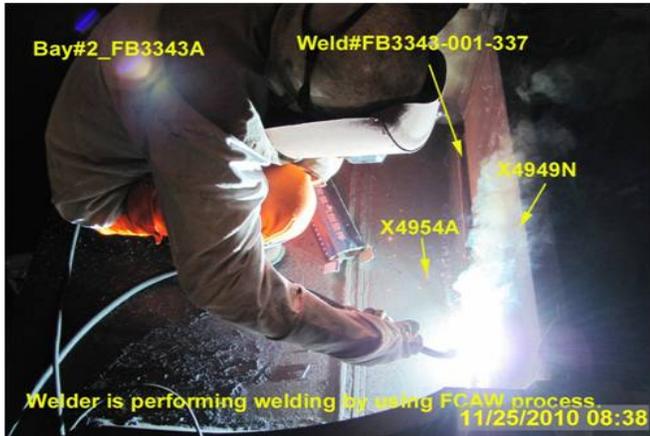
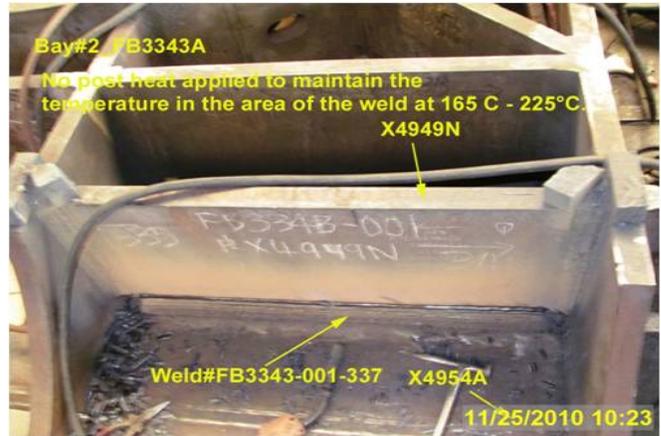
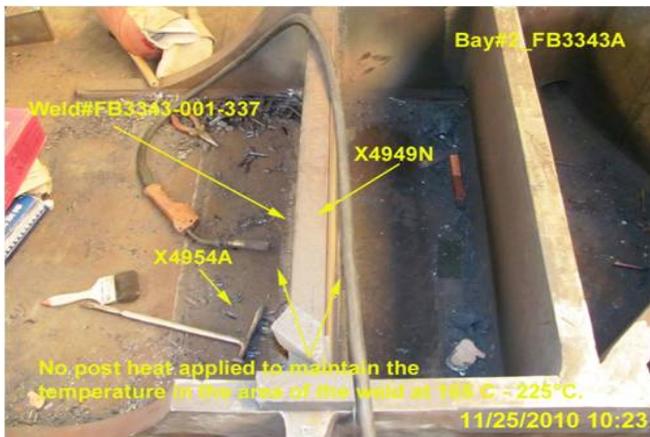
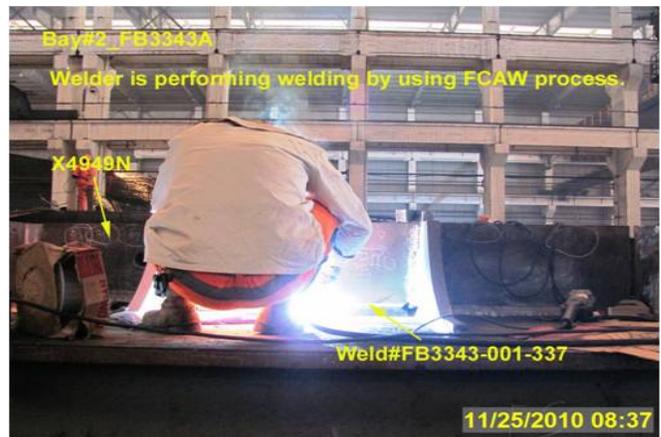
During Caltrans QA in process observations of the fabrication of FB3343A, this QA discovered ZPMC welding personnel appear to not be following the NEW WELD PROCEDURE (Rager/McQuaid)

5. Postweld Thermal Treatment (5A, 5C, 5D)

The weld is identified as FB3343-001-337

The welding process used was Flux Cored Arc Welding.

The area was being preheated using electric strip heaters.

The weld is a Complete Joint Penetration with steel backing joining FB web plate (X4954A) to Stiffener plate (X4949N).

The FB web base material thickness is 50 mm and stiffener plate is 45 mm.

For further information see the attached photos.

Contractor will provide the NDT report to prove the weld is acceptable.

Contractor provided the NDT report. The NDT report proves the weld is acceptable.
