Contract #: 04-0120F4
 Cty: SF/ALA Rte: 80 PM: 13.2/13.9
 File #: 69.25B

QUALITY ASSURANCE -- NON-CONFORMANCE REPORT

Report No: NCR-000924

Reference Description: QA found 2 missed MT indications after ZPMC had tested and accepted the weld at Segment 11EW

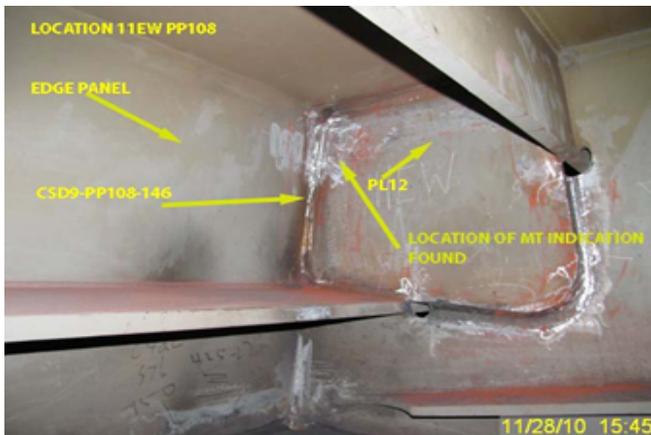
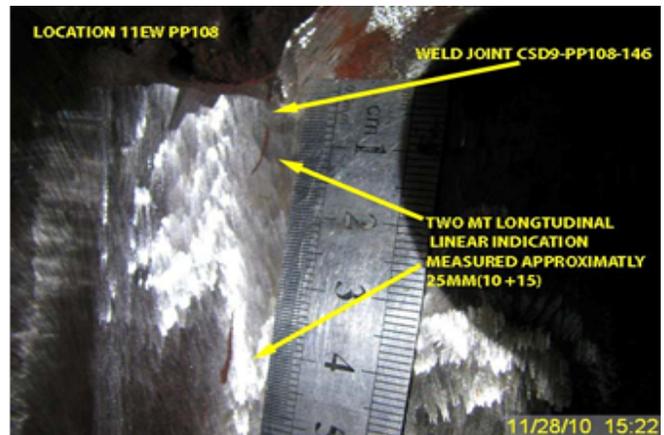
During the Quality Assurance (QA) Magnetic Particle Testing (MT) review of welds located on OBG 11EW PP108, this QA Inspector discovered the following issue:

- Two (2) longitudinal indication 10mm and 15mm in length found Toe of the Fillet weld identified as CSD9-PP108-146
- The weld is a fillet weld (CSD9-PP108-146), joining the Floor beam (FB9B) to suspender bracket retrofit plate (PL12).
- The Y location is 6mm measured from the upper termination of the weld and is clearly marked on the material.
- OBG 11EW is located at Trial assembly.
- The Notice of Witness Inspection Number (NWIT) is 07529.
- This weld is within an area previously tested and accepted by ABF Quality Control (QC) personnel.

Contractor will repair the weld with indications, and provide the NDT report to prove the weld is acceptable. Contractor will issue an internal NCR to the inspector who missed the weld indication. Contractor will monitor the inspector's performance. Disciplinary action will be taken if the inspector misses the indications continuously.

Contractor repaired the weld, and provided the NDT report to prove the weld is acceptable. Contractor also issued the internal NCR to the inspector who missed the indication and continued to monitor his performance.

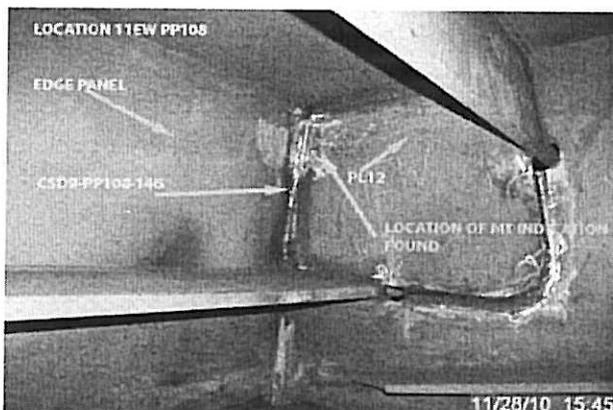
During the Quality Assurance (QA) Magnetic Particle Testing (MT) review of welds located on OBG 11EW PP108, this QA Inspector discovered the following issue:

- Two (2) longitudinal indication 10mm and 15mm in length found Toe of the Fillet weld identified as CSD9-PP108-146
- The weld is a fillet weld (CSD9-PP108-146), joining the Floor beam (FB9B) to suspender bracket retrofit plate (PL12).
- The Y location is 6mm measured from the upper termination of the weld and is clearly marked on the material.
- OBG 11EW is located at Trial assembly.
- The Notice of Witness Inspection Number (NWIT) is 07529.
- This weld is within an area previously tested and accepted by ABF Quality Control (QC) personnel.
