Contract #: 04-0120F4Cty: SF/ALA Rte: 80 PM: 13.2/13.9File #: xx.25B**QUALITY ASSURANCE -- NON-CONFORMANCE REPORT****Location:** Changxing Island, Shanghai, China**Report No:** NCR-000925**Prime Contractor:** American Bridge/Fluor Enterprises, a JV**Date:** 27-Nov-2010**Submitting Contractor:** Zhenhua Port Machinery Company, Ltd (ZPMC), Changxing Island**NCR #:** ZPMC-0887**Type of problem:**

Reference Description: Critical Weld Repair on Lift 13W Saddle Grillage without Prior Approval from Engineer

Subject: NCR No. ZPMC-0887

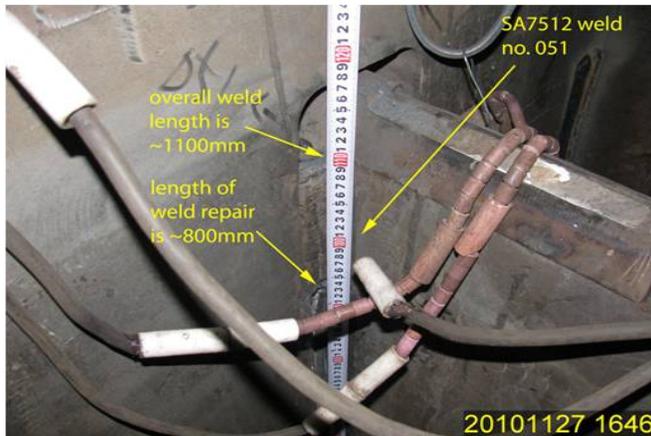
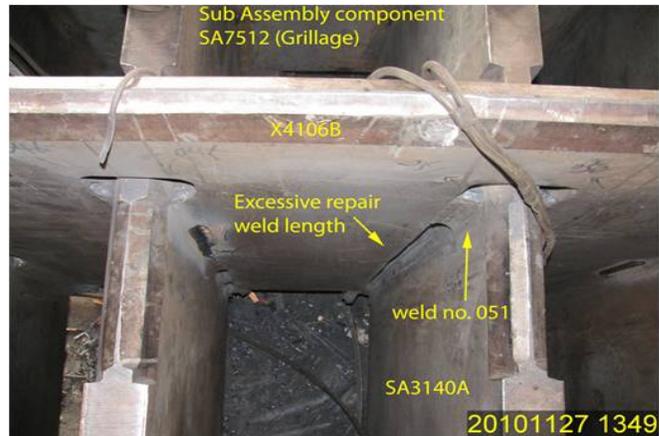
- ZPMC has performed Critical Weld Repairs (CWR) on Seismic Performance Critical Material (SPCM) without the Engineers approval.
 - The length of the excavation exceeded the limits of a Non Critical Weld Repair as defined in Section 12 of AWS D1.5 2002.
 - The length of excavation as measured by this QA was approximately 800mm on a 1100mm long weld.
 - The weld is identified as SA7512-051.
 - The repair documentation available for review was identified as B-WR-17780 and WPS-345-FCAW-3G (3F)-FCM-Repair.
 - The weld is a Complete Joint Penetration (CJP) joint, joining component identified as SA3141A to component identified as X4106B. Both plates are identified as SPCM on the approved shop drawings.
 - OBG Sub Assembly SA7512A is located in Bay 2.
- For further information, please see the attached pictures below.

AWS D1.5M – 2002 section 12.17.2(4) Noncritical Repair Welds – “First time excavation and repair from one side of groove welds and fillet welds which contain unacceptable porosity, slag, and fusion discontinuities, provided the excavations do not exceed the following limits: Length of weld “L” over 1.0m to 2.0m excavation is not to exceed 450mm.”

AWS D1.5M – 2002 section 12.17.3 Critical weld repairs. “Except as provided in 12.17.2, all welded repairs shall be considered critical. They include, but are not limited to the following:

(5) Corrections requiring weld removal and re-welding except as provided in 12.17.2 (4)”.

Propose a resolution for the identified non-conformance with revised procedures to prevent future occurrences. A response for the resolution of this issue is expected within 7 days.
