Contract #: 04-0120F4Cty: SF/ALA Rte: 80 PM: 13.2/13.9File #: 69.25B**QUALITY ASSURANCE -- NON-CONFORMANCE REPORT****Location:** Changxing Island, Shanghai, China**Report No:** NCR-000926**Prime Contractor:** American Bridge/Fluor Enterprises, a JV**Date:** 26-Nov-2010**Submitting Contractor:** Zhenhua Port Machinery Company, Ltd (ZPMC), Changxing Island**NCR #:** ZPMC-0888**Type of problem:**

**Reference Description:** Excessive Root Openings on Lift 14E Hinge A Bulkhead Stiffeners Discovered by QA**Description of Non-Conformance:**

**Reference Description:** Excessive Root Openings on Lift 14E Hinge A Bulkhead Stiffeners Discovered by QA

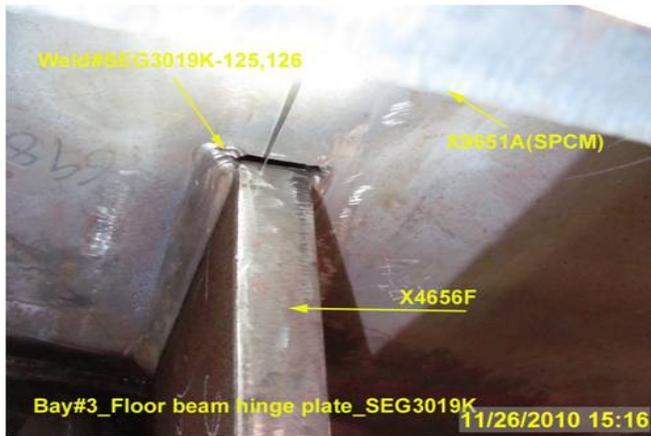
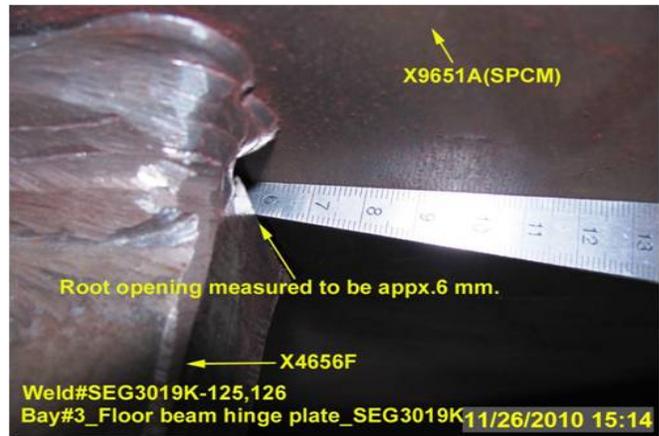
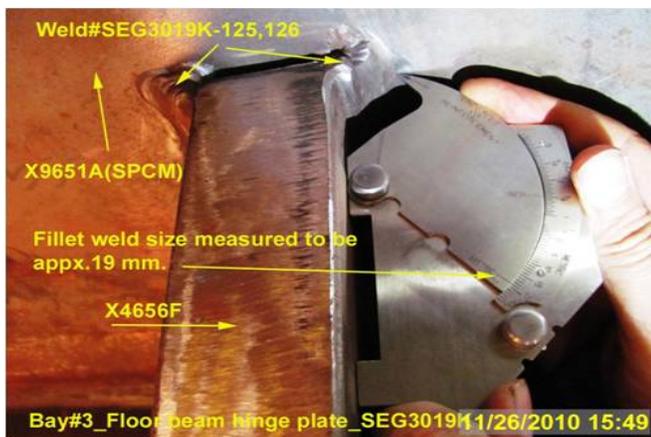
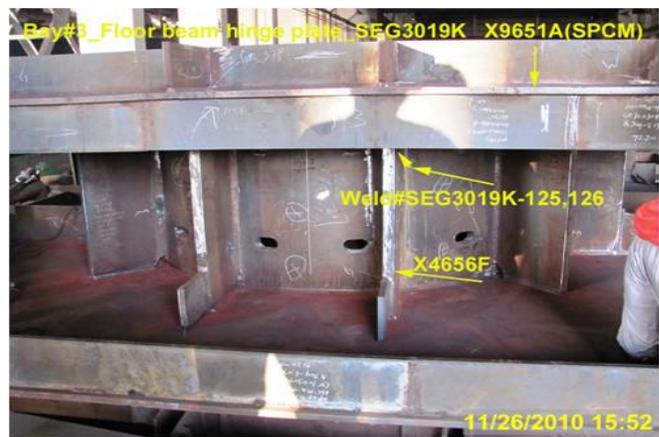
During Quality Assurance Visual Testing and Magnetic Particle Testing (MT) review of welds located on Orthotropic Box Girder (OBG) 14 East Hinge A Bulkhead on SEG3019K, this Quality Assurance Inspector (QA) discovered the following issues:

- ZPMC welded two joints with an excessive root opening.
- The root opening measured approximately 6 mm.
- The root opening exceeds the maximum tolerance specified in Caltrans approved Welding Procedure Specification WPS-B-T-2132-3 and AWS D1.5/2002 Section 3.3.1.
- The welds are identified as: SEG3019K-125,126.
- The floor beam web plate is Seismic Performance Critical Material (SPCM).
- The welds are Fillet welds joining to web plate identified as (X9651A-SPCM) to stiffener plate (X4656F).
- The fillet weld size is approximately 19 mm
- The required fillet weld size is 15 mm.
- The web plate material thickness is 25 mm and stiffener plate is 45 mm.
- The hinge plate is located in Sub assembly Bay#3.

AWS D1.5/2002 Section 3.3.1- "The parts to be joined by fillet welds shall be brought into as close contact as practicable. The root opening shall not exceed 5 mm [3/16 in.]..."

Contract Approved Welding Procedure Specification: WPS-B-T-2132-3 specifies the root opening to be 0~2 mm.

**Reference Resolution:** ZPMC has changed the fillet weld into a single CJP with new weld ID, SEG3019K-127 with the Engineer's approval. ZPMC has changed the fillet weld into a single CJP with new weld ID, SEG3019K-127 with the Engineer's approval. Attached is NDT documentation of the weld showing it is acceptable, based on this ZPMC requests closure of this NCR.

The proposed resolution is acceptable. This NCR is considered closed.

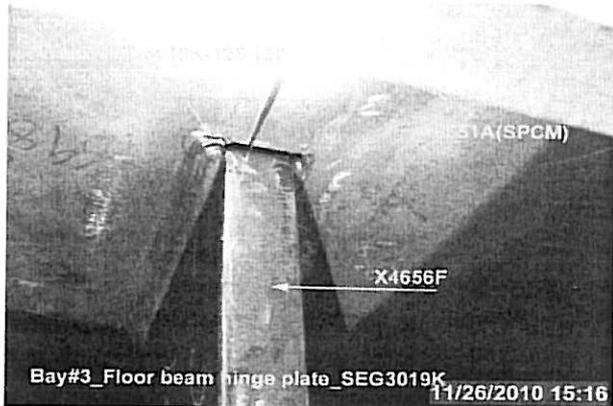
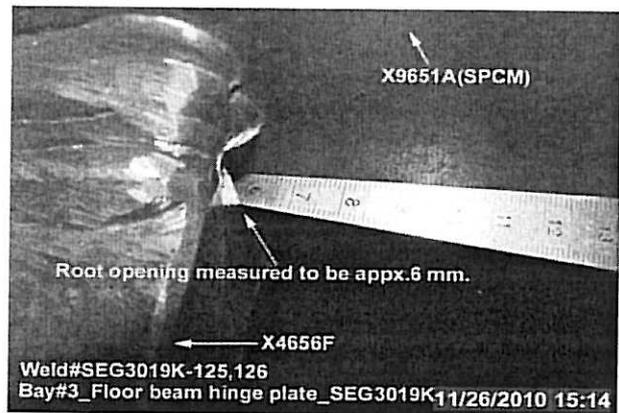
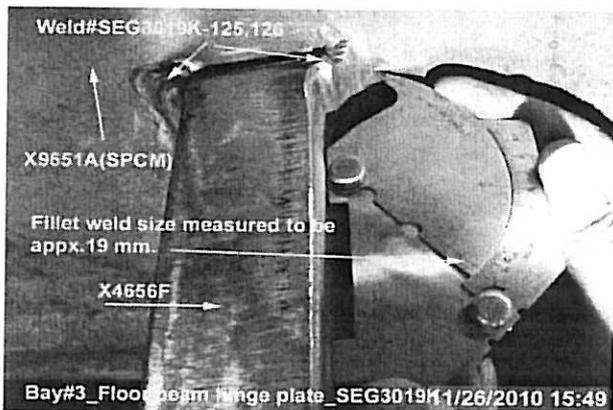
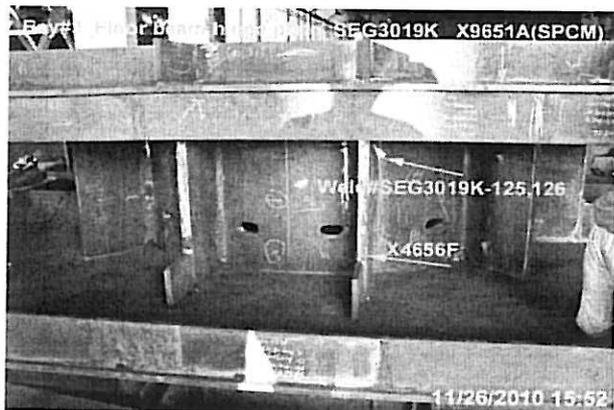
During Quality Assurance Visual Testing and Magnetic Particle Testing (MT) review of welds located on Orthotropic Box Girder (OBG) 14 East Hinge A Bulkhead on SEG3019K, this Quality Assurance Inspector (QA) discovered the following issues:

- ZPMC welded two joints with an excessive root opening.
- The root opening measured approximately 6 mm.
- The root opening exceeds the maximum tolerance specified in Caltrans approved Welding Procedure Specification WPS-B-T-2132-3 and AWS D1.5/2002 Section 3.3.1.
- The welds are identified as: SEG3019K-125,126.
- The floor beam web plate is Seismic Performance Critical Material (SPCM).
- The welds are Fillet welds joining to web plate identified as (X9651A-SPCM) to stiffener plate (X4656F).
- The fillet weld size is approximately 19 mm
- The required fillet weld size is 15 mm.
- The web plate material thickness is 25 mm and stiffener plate is 45 mm.
- The hinge plate is located in Sub assembly Bay#3.

AWS D1.5/2002 Section 3.3.1- "The parts to be joined by fillet welds shall be brought into as close contact as practicable. The root opening shall not exceed 5 mm [3/16 in.]..."

Contract Approved Welding Procedure Specification: WPS-B-T-2132-3 specifies the root opening to be 0~2 mm.

Contractor proposes to change the fillet weld into a single CJP with new weld ID, SEG3019K-127 with the Engineer's approval. Contractor will provide the NDT report to show the weld is acceptable.
