Contract #: 04-0120F4Cty: SF/ALA Rte: 80 PM: 13.2/13.9File #: 69.25B**QUALITY ASSURANCE -- NON-CONFORMANCE REPORT****Location:** Changxing Island, Shanghai, China**Report No:** NCR-000932**Prime Contractor:** American Bridge/Fluor Enterprises, a JV**Date:** 07-Dec-2010**Submitting Contractor:** Zhenhua Port Machinery Company, Ltd (ZPMC), Changxing Island**NCR #:** ZPMC-0893**Type of problem:****Welding****Concrete****Other****Welding****Curing****Procedural****Bridge No:** 34-0006**Joint fit-up****Coating****Other****Component:** CB19 - Floorbeam diaphragm FB3246**Procedural****Procedural****Description:****Reference Description:** Base Metal Repair without Prior Approval from the Engineer on Crossbeam 19**Description of Non-Conformance:**

Dear: Mr. Charles Kanapicki
Job Name: SAS Superstructure

Subject: NCR No. ZPMC-0893

Reference Description: Base Metal Repair without Prior Approval from the Engineer on Crossbeam 19

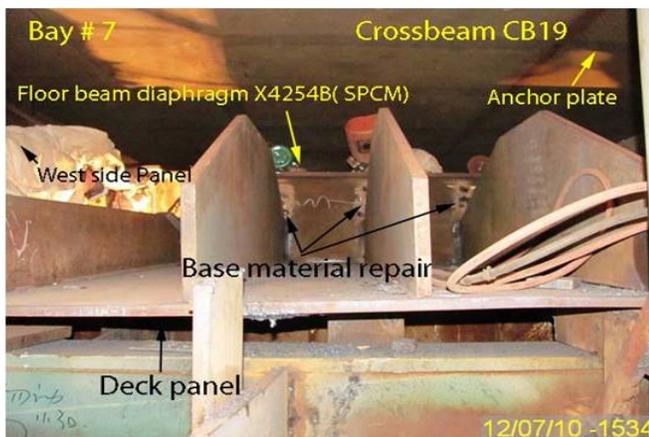
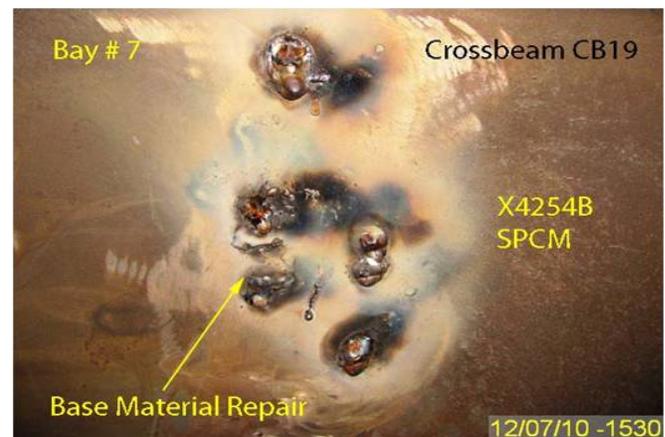
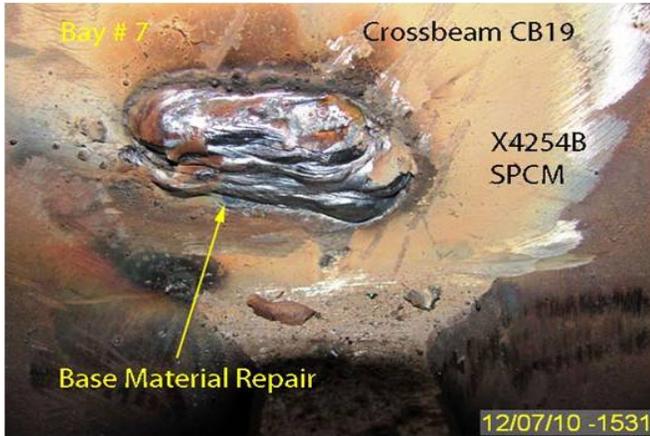
During the Quality Assurance (QA) random in-process visual inspection of Orthotropic Box Girder (OBG) Crossbeam CB19, this QA inspector discovered the following issue:

- Base metal repairs being performed without prior approval of the Engineer.
- Repairs were being performed in runoff tab removal areas on the Floor beam diaphragm web plate.
- Floor beam diaphragm is identified as FB3246
- Web plate is identified as X4254B (SPCM)
- The material is A709 Grade 345 Seismic Performance Critical Member (SPCM).
- OBG Cross beam CB19 is located in the Bay 7.

Caltrans Special Provision Section 8-3.01: "The Engineer shall be notified immediately in writing when welding problems, deficiencies, base metal repairs, or any other type of repairs not submitted in the WQCP are discovered and also of the proposed repair procedures to correct them. For requests to perform repairs, The contractor shall include an engineering evaluation of the proposed repair."

ZPMC Welding Quality Control Plan, Section 9.2.1.2: "Prior approval of the Engineer shall be obtained for repairs to base metal other than what was identified in Section 9.2.1.1 of this manual and the repair of all other cracks."

AWS D1.5/2002, Section 3.7.4: "Prior approval of the Engineer shall be obtained for repairs to base metal."

Contractor will repair the defective area, and provide the NDT report to prove the repairs are completed satisfactorily. ZPMC will issue an internal NCR to the QC personnel and will discuss with shop floor CWI regarding the requirement of seeking Engineer's approval prior to any base metal repair.

Contractor repaired the defects. NDT reports provided subsequently show the repairs are acceptable. Contractor also reinforced to the shop floor CWI's that the Engineer needs to be notified prior to base metal repair.

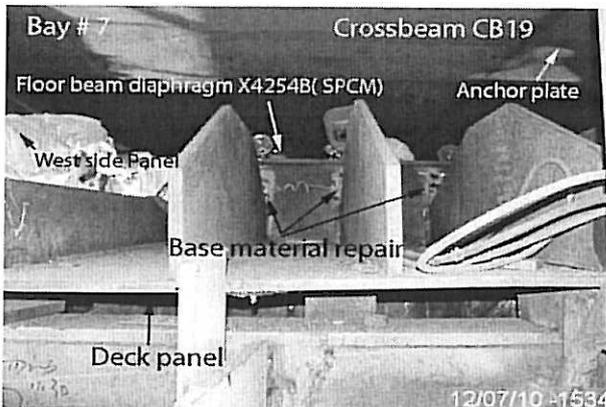
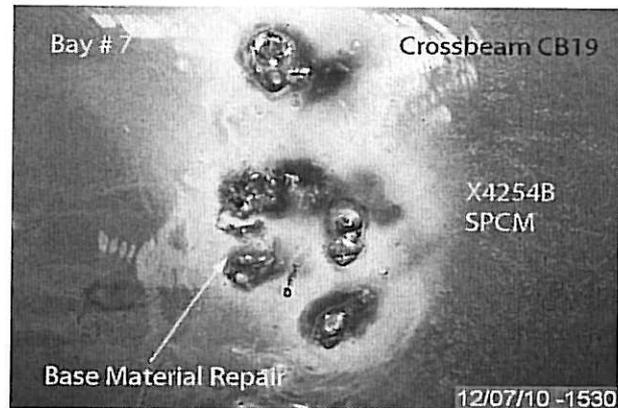
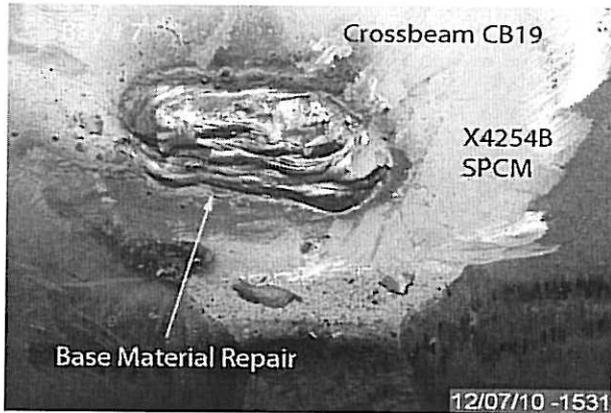
During the Quality Assurance (QA) random in-process visual inspection of Orthotropic Box Girder (OBG) Crossbeam CB19, this QA inspector discovered the following issue:

- Base metal repairs being performed without prior approval of the Engineer.
- Repairs were being performed in runoff tab removal areas on the Floor beam diaphragm web plate.
- Floor beam diaphragm is identified as FB3246
- Web plate is identified as X4254B (SPCM)
- The material is A709 Grade 345 Seismic Performance Critical Member (SPCM).
- OBG Cross beam CB19 is located in the Bay 7.

Caltrans Special Provision Section 8-3.01: "The Engineer shall be notified immediately in writing when welding problems, deficiencies, base metal repairs, or any other type of repairs not submitted in the WQCP are discovered and also of the proposed repair procedures to correct them. For requests to perform repairs, The contractor shall include an engineering evaluation of the proposed repair."

ZPMC Welding Quality Control Plan, Section 9.2.1.2: "Prior approval of the Engineer shall be obtained for repairs to base metal other than what was identified in Section 9.2.1.1 of this manual and the repair of all other cracks."

AWS D1.5/2002, Section 3.7.4: "Prior approval of the Engineer shall be obtained for repairs to base metal."
