Contract #: 04-0120F4Cty: SF/ALA Rte: 80 PM: 13.2/13.9File #: 69.25B**QUALITY ASSURANCE -- NON-CONFORMANCE REPORT****Location:** Changxing Island, Shanghai, P.R. China**Report No:** NCR-000933**Prime Contractor:** American Bridge/Fluor Enterprises, a JV**Date:** 09-Dec-2010**Submitting Contractor:** Zhenhua Port Machinery Company, Ltd (ZPMC), Changxing Island**NCR #:** ZPMC-0894**Type of problem:**

Reference Description: Contractor performed CJP welding on Lift 11 Suspender Brackets (SB104W & SB106E) without following the D1.5 requirements (No run-off tap)

To: AMERICAN BRIDGE/FLUOR, A JV **Date:** 10-Dec-2010
 375 BURMA ROAD
 OAKLAND CA 95607 **Contract No:** 04-0120F4
 04-SF-80-13.2 / 13.9
Dear: Mr. Charles Kanapicki **Job Name:** SAS Superstructure
Attention: Mr. Thomas Nilsson Project/Fabrication Manager **Document No:** 05.03.06-000890
Subject: NCR No. ZPMC-0894

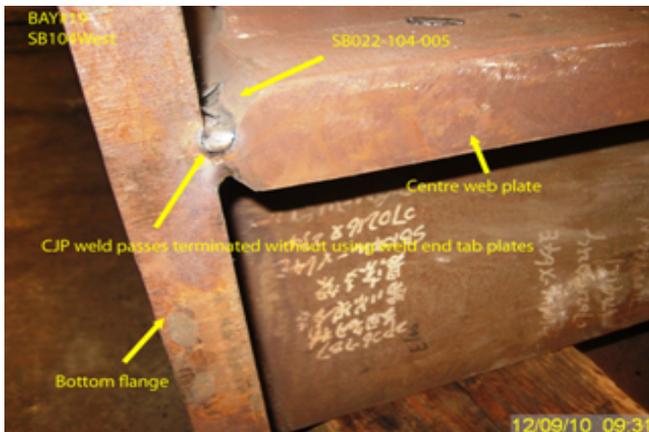
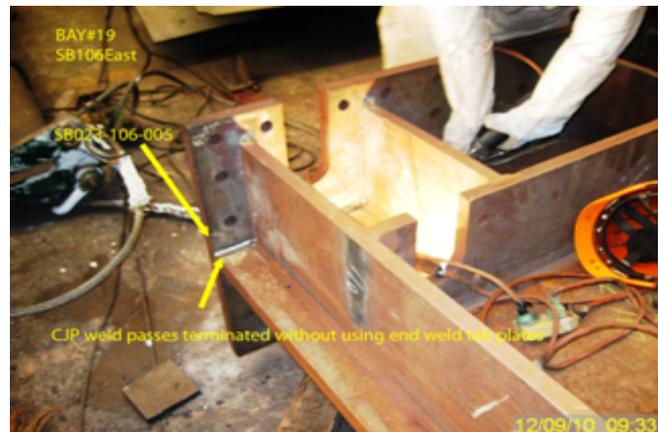
During Quality Assurance (QA) random in-process observations of the fabrication of OBG Lift 11 Suspender brackets SB104W and SB106E, this Caltrans QA inspector discovered the following issue:

- ZPMC welding personnel performing welding of CJP joint without using weld tabs (extension bars and run-off plates).
- The weld joints are identified as SB022-104-005 of SB104W and SB023-106-005 of SB106E.
- The welds are Complete Joint Penetration, T joints joining center web plates (SB104W-A and SB106E-A) to side plates (X64A and X64B).
- The welding being performed using Flux cored arc welding process in the Flat position (1G).
- The thicknesses of the web and side plates are 45 mm and 35 mm.
- OBG Suspender brackets are currently located in the Sub-assembly Bay19.
- On October 24, 2010, a similar non-conformance took place in Bay 19 also. Reference NCR ZPMC-0835.

American Weld Society (AWS) D1.5 2002 section 3.12.1 "Welds shall be terminated at the end of a joint in a manner that will ensure sound welds. Whenever possible, this shall be done using weld tabs (extension bars and run off plates) placed in a manner that will duplicate the joint detail being welded".

ZPMC is providing NDT of the welds to show they are acceptable despite being welded without run off tabs. The QC inspector has been reminded that these must be checked prior to welding to prevent future occurrences. Based on this ZPMC requests closure of this NCR.

Contractor submitted the NDT report showing the welds are acceptable. QC inspector was reminded that fit-up including run-on/run-off tabs must be checked prior to welding to prevent future occurrences.

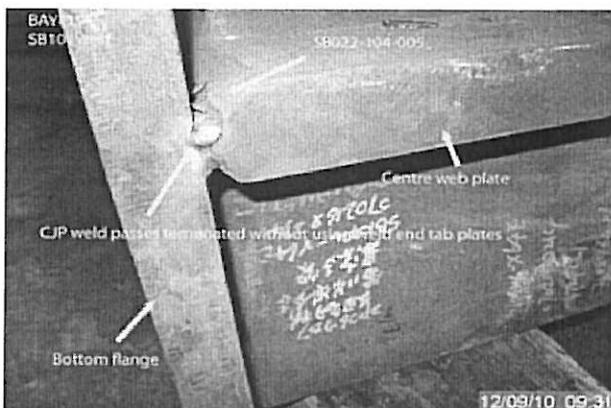
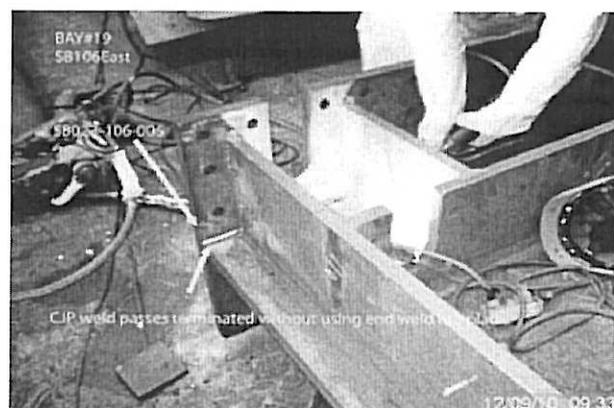
During Quality Assurance (QA) random in-process observations of the fabrication of OBG Lift 11 Suspender brackets SB104W and SB106E, this Caltrans QA inspector discovered the following issue:

- ZPMC welding personnel performing welding of CJP joint without using weld tabs (extension bars and run-off plates).
- The weld joints are identified as SB022-104-005 of SB104W and SB023-106-005 of SB106E.
- The welds are Complete Joint Penetration, T joints joining center web plates (SB104W-A and SB106E-A) to side plates (X64A and X64B).
- The welding being performed using Flux cored arc welding process in the Flat position (1G).
- The thicknesses of the web and side plates are 45 mm and 35 mm.
- OBG Suspender brackets are currently located in the Sub-assembly Bay19.
- On October 24, 2010, a similar non-conformance took place in Bay 19 also. Reference NCR ZPMC-0835.

American Weld Society (AWS) D1.5 2002 section 3.12.1 "Welds shall be terminated at the end of a joint in a manner that will ensure sound welds. Whenever possible, this shall be done using weld tabs (extension bars and run off plates) placed in a manner that will duplicate the joint detail being welded".

Contractor to provide NDT report to prove the welds are acceptable despite being welded without run off tabs. The QC inspector will be reminded the fit-up must be checked prior to welding to prevent future occurrences.
