Contract #: 04-0120F4
 Cty: SF/ALA Rte: 80 PM: 13.2/13.9
 File #: 69.25B

QUALITY ASSURANCE -- NON-CONFORMANCE REPORT

Report No: NCR-000934

Reference Description: ZPMC removed welds and re-welded without Engineer's approval and QC presence over 30 minutes (Steel Barriers E5-SB13-066 and E5-SB13-072)

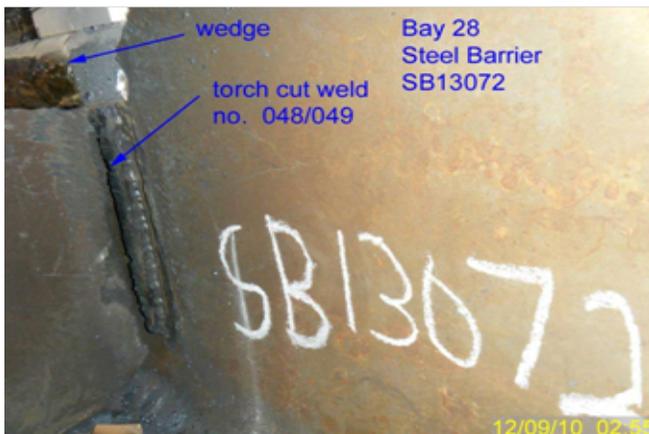
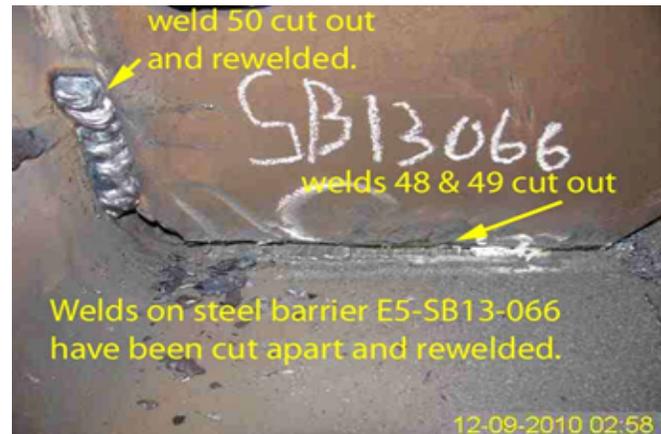
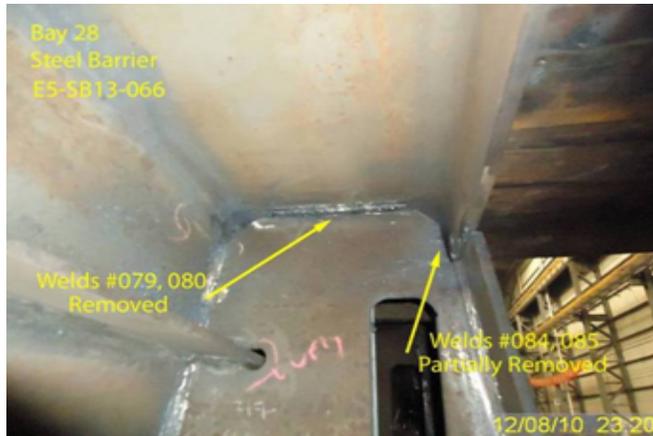
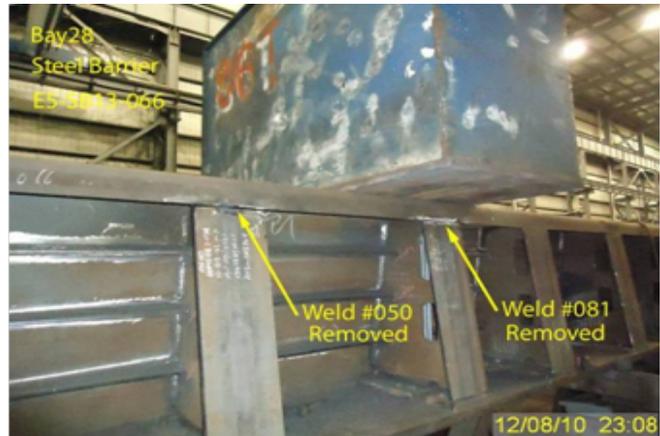
- ZPMC workers have removed multiple CJP and fillet weld joints to correct misalignment of Steel Barriers E5-SB13-066 and E5-SB13-072.
- The Contractor did not notify the Engineer of the intent to remove welds E5-SB13-066-048, 049, 050, 079, 080, 081, 084, and 085; E5-SB13-072-048, and 049 as identified in the pictures.
- Subsequently, ZPMC workers performed welding at several above mentioned locations, such as E5-SB13-066-050 as seen in the picture below.
- No ZPMC QC or CWI was present during the removal of the welds.
- No ZPMC QC or CWI was present during weld repairs.
- ZPMC workers performed welding of steel barriers inside Bay 28 on December 9, 2010 between 0200 hours and 0245 hours.
- Doors accessing Bay 28 were locked during the welding repairs.

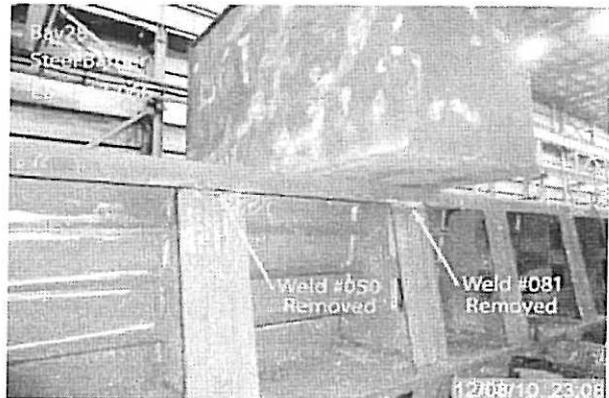
-ZPMC workers have removed multiple CJP and fillet weld joints to correct misalignment of Steel Barriers E5-SB13-066 and E5-SB13-072.

-The Contractor did not notify the Engineer of the intent to remove welds E5-SB13-066-048, 049, 050, 079, 080, 081, 084, and 085; E5-SB13-072-048, and 049 as identified in the pictures.

-Subsequently, ZPMC workers performed welding at several above mentioned locations, such as E5-SB13-066-050 as seen in the picture below.

-No ZPMC QC or CWI was present during the removal of the welds.

-No ZPMC QC or CWI was present during weld repairs.

Contractor provided the NDT report to prove the welds are acceptable. Contractor also discussed with the CWI leader regarding the requirement of QC coverage during welding, and instructed the Engineer must be notified when there is weld removal.
