QUALITY ASSURANCE -- NON-CONFORMANCE REPORT

Report No: NCR-000941

Reference Description: The joint fit-up of a PJP weld joint exceeded the allowable tolerance (Bikepath BK004A-061)

Job Name: SAS Superstructure

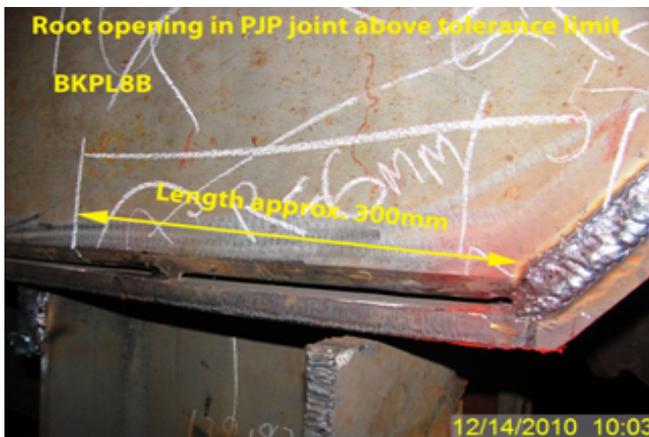
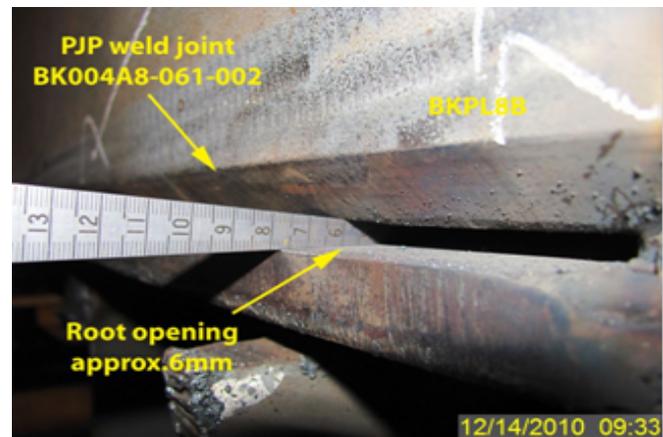
During a random visual inspection of Bikepath BK004A-061, the Quality Assurance (QA) Inspector observed excessive root openings on the PJP weld joint.

- Excessive root opening up to 6mm was observed on the Partial Joint Penetration (PJP).
- According to the approved drawing weld details and the approved WPS, the tolerance for root opening is 0mm (+3mm,-2mm for tolerance)
- The weld is identified as: BK004A8-061-002 corner weld, joining the Top Plate (BKPL2A) to Closure Plate (BKPL8B).
- The Y location of more root gap at 0 mm to 300 mm (Measuring from Side Plate BKPL3B).
- The Weld is a Partial Joint Penetration (PJP).
- The OBG Bike path is located at Bay #8.

AWS D1.5-2002 Section 3.3.2: The root opening between parts to be joined by PJP groove welds parallel to the member length (bearing joints excepted) shall be zero, or as small as practicable.

Propose a resolution for the identified non-conformance with revised procedures to prevent future occurrences..A response for the resolution of this issue is expected within 7 days.
