Contract #: 04-0120F4Cty: SF/ALA Rte: 80 PM: 13.2/13.9File #: 69.25B**QUALITY ASSURANCE -- NON-CONFORMANCE REPORT****Location:** Changxing Island, Shanghai P.R. China**Report No:** NCR-000943**Prime Contractor:** American Bridge/Fluor Enterprises, a JV**Date:** 13-Dec-2010**Submitting Contractor:** Zhenhua Port Machinery Company, Ltd (ZPMC), Changxing Island**NCR #:** ZPMC-0902**Type of problem:**

Reference Description: 2 Transverse Cracks located at Tower Facade Connection Plate**Description of Non-Conformance:**

Job Name: SAS Superstructure
Document No: 05.03.06-000898

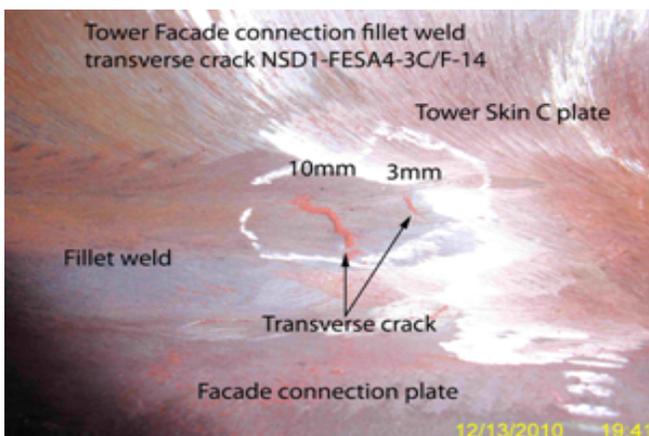
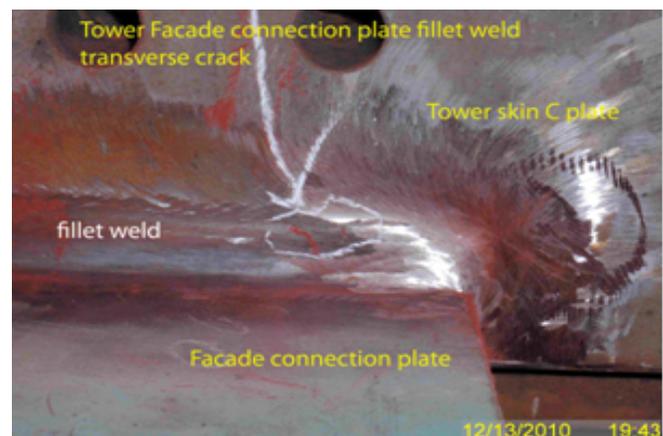
During the Quality Assurance Magnetic particle Testing (MT) review of welds located on NSD1-FESA4-3C/F, this Quality Assurance Inspector (QA) discovered the following issues:

- 2 Transverse cracks measuring approximately 3mm and 10mm.
- The weld is identified as: NSD1-FESA4-3C/F-14
- The Y location is approximately 25mm and 35mm, respectively from the right end of the weld.
- The Weld is a fillet weld joining the façade connection plate to north tower skin C.
- The weld is not SPCM.
- The member is located in Bay # 10

The Notice of Witness Inspection Number (NWIT) is 7766. The indication is within the area that has been previously tested and accepted by ZPMC Quality Control (QC) personnel. As per the contract documents, ZPMC's QC personnel are required to perform 10% MT inspection of this weld.

AWS D1.5 (02) Section 6.26.2 – “Welds that are subject to MT in addition to visual inspection shall have no cracks and shall be unacceptable if the MT shows any types of discontinuities.”

Contractor proposes to perform 100% MT instead of 10% to prove the weld is acceptable. Contractor will issue a CWR (Critical Welding Repair) to repair this component.

Contractor issued a CWR and performed the repair. Performed 100% MT of the component. The NDT report shows the weld is acceptable, and the component was green tagged.

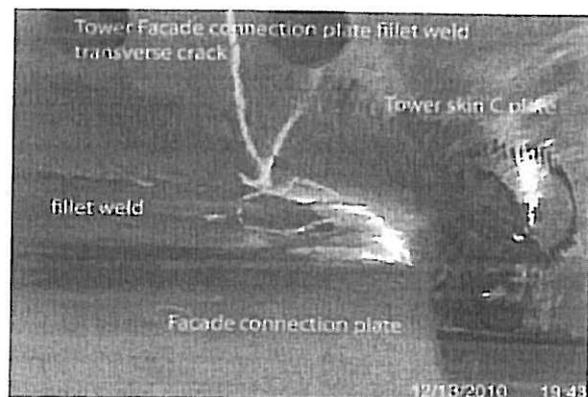
During the Quality Assurance Magnetic particle Testing (MT) review of welds located on NSD1-FESA4-3C/F, this Quality Assurance Inspector (QA) discovered the following issues:

- 2 Transverse cracks measuring approximately 3mm and 10mm.
- The weld is identified as: NSD1-FESA4-3C/F-14
- The Y location is approximately 25mm and 35mm, respectively from the right end of the weld.
- The Weld is a fillet weld joining the facade connection plate to north tower skin C.
- The weld is not SPCM.
- The member is located in Bay # 10

The Notice of Witness Inspection Number (NWIT) is 7766. The indication is within the area that has been previously tested and accepted by ZPMC Quality Control (QC) personnel. As per the contract documents, ZPMC's QC personnel are required to perform 10% MT inspection of this weld.

AWS D1.5 (02) Section 6.26.2 – “Welds that are subject to MT in addition to visual inspection shall have no cracks and shall be unacceptable if the MT shows any types of discontinuities.”

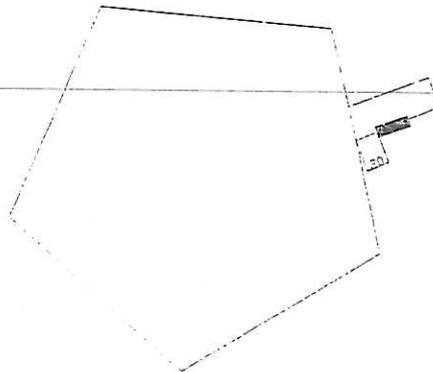
Draft of Welding Discontinuity:

线性缺陷
Linear indication

Crack Repair

List weld No.(焊缝编号) : NSD1-FESA4-3C/F-14

1. 火焰加热时, 水汽没有完全的去掉或者这个区域预热不够;
1. Moisture wasn't completely removed during drying operation (preheating) or the area wasn't preheated sufficiently.

1. QC and a Lead CWI shall be present, direct and supervise all grinding and welding operations during this repair to ensure the repair is per the disposition requirements

2. QC and a Lead CWI shall have an approved copy of the CWR in hand prior to the repair.
3. Remove paint $\geq 25\text{mm}$ in all direction of HAZ prior to MT.

4. Clean the excavation area of all loose debris including MT powder. Preheat to 65° C before removing cracks by grinding, repair area shall extend a minimum of 50mm beyond each end of single crack repairs, (and 50mm beyond the outermost cracks for multiple crack repairs).

5. If base metal is damaged by grinding, the damaged area shall be ground clean prior to performing weld repair. If gap $> 5\text{mm}$ is found during or after grinding, comply with the notification on changing fillet weld to CJP which is submitted to Engineer's review and approval form. Prior to continuing with Repair work.

6. Prepare excavation in accordance with the New Repair Procedure prior to welding.
7. Before this repair, Verify with VT and MT repair areas are defects free, and also MT shall be performed on the base metal laying abroad cracks to ensure that no cracks were propagated to the base metal. Separate CWR approval is needed if cracks are found in the base metal, and only after this new CWR's approval can continue the repair.

8. Clean excavation area of all loose debris including MT powder after excavation. Preheat and weld according to repair WPS. Preheat in accordance with the following pre-heat table.

9. Perform post weld heating according to repair WPS, the postheat in accordance with the following table for one hour minimum.

10. Allow the weld to cool to ambient temperature gradually. Control cooling rate after PWHT to no more than 50° C per hour.
11. Grind the repaired area flush with base metal or the adjacent weld after post weld heating.
12. Wait 48 hours at least after the repair area has cooled to ambient temperature before performing NDT.
13. Perform MT inspection to all repair area according to Contract Drawings along with all additional NDT required by the applicable notes Special Provision Section 10-1.59 'Steel Structure', subsection 'inspect on testing'. NDT include VT, MT and UT if it is a CJP weld.

1. QC shall verify sufficient preheat has been applied, to remove moisture, prior to welding.
