Contract #: 04-0120F4Cty: SF/ALA Rte: 80 PM: 13.2/13.9File #: 69.25B**QUALITY ASSURANCE -- NON-CONFORMANCE REPORT****Location:** Changxing Island, Shanghai, P.R. China**Report No:** NCR-000946**Prime Contractor:** American Bridge/Fluor Enterprises, a JV**Date:** 14-Dec-2010**Submitting Contractor:** Zhenhua Port Machinery Company, Ltd (ZPMC), Changxing Island**NCR #:** ZPMC-0905**Type of problem:**

Reference Description: QA found 8 missed VT cracks after ZPMC had tested and accepted the welds on the OBG Steel Barrier E2-SB1-049

Subject: NCR No. ZPMC-0905

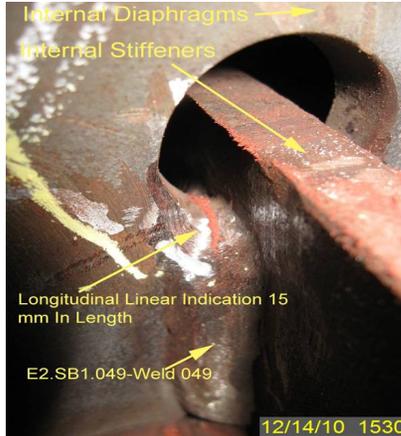
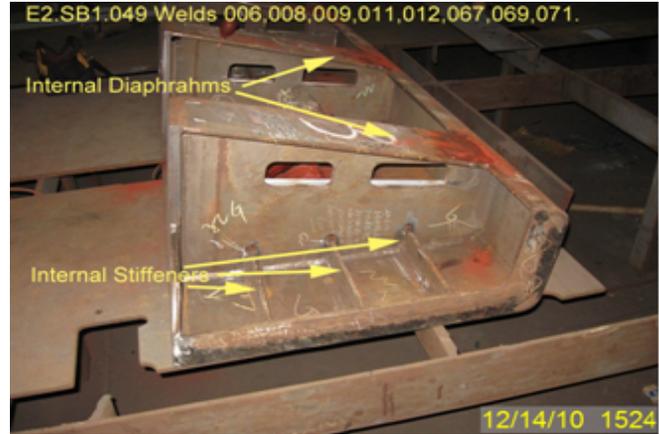
During Quality Assurance (QA) Visual Testing (VT) verification of welds located on OBG steel barrier E2-SB1-049, Caltrans QA inspectors discovered the following issues:

- 8 Longitudinal cracks measuring approximately 3mm to 15mm were found with VT.
- The cracks were verified using Magnetic Particle Testing (MT).
- The welds are fillet welds joining the stiffeners to the internal diaphragms.
- The location of each crack is in the crater area of the welds where the weld wraps through the "key hole" in the diaphragm.
- The welds are not SPCM.
- The steel barrier is located in Bay 1
- The members and weld numbers are identified as follows:
E2-SB1-049-006, 008, 009, 011, 012, 067, 069, 071.
- The notice of witness Inspection Number (NWIT) is 07777. The Longitudinal Linear Indications are located within an area that has been previously inspected by ZPMC Quality Control (QC) personal. As per contract documents ZPMC is required to perform 100% visual testing (VT) of these welds.

AWS D1.5 (02) Section 6.26.1.1 – “The weld shall have no cracks.”

ZPMC acknowledged this problem and has issued an internal NCR. ZPMC has removed the unspecified wrapping welds and is providing NDT documentation after the grinding to show the indication has been removed. ABFJV has noted which inspector was responsible for this missed inspections and is monitoring his performance as well as all inspector performance, if he continues to miss indications disciplinary action will be undertaken. Based on these actions, ZPMC requests closure of this NCR.

Contractor will remove the indications by grinding, and NDT will be performed after grinding. Contractor will identify the CWI, and issue an internal NCR to him. Contractor will monitor his performance, and disciplinary action will be taken if the inspector misses the indications further.

Contractor repaired the weld by grinding and provided the NDT report subsequently. The NDT report shows the welds are now in conformance with the contract requirement.

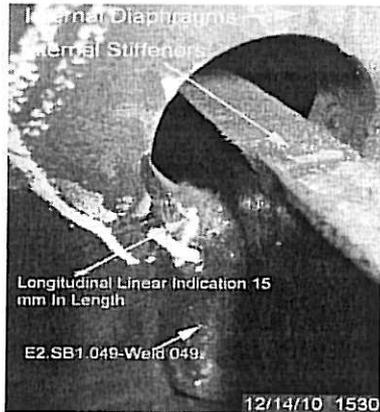
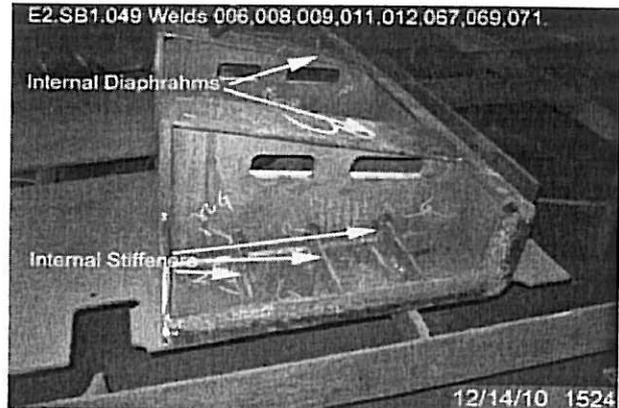
During Quality Assurance (QA) Visual Testing (VT) verification of welds located on OBG steel barrier
 E2-SB1-049, Caltrans QA inspectors discovered the following issues:

- 8 Longitudinal cracks measuring approximately 3mm to 15mm were found with VT.
- The cracks were verified using Magnetic Particle Testing (MT).
- The welds are fillet welds joining the stiffeners to the internal diaphragms.
- The location of each crack is in the crater area of the welds where the weld wraps through the "key hole" in the diaphragm.
- The welds are not SPCM.
- The steel barrier is located in Bay 1
- The members and weld numbers are identified as follows:
 E2-SB1-049-006, 008, 009, 011, 012, 067, 069, 071.
- The notice of witness Inspection Number (NWIT) is 07777. The Longitudinal Linear Indications are located within an area that has been previously inspected by ZPMC Quality Control (QC) personal. As per contract documents ZPMC is required to perform 100% visual testing (VT) of these welds.

AWS D1.5 (02) Section 6.26.1.1 – “The weld shall have no cracks.”
