Contract #: 04-0120F4Cty: SF/ALA Rte: 80 PM: 13.2/13.9File #: 69.25B**QUALITY ASSURANCE -- NON-CONFORMANCE REPORT****Location:** Changxing Island, Shanghai, P.R. China**Report No:** NCR-000947**Prime Contractor:** American Bridge/Fluor Enterprises, a JV**Date:** 15-Dec-2010**Submitting Contractor:** Zhenhua Port Machinery Company, Ltd (ZPMC), Changxing Island**NCR #:** ZPMC-0906**Type of problem:**

Welding	Concrete	Other	
Welding	Curing	Procedural	Bridge No: 34-0006
Joint fit-up	Coating	Other	Component: Traveler Rail 20TR2-048
Procedural	Procedural	Description: 10 Missed MT indication by QC

Reference Description: QA found 10 missed MT indications after ZPMC had tested and accepted the weld (battered base metal) on the Traveler Rail

Dear: Mr. Charles Kanapicki
Job Name: SAS Superstructure

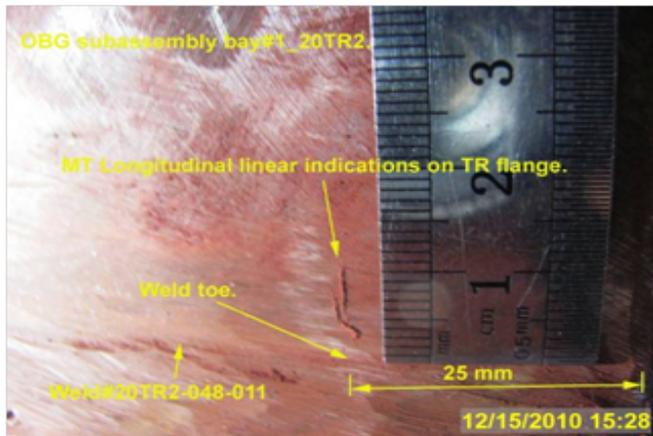
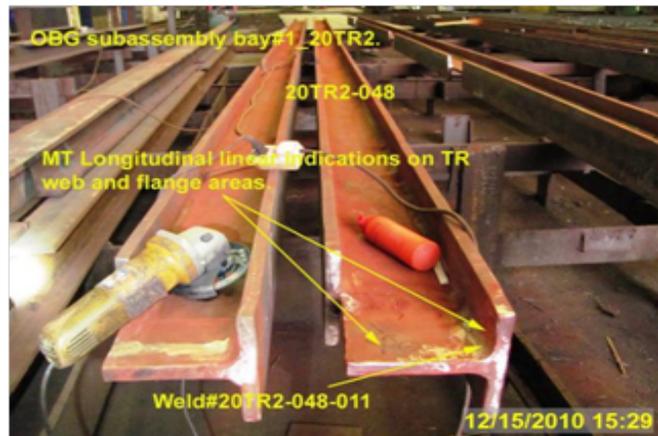
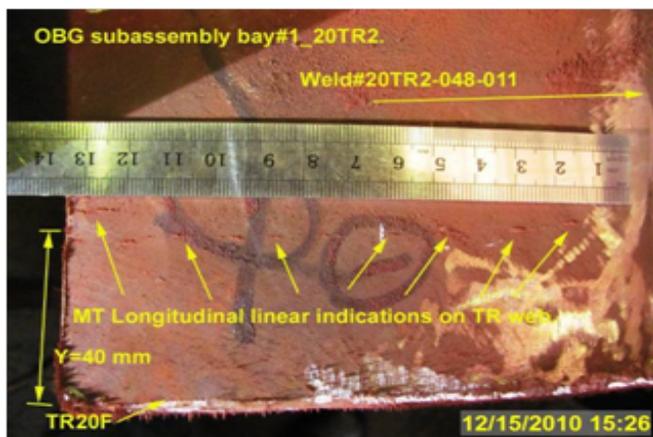
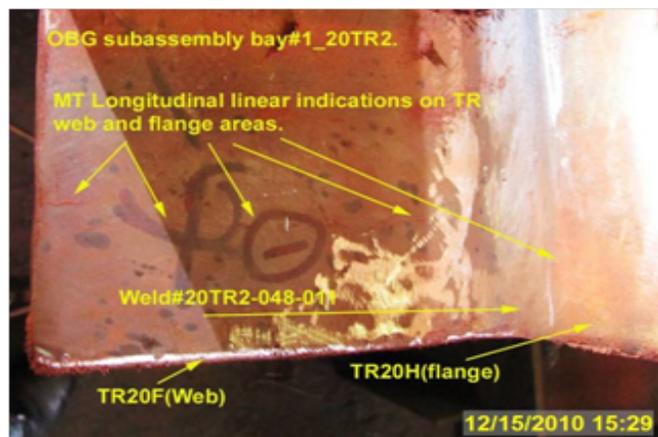
- 10 linear indications measuring approximately 4 ~10 mm in length were found on this traveler rail.
- The indications are located at the base metal of the web and flange, and the battered areas at the end of the traveler rail.

- The nearest weld is identified as: 20TR2-048-011.
- The web and flange are identified as TR20F and TR20H respectively.
- The "Y" locations of the indications are approximately 40 mm and 25 mm for web and flange, respectively.

- The "Y" locations are measured from the end of the traveler rail as shown in the photos below.
- The thickness of the TR web and flange is 20 mm.
- Traveler rail 20TR2-048 is currently located in the OBG Sub assembly Bay #1.

- The Notice of Witness Inspection Number (NWIT) is 07789. The indications are located within the area that has been previously tested and accepted by ZPMC Quality Control (QC) personnel. As per the contract documents, ZPMC QC personnel are required to perform 100% MT inspection of these welds and battered locations.

AWS D1.5 2002 figure 6.8 – “Specifies for weld size of 20mm the maximum discontinuity length is approximately 6mm and a minimum clearance between discontinuities of approximately 57mm.

ZPMC has repaired the indication noted in the NCR and is providing NDT documentation after the repair to show the indication has been removed. ABFJV has noted which inspector was responsible for this missed indication and is monitoring his performance as well as all inspector performance, if he continues to miss indications disciplinary action will be undertaken. Based on these actions, ZPMC requests closure of this NCR.

The proposed resolution is acceptable. This NCR is considered closed.

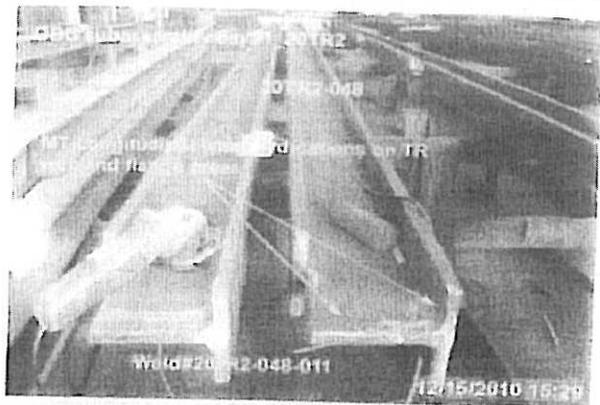
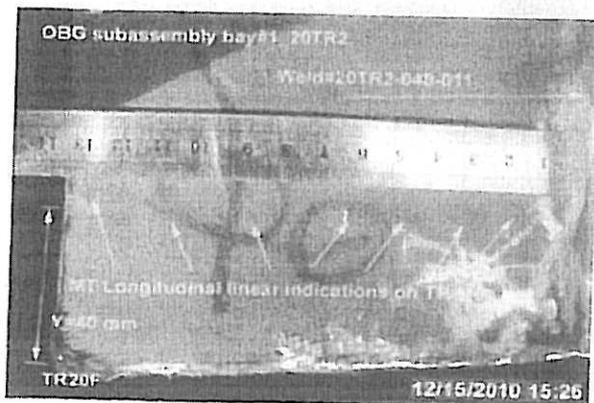
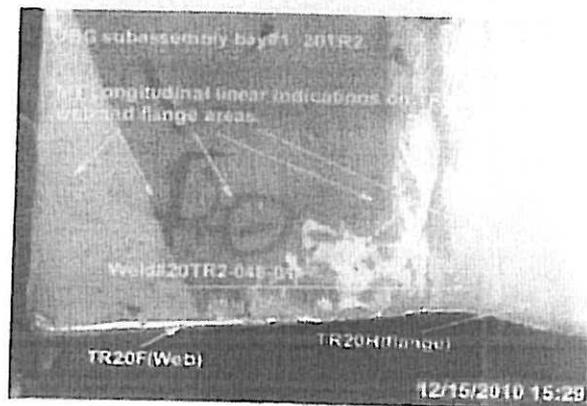
- 10 linear indications measuring approximately 4 ~10 mm in length were found on this traveler rail.
- The indications are located at the base metal of the web and flange, and the battered areas at the end of the traveler rail.

- The nearest weld is identified as: 20TR2-048-011.
- The web and flange are identified as TR20F and TR20H respectively.
- The "Y" locations of the indications are approximately 40 mm and 25 mm for web and flange, respectively.

- The "Y" locations are measured from the end of the traveler rail as shown in the photos below.
- The thickness of the TR web and flange is 20 mm.
- Traveler rail 20TR2-048 is currently located in the OBG Sub assembly Bay #1.

- The Notice of Witness Inspection Number (NWIT) is 07789. The indications are located within the area that has been previously tested and accepted by ZPMC Quality Control (QC) personnel. As per the contract documents, ZPMC QC personnel are required to perform 100% MT inspection of these welds and battered locations.

AWS D1.5 2002 figure 6.8 - "Specifies for weld size of 20mm the maximum discontinuity length is approximately 6mm and a minimum clearance between discontinuities of approximately 57mm.

Contractor will repair the welds, and perform NDT to prove the welds are acceptable. Contractor will identify and issue an internal NCR to the inspector who missed the indications. Contractor will monitor his performance. Disciplinary action will be taken if the inspector misses indications continuously.

Contractor repaired the weld and performed NDT subsequently. NDT report shows that the welds are acceptable. Contractor identified and issued an internal NCR to the inspector who missed the indications. Contractor is monitoring the inspector's performance.
