Contract #: 04-0120F4Cty: SF/ALA Rte: 80 PM: 13.2/13.9File #: 69.25B**QUALITY ASSURANCE -- NON-CONFORMANCE REPORT****Location:** Changxing Island, Shanghai, China**Report No:** NCR-000948**Prime Contractor:** American Bridge/Fluor Enterprises, a JV**Date:** 16-Dec-2010**Submitting Contractor:** Zhenhua Port Machinery Company, Ltd (ZPMC), Changxing Island**NCR #:** ZPMC-0907**Type of problem:**

**Reference Description:** QA Discovered Missing Weld already accepted by QC's VT Report on CB18**Description of Non-Conformance:**

**Job Name:** SAS Superstructure

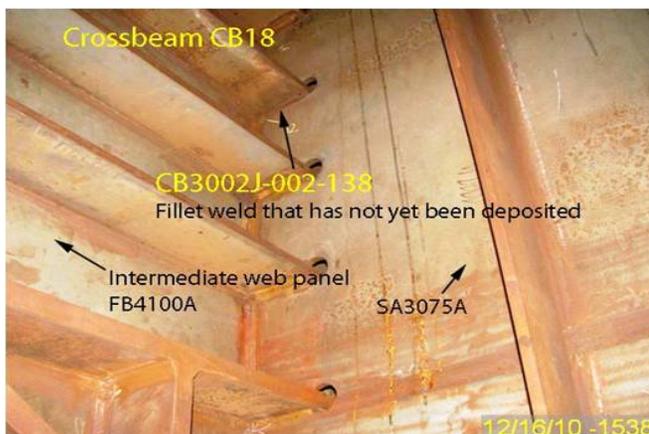
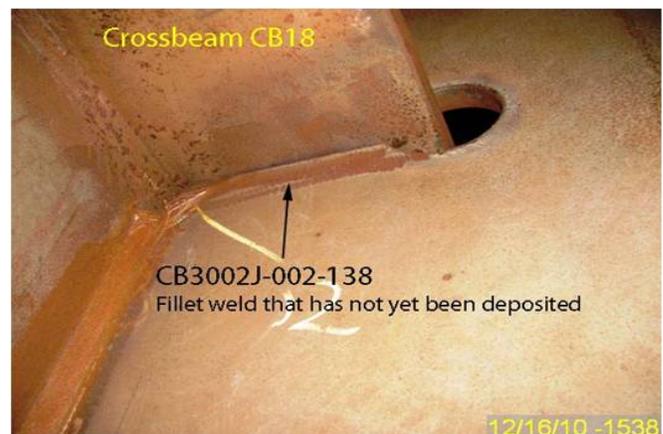
During Caltrans Quality Assurance (QA) Visual Testing (VT) verification of welds located on OBG Crossbeam identified as CB18, this QA discovered the following issue:

- ZPMC Quality Control (QC) inspectors have issued a report stating that they had visually tested and accepted a fillet weld where the fillet appears to be missing.
- VT report identified as B-VT-87758, documents that this weld was visually tested and accepted.
- The weld is identified as CB3002J-002-138.
- This weld is a fillet weld joining Floor Beam (FB4100A) to the I-rib stiffeners (X3726E) and the interior Diaphragm identified as SA3075A.
- CB18 is currently located outside the north end of Bay 18.

The notice of witness Inspection Number (NWIT) is 07782. This weld joint is within an area that has been previously tested and accepted by ZPMC Quality Control (QC) personal. As per contract documents ZPMC is required to perform 100% visual testing (VT) of this weld.

ZPMC has completed the weld and is providing the VT report to show that it is in fact present in accordance with the code and made certain that the size, length, and the location of all welds conform to the requirements. ZPMC QA has been reminded to check with their Production counterparts before issuing a inspection request to prevent this from occurring again. Based on this, ZPMC requests closure of this NCR.

The weld that was missed by QC has since been welded and the QC VT record (dated Feb 21, 2011) has been provided. The documentation received is sufficient and the Department concurs that Non-Conformance ZPMC-0907 is closed.

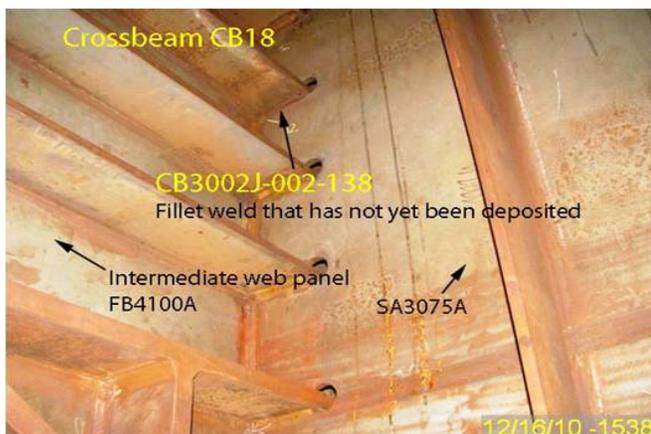
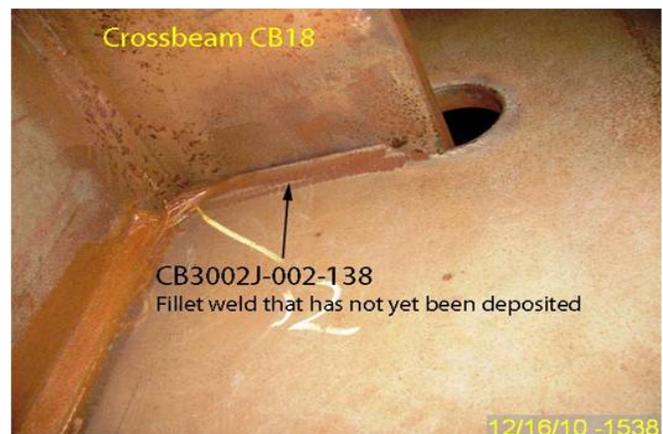
During Caltrans Quality Assurance (QA) Visual Testing (VT) verification of welds located on OBG Crossbeam identified as CB18, this QA discovered the following issue:

- ZPMC Quality Control (QC) inspectors have issued a report stating that they had visually tested and accepted a fillet weld where the fillet appears to be missing.
- VT report identified as B-VT-87758, documents that this weld was visually tested and accepted.
- The weld is identified as CB3002J-002-138.
- This weld is a fillet weld joining Floor Beam (FB4100A) to the I-rib stiffeners (X3726E) and the interior Diaphragm identified as SA3075A.
- CB18 is currently located outside the north end of Bay 18.

The notice of witness Inspection Number (NWIT) is 07782. This weld joint is within an area that has been previously tested and accepted by ZPMC Quality Control (QC) personal. As per contract documents ZPMC is required to perform 100% visual testing (VT) of this weld.

Contractor completed the missing weld and provided the VT report showing the weld was present as per Code and conformed to the requirement. Contractor's QC was reminded to check with the Production team before issuing notification for inspection.
