Contract #: 04-0120F4Cty: SF/ALA Rte: 80 PM: 13.2/13.9File #: 69.25B**QUALITY ASSURANCE -- NON-CONFORMANCE REPORT****Location:** Changxing Island, Shanghai, China**Report No:** NCR-000949**Prime Contractor:** American Bridge/Fluor Enterprises, a JV**Date:** 17-Dec-2010**Submitting Contractor:** Zhenhua Port Machinery Company, Ltd (ZPMC), Changxing Island**NCR #:** ZPMC-0908**Type of problem:**

Reference Description: Lack of Preheat Observed on Critical Weld Repair being performed on Saddle Grillage for Lift 13EA

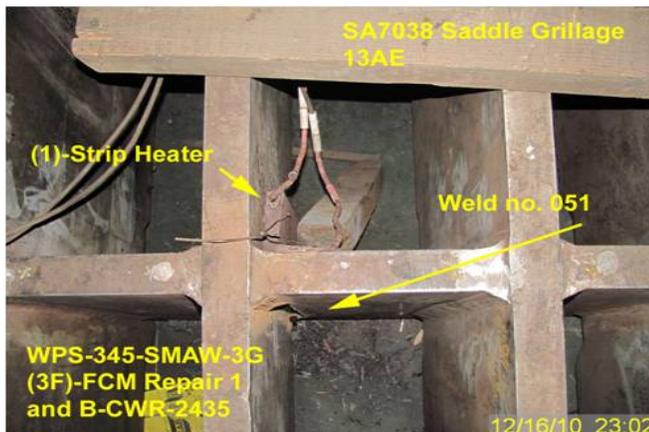
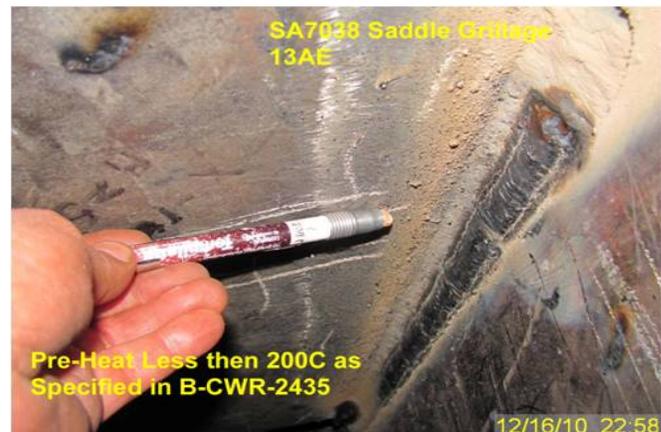
During the Quality Assurance in-process observation of the fabrication of the East Grillage sub-assembly SA7038A, this Quality Assurance Inspector (QA) discovered the following issue:

- ZPMC did not appear to properly preheat prior to performing a critical weld repair.
- The applicable critical weld repair report (B-CWR-2435) specifies a minimum preheat value of 200 C for material thickness greater than 40mm.
- This QA observed that a 200 C temp stick did not melt within 75mm of the Complete Joint Penetration (CJP) joint being repaired.
- The weld joint is identified as SA7038-051.
- The weld is a CJP joint, joining members identified as X3801A To X3788A (SPCM and TTP).
- Material thickness is 75 mm.
- Welding process is Shielded Metal Arc Welding (SMAW)
- The member is located in fabrication Bay 13.

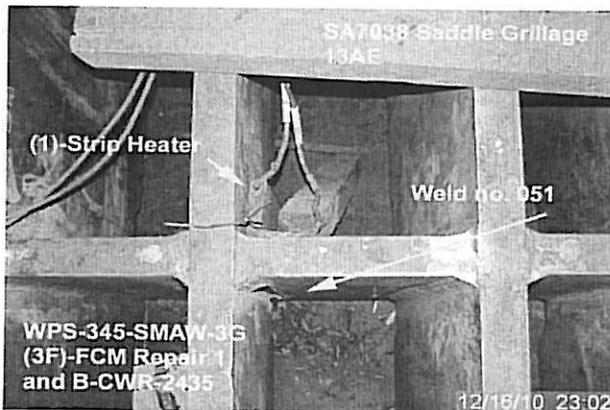
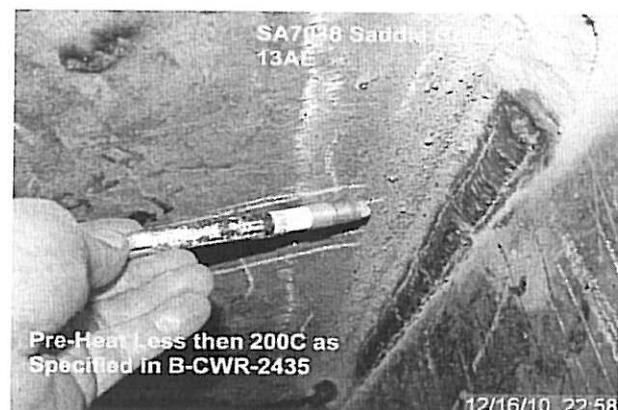
During the Quality Assurance in-process observation of the fabrication of the East Grillage sub-assembly SA7038A, this Quality Assurance Inspector (QA) discovered the following issue:

- ZPMC did not appear to properly preheat prior to performing a critical weld repair.
- The applicable critical weld repair report (B-CWR-2435) specifies a minimum preheat value of 200 C for material thickness greater than 40mm.
- This QA observed that a 200 C temp stick did not melt within 75mm of the Complete Joint Penetration (CJP) joint being repaired.
- The weld joint is identified as SA7038-051.
- The weld is a CJP joint, joining members identified as X3801A To X3788A (SPCM and TTP).
- Material thickness is 75 mm.
- Welding process is Shielded Metal Arc Welding (SMAW)
- The member is located in fabrication Bay 13.
