Contract #: 04-0120F4Cty: SF/ALA Rte: 80 PM: 13.2/13.9File #: 69.25B**QUALITY ASSURANCE -- NON-CONFORMANCE REPORT****Location:** Changxing Island, Shanghai P.R. China**Report No:** NCR-000951**Prime Contractor:** American Bridge/Fluor Enterprises, a JV**Date:** 18-Dec-2010**Submitting Contractor:** Zhenhua Port Machinery Company, Ltd (ZPMC), Changxing Island**NCR #:** ZPMC-0910**Type of problem:**

Reference Description: One Longitudinal Indication found in Tower Suspender Bracket**Description of Non-Conformance:**

Job Name: SAS Superstructure

Subject: NCR No. ZPMC-0910

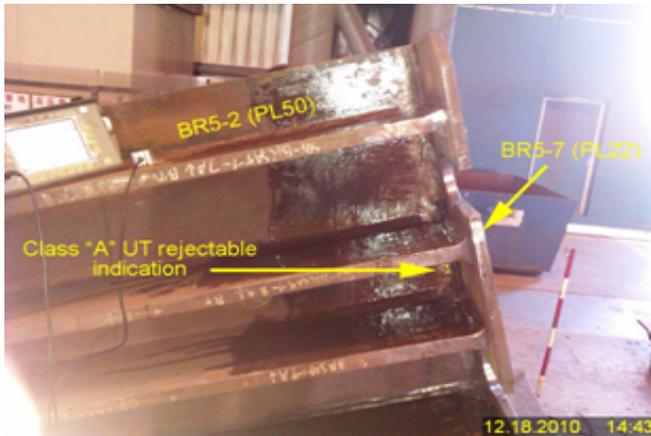
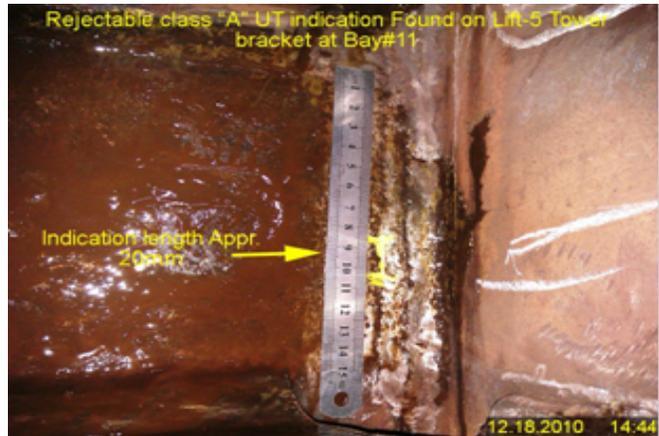
During the Quality Assurance Ultrasonic Testing (UT) review of welds located on Tower Lift-5 Bracket at Bay#11, this Quality Assurance Inspector (QA) discovered the following issues:

- One longitudinal linear Class "A" rejectable indication measuring approximately 20mm in length.
- The indication dbS rating is a +3.
- Material thickness is 50mm.
- The depth of the indication is approximately 28mm.
- The weld is identified as SD1-BRSA5-1-19.
- The weld is Complete Joint Penetration (CJP) "T" joint joining Web BR5-2(PL50) to flange BR5-7(PL22).
- The indication is clearly marked on or near the weld.
- The Y distance for this indication is 570 mm from edge of the bracket.
- The tower bracket is located at Bay#11.

The Notice of Witness Inspection (NWIT) No. is 07818. The indication is located within an area previously tested and accepted by ZPMC Quality Control (QC) personnel. As per the contract documents, ZPMC's QC personnel are required to perform 100% UT inspection of this weld.

AWS D1.5-02 Section 6; Table 6.3 specifies a class "A" indication as having a rating of 4dbs and under for material thicknesses 38mm through 60mm.

Contractor will repair the indication identified, and will provide NDT report to prove the weld is acceptable. Contractor will also provide an additional training to the inspector who missed the indication

Contractor repaired the indication of the weld, and NDT reports were provided. The NDT report shows the weld is acceptable. The component was green tagged by CT. Contractor provided an additional training to the inspector who missed the indication.

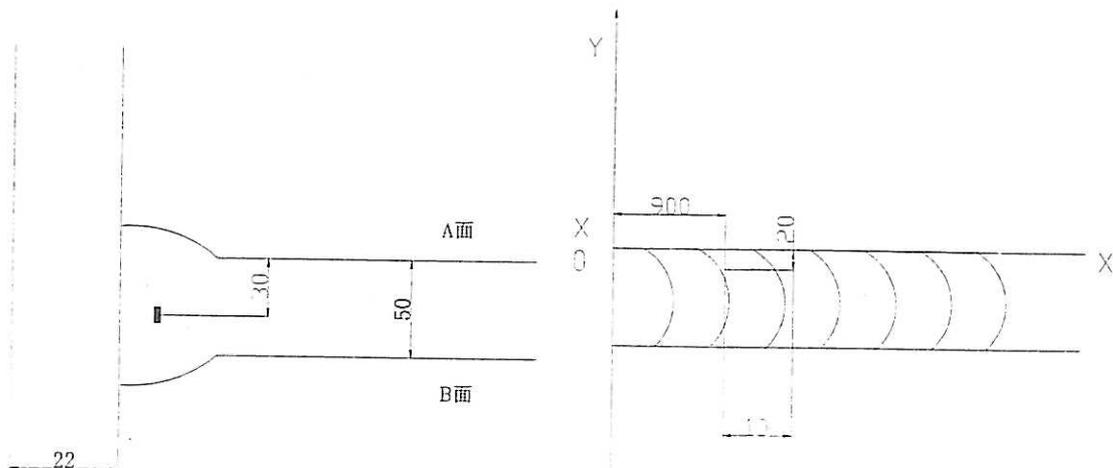
WELD NUMBER: SD1-BRSA5-1-19A/B

Weld No. 焊缝编号为：SD1-BRSA5-1-19A/B

1、焊道未及时处理干净。

1. Did not clear the weld pass completely in time.

1. Prepare the joint according to the approved WPS.
2. Grind or gouge the repair area to a smooth finish according to the approved repair WPS.
3. Remove all defects by grinding to ensure all defects are completely removed if defects still exist.
4. Preheat and weld according to the approved WPS.
5. Grind the weld flush after welding.
6. Perform NDT of the repair area.

1. Improve monitoring of welding and interpass cleaning.
