Contract #: 04-0120F4Cty: SF/ALA Rte: 80 PM: 13.2/13.9File #: 69.25B

QUALITY ASSURANCE -- NON-CONFORMANCE REPORT

Location: Changxing Island, Shanghai, China**Report No:** NCR-000952**Prime Contractor:** American Bridge/Fluor Enterprises, a JV**Date:** 23-Dec-2010**Submitting Contractor:** Zhenhua Port Machinery Company, Ltd (ZPMC), Changxing Island**NCR #:** ZPMC-0911**Type of problem:**

Reference Description: Cuts Made on Lift 14E East Anchorage (SA) Vertical Plates Not Shown on Approved Shop Drawings

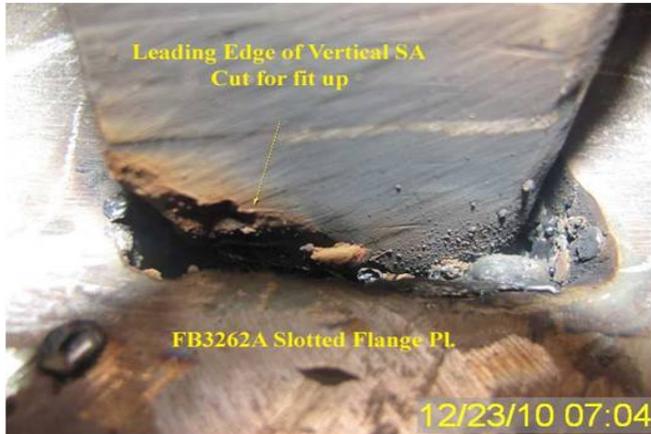
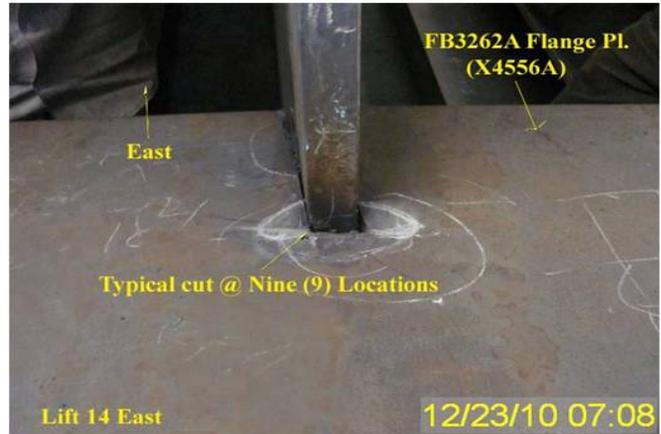
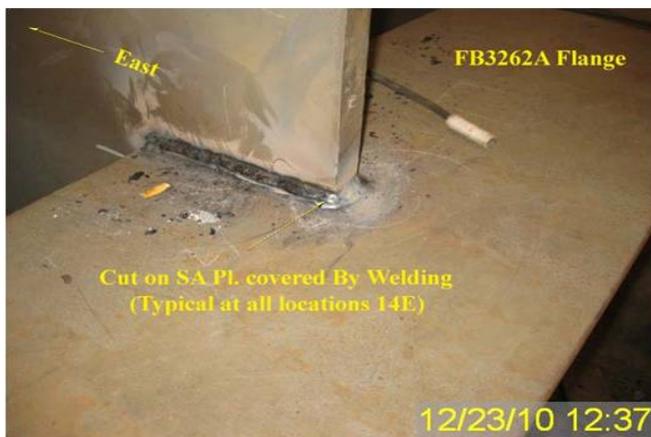
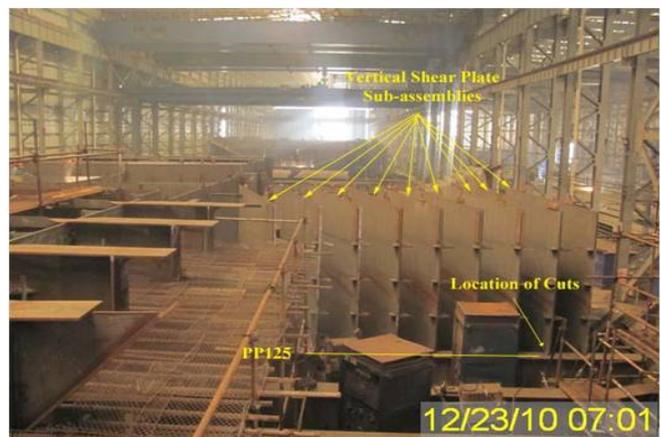
- ZPMC personnel cut out the leading edge of the Vertical Shear Plate Sub-Assemblies (Web) in a total of nine (9) locations to facilitate fit up at the Panel Point 125 Floorbeam (FB3262A) slotted flange connection.
- Following the removal of the Shear Plate web material, ZPMC personnel have masked the roughly free hand cut area by welding it to the flange plate.
- The Vertical Shear Plate sub-assemblies are identified as SA3357A, SA3358A, SA3359A, SA3360A, SA3361A, SA3362A, SA3363A, SA3364A and SA3365A and are designated on the contract drawings as Seismic Performance Critical Members (SPCM).
- Maximum dimension of the Vertical Shear Plate web removal was 20mm deep and 40mm in length.
- Segment 14E is in the OBG Fabrication Bay 14.

See attached photographs for additional detail.

Standard Specifications July 1999, section 5-1.03; "Work and materials shall conform to the lines, grades, typical cross sections, dimensions and material requirements, including tolerances, shown on the plans or indicated in the specifications."

AWS D1.5 2002; Section 3.2.2 "In all thermal cutting, the cutting flame shall be so adjusted and manipulated as to avoid cutting beyond (inside) the prescribed lines."

During the installation of EB anchorage shear plates, ZPMC had to cut a portion of the leading edge. As discussed with engineer, the proposal to taper the cutout with 1:10 transition and grind smooth the cut surface was accepted. All the remedial work as required has been completed. Based on this, ZPMC is requested closure of this NCR.

Contractor to carry out the retrofit work as per the TC-RFI which has been accepted.

ZPMC completed the retrofit as required in the TC-RFI and has been inspected and accepted by QA.

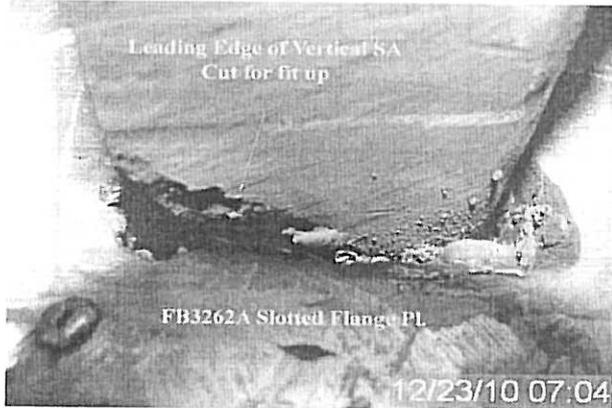
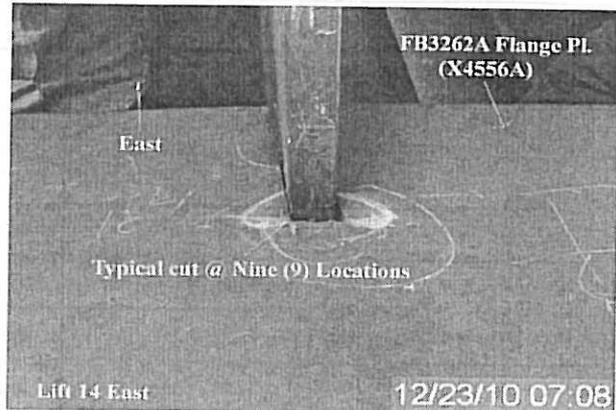
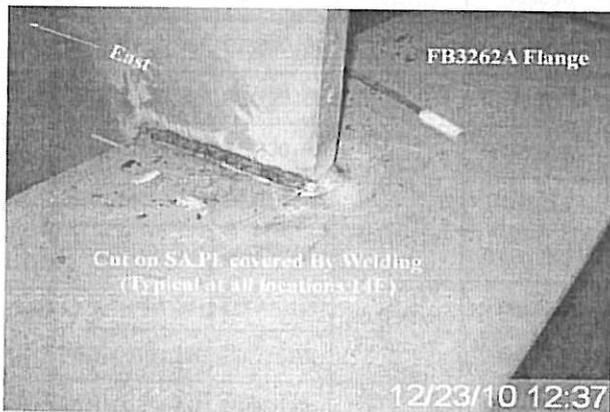
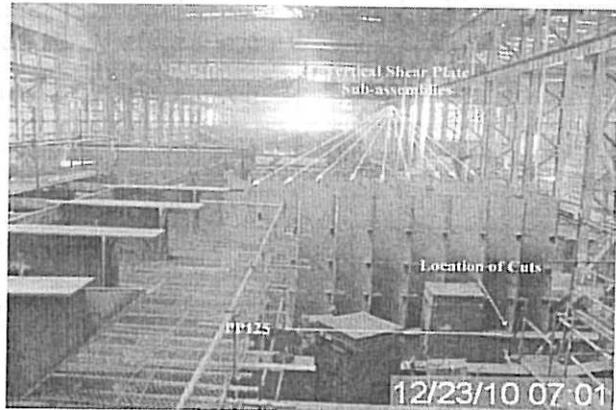
- ZPMC personnel cut out the leading edge of the Vertical Shear Plate Sub-Assemblies (Web) in a total of nine (9) locations to facilitate fit up at the Panel Point 125 Floorbeam (FB3262A) slotted flange connection.
- Following the removal of the Shear Plate web material, ZPMC personnel have masked the roughly free hand cut area by welding it to the flange plate.
- The Vertical Shear Plate sub-assemblies are identified as SA3357A, SA3358A, SA3359A, SA3360A, SA3361A, SA3362A, SA3363A, SA3364A and SA3365A and are designated on the contract drawings as Seismic Performance Critical Members (SPCM).
- Maximum dimension of the Vertical Shear Plate web removal was 20mm deep and 40mm in length.
- Segment 14E is in the OBG Fabrication Bay 14.

See attached photographs for additional detail.

Standard Specifications July 1999, section 5-1.03; "Work and materials shall conform to the lines, grades, typical cross sections, dimensions and material requirements, including tolerances, shown on the plans or indicated in the specifications."

AWS D1.5 2002; Section 3.2.2 "In all thermal cutting, the cutting flame shall be so adjusted and manipulated as to avoid cutting beyond (inside) the prescribed lines."

During the installation of EB anchorage shear plates, ZPMC had to cut a portion of the leading edge to clear the interference with PP125 FB flange. Please confirm if it is acceptable to taper the cutout with 1:10 transition and grind smooth the cut surface. No weld repair will be needed.
