Contract #: 04-0120F4Cty: SF/ALA Rte: 80 PM: 13.2/13.9File #: 69.25B**QUALITY ASSURANCE -- NON-CONFORMANCE REPORT****Location:** Changxing Island, Shanghai, China**Report No:** NCR-000954**Prime Contractor:** American Bridge/Fluor Enterprises, a JV**Date:** 24-Dec-2010**Submitting Contractor:** Zhenhua Port Machinery Company, Ltd (ZPMC), Changxing Island**NCR #:** ZPMC-0913**Type of problem:**

Reference Description: Base Metal Repair without Prior Approval from the Engineer**Description of Non-Conformance:**

Job Name: SAS Superstructure
Document No: 05.03.06-000910

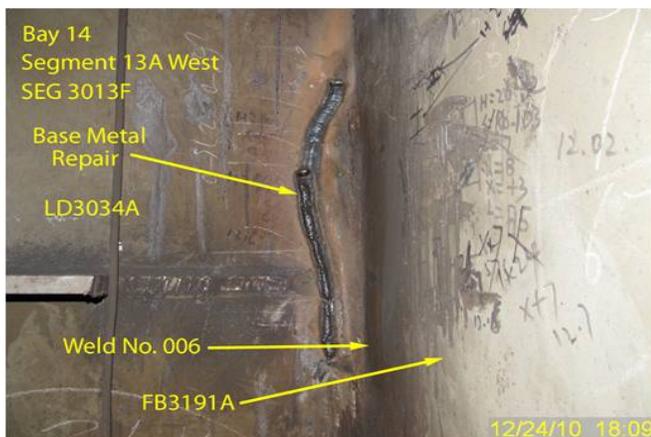
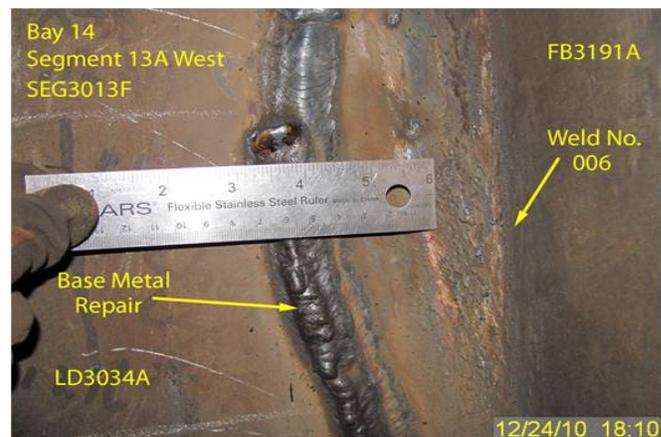
-ZPMC personnel performing base metal repair on the Longitudinal Diaphragm (LD) web at W3, panel point 119 +1500 of Segment 13AW without the Engineer's approval.

-The Longitudinal Diaphragm is identified as: LD3034A

- Repairs were being performed adjacent to the Vertical web splice identified as LD3034-003 and floor beam to LD weld identified as SEG3013F-006.

-The material utilized is A709 Grade 345 SPCM.

-The welding process used was SMAW.

Reference Resolution: ZPMC is providing NDT of the base metal repair to show that the repair was successful.

ZPMC is providing NDT of the base metal repair to show that the repair was successful. The QA and QC departments have been reminded that if they see repairs they must verify that the proper documents on hand before allowing the repair to proceed. The production foreman has been reminded as well that documents on hand are needed before this work should be executed. Based on this ZPMC requests closure of this NCR.

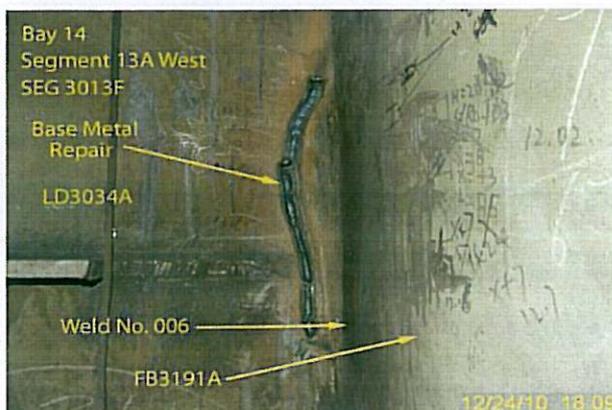
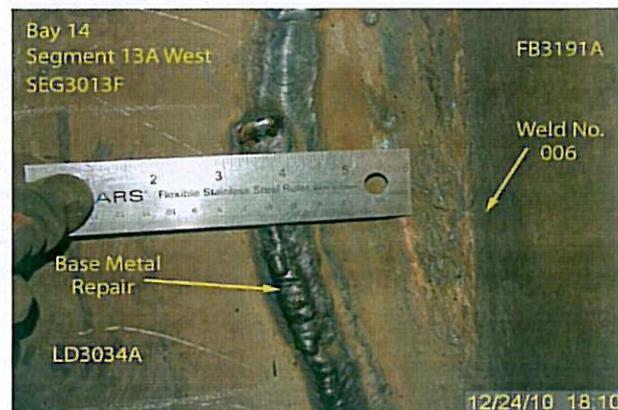
-ZPMC personnel performing base metal repair on the Longitudinal Diaphragm (LD) web at W3, panel point 119 +1500 of Segment 13AW without the Engineer's approval.

-The Longitudinal Diaphragm is identified as: LD3034A

-Repairs were being performed adjacent to the Vertical web splice identified as LD3034-003 and floor beam to LD weld identified as SEG3013F-006.

-The material utilized is A709 Grade 345 SPCM.

-The welding process used was SMAW.

Contractor will provide the NDT report to prove the repair is successful. Contractor will remind the QC department and the production foreman that proper repair documentation should be on hand prior to any repair works.

Contractor provided the NDT report showing the repair is successful. The QC department and the production foreman was reminded that proper repair documentation should be on hand prior to execution of repair works.
