Contract #: 04-0120F4
 Cty: SF/ALA Rte: 80 PM: 13.2/13.9
 File #: 69.25B

QUALITY ASSURANCE -- NON-CONFORMANCE REPORT

Report No: NCR-000955

Reference Description: Excessive Root Opening on PJP Welds for Lift 13AE Saddle Grillage Wing Plates

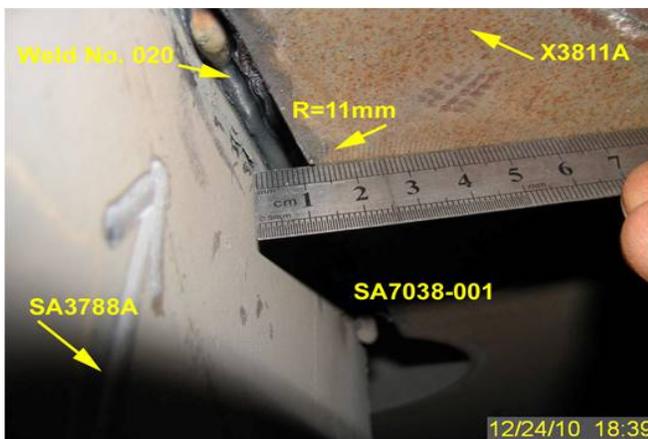
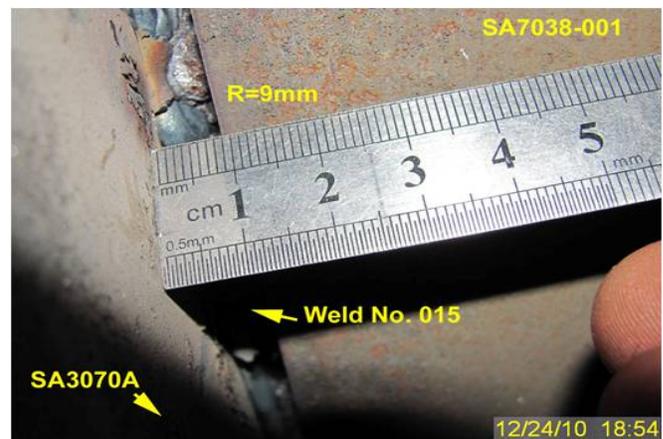
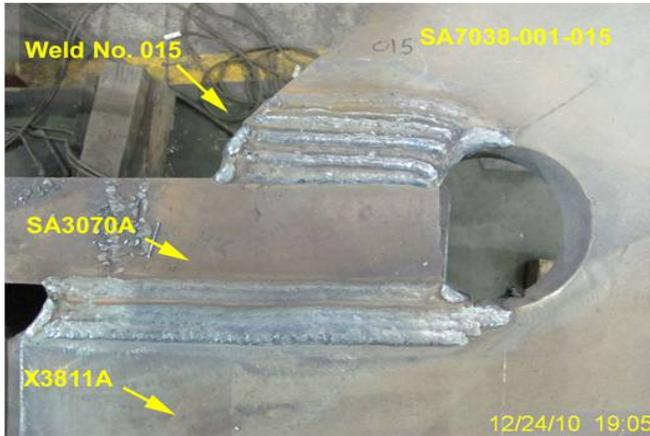
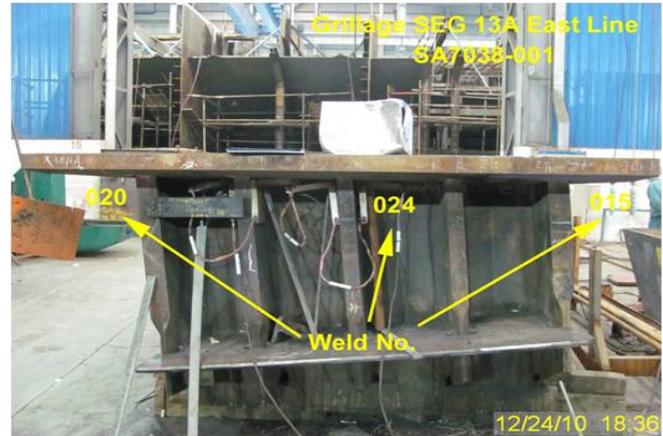
- The connection plate (X3811A) to the Grillage Plate A (X3788A, X3787A, X3786A) Partial Joint Penetration corner welds with root openings between 9mm to 11mm in a total of three (3) locations.
 - The maximum allowable root opening per the applicable WPS is 3mm as fit up.
 - The affected welds are designated as SA7038-015, 020 and 024.
 - The welds are designated on the contract drawings as Seismic Performance Critical Members (SPCM), and require through thickness properties (TTP).
 - The members are located in OBG fabrication Bay 13.
- See attached photographs for additional detail.

The proposal to change the PJP welds noted in the attachments to be out of root gap tolerance to CJP welds with 100% MT of the backgouge and 100% MT of the finished weld is acceptable

Contractor finished the weld according to the approved RFI 921. The weld has been changed from PJP to CJP. However Contractor requested UT on this weld to be waived and the request has been accepted. MT report submitted, and the report shows the weld is acceptable.

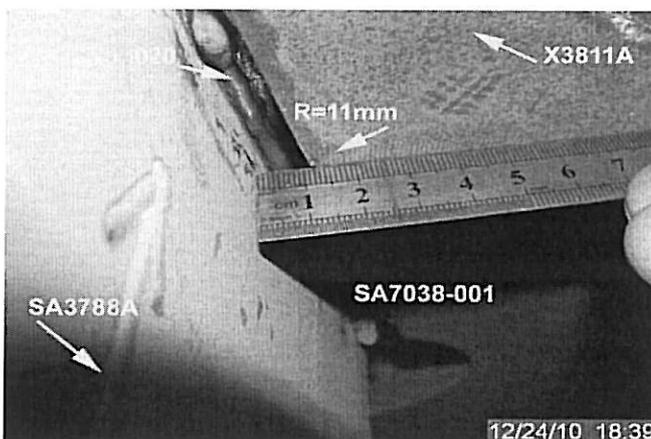
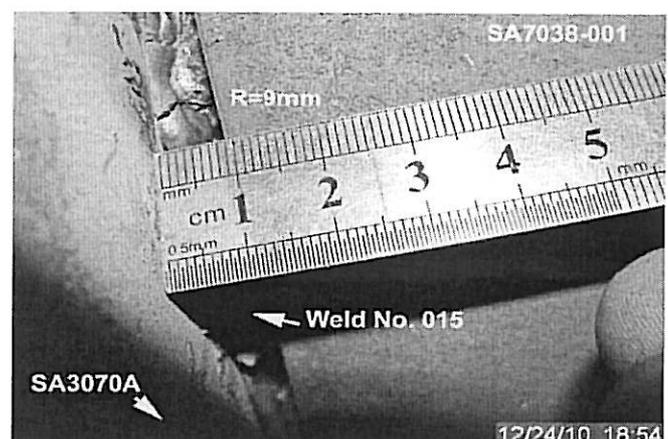
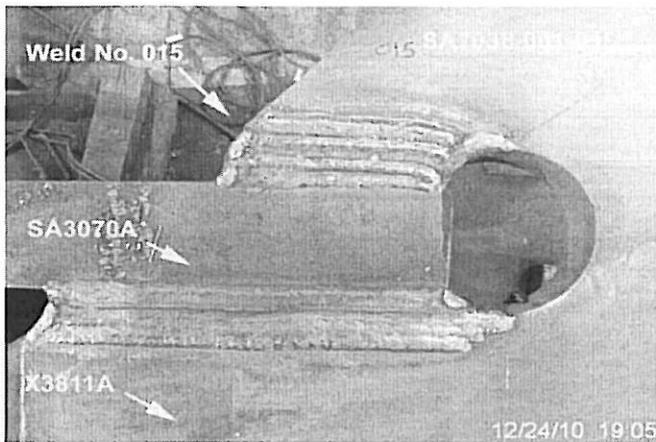
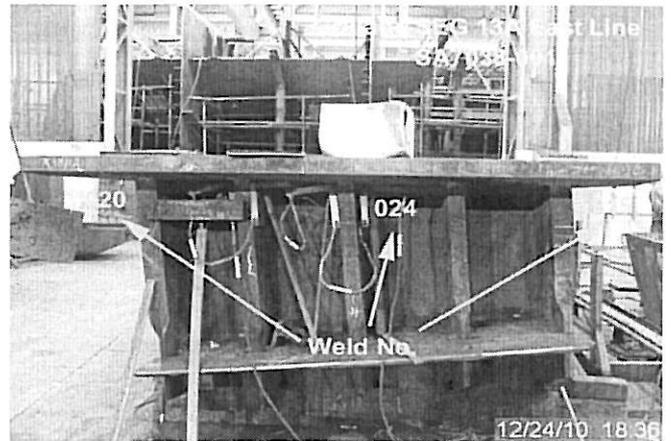
Reference Description: Excessive Root Opening on PJP Welds for Lift 13AE Saddle Grillage Wing Plates

- The connection plate (X3811A) to the Grillage Plate A (X3788A, X3787A, X3786A) Partial Joint Penetration corner welds with root openings between 9mm to 11mm in a total of three (3) locations.
 - The maximum allowable root opening per the applicable WPS is 3mm as fit up.
 - The affected welds are designated as SA7038-015, 020 and 024.
 - The welds are designated on the contract drawings as Seismic Performance Critical Members (SPCM), and require through thickness properties (TTP).
 - The members are located in OBG fabrication Bay 13.
- See attached photographs for additional detail.
