Contract #: 04-0120F4  
 Cty: SF/ALA Rte: 80 PM: 13.2/13.9  
 File #: 69.25B

## QUALITY ASSURANCE -- NON-CONFORMANCE REPORT

**Report No:** NCR-000956

**Reference Description:** ZPMC performed welding on a fillet weld joint with excessive root gaps at 2 weld joints on bikepath BK004A2-031

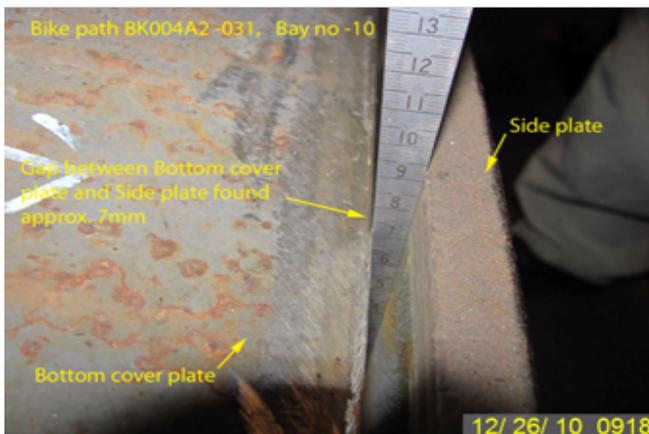
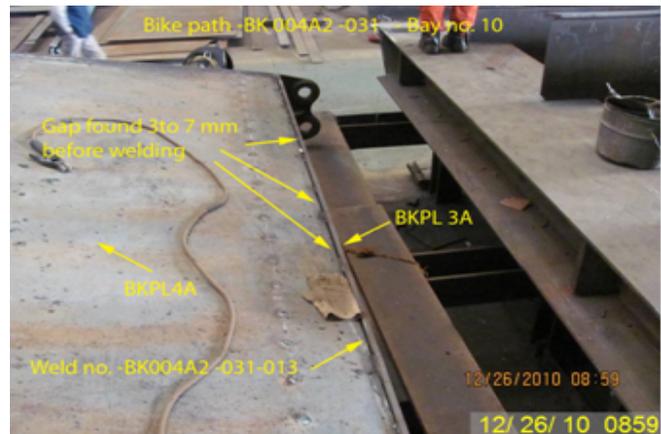
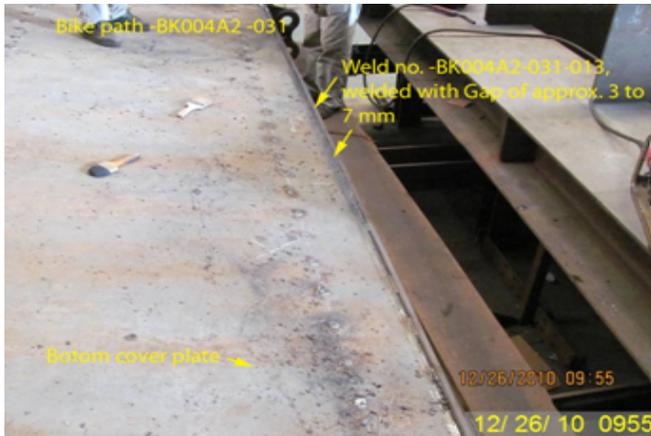
- The root gaps of 7mm were found between Bottom cover plate and Side plate of Bike path BK 004A2-031 at Y location from approximately 0 to 2000mm at 2 welds.
- At the time, plug welds of the cover plate and tack welds of the cover to side plates were completed.
- The welds are identified as BK004A2-031-013 and BK 004A2-031-021
- CT QA Inspector informed the Contractor's QC inspectors of this issue.
- The weld is a 6mm fillet weld joining, Bottom Plate (BKPL4A) to Side Plate (BKPL3A).
- Y location is approximately 2000 mm from BKPL6B, bottom diaphragm plate.
- Bikepath is located in Bay 10.
- Without resolving the excessive root gaps issue, ZPMC finished welding these fillet welds by not conforming to AWS D1.5 Section 3.3.1.

AWS D1.5 Section - 3.3.1 –“The parts to be joined by fillet welds shall be brought into as close contact as practicable. The root opening shall not exceed 5 mm [3/16 in.] except in cases involving either shapes or plates 75 mm [3 in.] or greater in thickness if, after straightening and in assembly, the root opening cannot be closed sufficiently to meet this tolerance.”

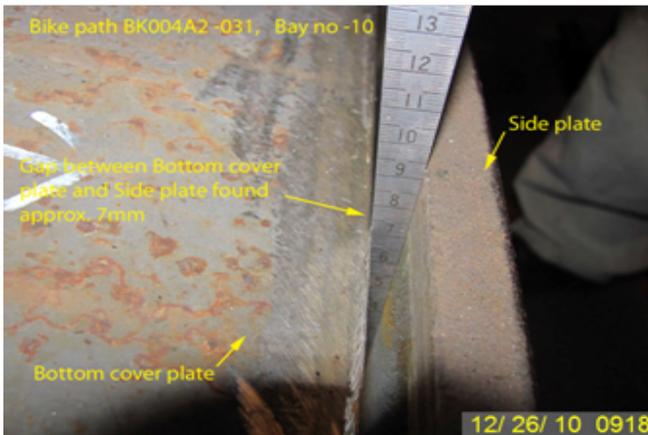
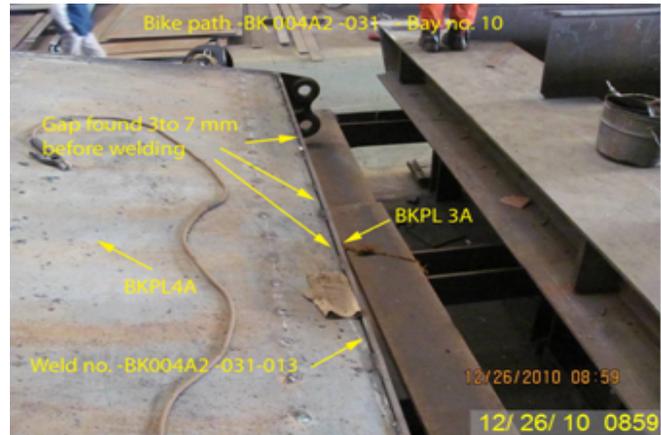
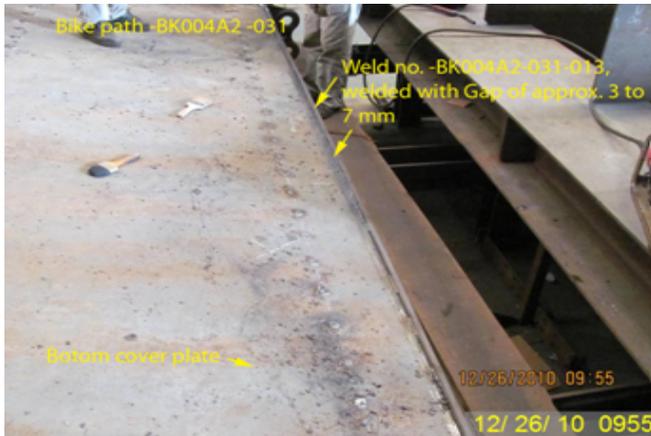
- The root gaps of 7mm were found between Bottom cover plate and Side plate of Bike path BK 004A2-031 at Y location from approximately 0 to 2000mm at 2 welds.
- At the time, plug welds of the cover plate and tack welds of the cover to side plates were completed.
- The welds are identified as BK004A2-031-013 and BK 004A2-031-021
- CT QA Inspector informed the Contractor's QC inspectors of this issue.
- The weld is a 6mm fillet weld joining, Bottom Plate (BKPL4A) to Side Plate (BKPL3A).
- Y location is approximately 2000 mm from BKPL6B, bottom diaphragm plate.
- Bikepath is located in Bay 10.
- Without resolving the excessive root gaps issue, ZPMC finished welding these fillet welds by not conforming to AWS D1.5 Section 3.3.1.

AWS D1.5 Section - 3.3.1 –“The parts to be joined by fillet welds shall be brought into as close contact as practicable. The root opening shall not exceed 5 mm [3/16 in.] except in cases involving either shapes or plates 75 mm [3 in.] or greater in thickness if, after straightening and in assembly, the root opening cannot be closed sufficiently to meet this tolerance.”

This non conformance was the result of ZPMC production not following the direction of the ZPMC's QC department to rectify the root gap issue and continuing to weld. ZPMC QA has issued an NCR on both the QC and Production teams involved to demonstrate that non conformances should be rectified when pointed out during the fabrication process. In addition to normal inspection, ZPMC and ABFJV will ensure the inspectors identify these types of situations in the future and prevent them from moving forward in production. Based on these actions and previously submitted documents, ZPMC requests closure of this NCR.
