Contract #: 04-0120F4Cty: SF/ALA Rte: 80 PM: 13.2/13.9File #: 69.25B**QUALITY ASSURANCE -- NON-CONFORMANCE REPORT****Location:** Changxing Island, Shanghai, P.R. China**Report No:** NCR-000960**Prime Contractor:** American Bridge/Fluor Enterprises, a JV**Date:** 28-Dec-2010**Submitting Contractor:** Zhenhua Port Machinery Company, Ltd (ZPMC), Changxing Island**NCR #:** ZPMC-0919**Type of problem:****Welding****Concrete****Other****Welding****Curing****Procedural****Bridge No:** 34-0006**Joint fit-up****Coating****Other****Component:** Bikepath BK004A-013**Procedural****Procedural****Description:**

**Reference Description:** ZPMC welder performed welding in a position which he is not qualified to weld (Bikepath BK004A-013)

**Subject:** NCR No. ZPMC-0919

**Job Name:** SAS Superstructure

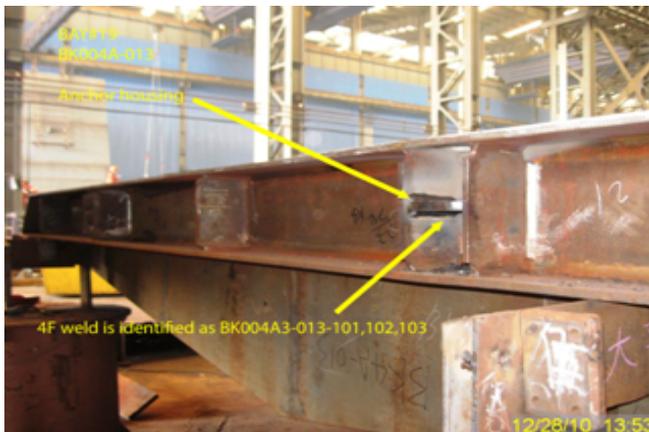
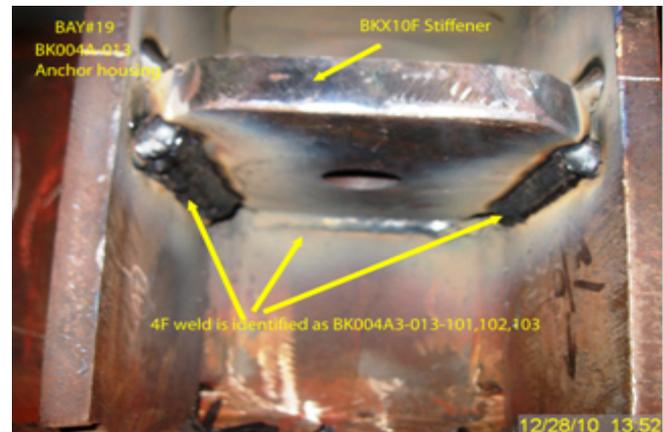
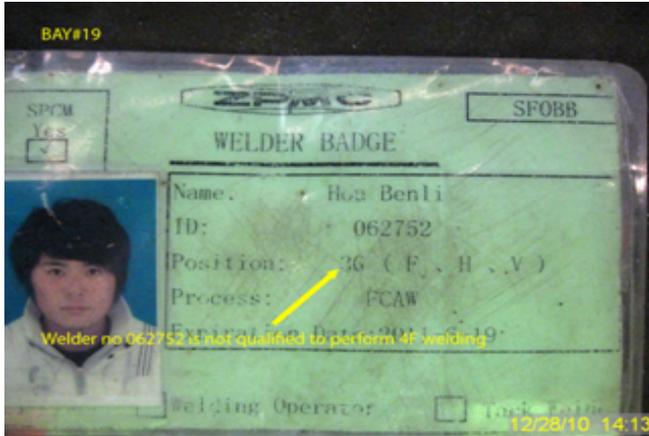
During the Quality Assurance (QA) random observation of the fabrication of OBG Bike path BK004A-013, this QA Inspector discovered the following issue:

- ZPMC welder ID#062752 performed welding in a position in which he is not qualified according to his welder card.
- The welder is qualified to the 3G (FCAW) position.
- The welder was observed by this QA welding in the 4F position.
- There are three fillet weld joints completed by this welder in the 4F position.
- The welds are identified as BK004A3-013-101,102 and 103.
- The welds are fillet welds joint connecting the stiffener BKX10F to 25mm stiffener plate BKX11 and stiffener BKSA1A (Anchor Housing assembly).
- OBG Bike path is located inside bay 19.

AWS D1.5-2002, Table 5.6, Welder Qualification-Type and Position Limitations Specifies a welder tested in the 3G position is qualified to weld in the 1G,2G,3G and 1F,2F,3F positions only.

**Reference Resolution:** ZPMC has removed the plate and welds, this plate was not on the drawing so ZPMC is providing NDT of the base metal where the plate and welds were removed.

ZPMC acknowledged this problem and has written an internal NCR. The unsatisfied welds have been removed and were repaired with CWR report after doing NDT on removal area. As the area no NDT request after welding, ZPMC is just providing the NDT record of base metal for Engineer to review and is expecting the closure of this NCR.

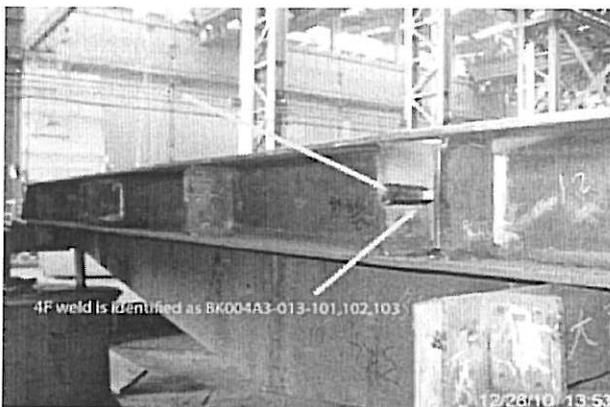
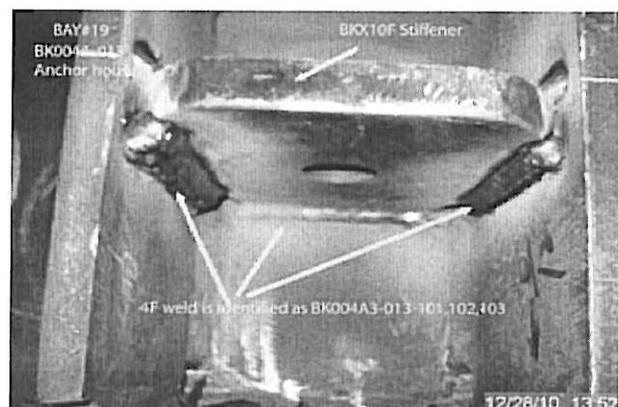
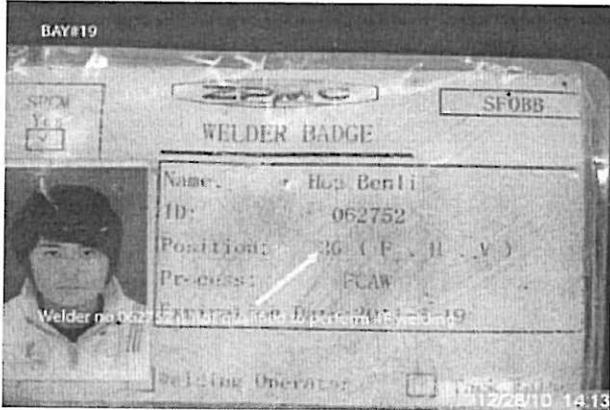
During the Quality Assurance (QA) random observation of the fabrication of OBG Bike path BK004A-013, this QA Inspector discovered the following issue:

- ZPMC welder ID#062752 performed welding in a position in which he is not qualified according to his welder card.
- The welder is qualified to the 3G (FCAW) position.
- The welder was observed by this QA welding in the 4F position.
- There are three fillet weld joints completed by this welder in the 4F position.
- The welds are identified as BK004A3-013-101,102 and 103.
- The welds are fillet welds joint connecting the stiffener BKX10F to 25mm stiffener plate BKX11 and stiffener BKSA1A (Anchor Housing assembly).
- OBG Bike path is located inside bay 19.

AWS D1.5-2002, Table 5.6, Welder Qualification-Type and Position Limitations Specifies a welder tested in the 3G position is qualified to weld in the 1G,2G,3G and 1F,2F,3F positions only.

Contractor will remove the non-conforming welds, and submit the Critical Welding Report. As this plate is not on the drawing Contractor will perform NDT on the base metal where the plate has been removed. Contractor will issue an internal NCR to the QC personnel involved.

Contractor removed the welds, and repaired as Critical Welding Repair to the approved procedure. NDT report has been provided proving the base metal is acceptable after repair. ZPMC issued an internal NCR to the QC personnel.
