Contract #: 04-0120F4Cty: SF/ALA Rte: 80 PM: 13.2/13.9File #: 69.25B**QUALITY ASSURANCE -- NON-CONFORMANCE REPORT****Location:** Changxing Island, Shanghai, P.R. China**Report No:** NCR-000964**Prime Contractor:** American Bridge/Fluor Enterprises, a JV**Date:** 05-Jan-2011**Submitting Contractor:** Zhenhua Port Machinery Company, Ltd (ZPMC), Changxing Island**NCR #:** ZPMC-0923**Type of problem:**

Reference Description: Lift 4 131m and 139m Facades connecting from West and North Shafts**Description of Non-Conformance:**

Job Name: SAS Superstructure

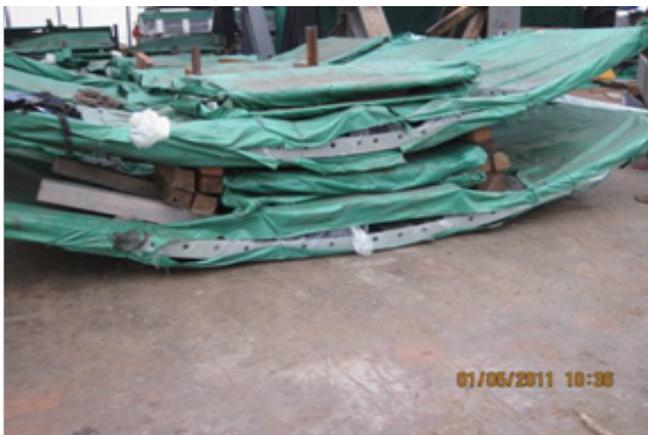
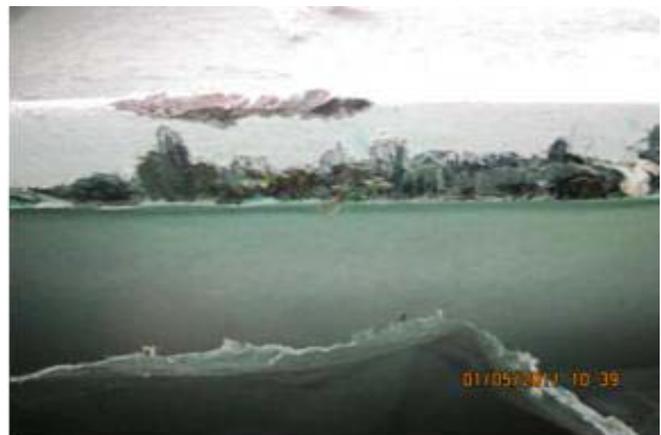
During random in-process visual inspection of Tower sub-assemblies (Facades), Caltrans Quality Assurance (QA) Inspector discovered the following issue:

- Facades have been accepted by CT after paint inspection in the Paint Shop.
- Paint damaged during transportation from Paint Shop to Ship Zhenhua #18 for Tower Shipment 4. Protective softeners were found detached/damaged.
- The façades are identified as ND1-SPSA4-336-131m, ND1-SPSA4-335-139m.

Contractor proposes to repair the paint on the damaged areas. Contractor will ask for inspection after the paint repaired.

Contractor repaired the paint damaged areas. QA Inspection was performed, and accepted.

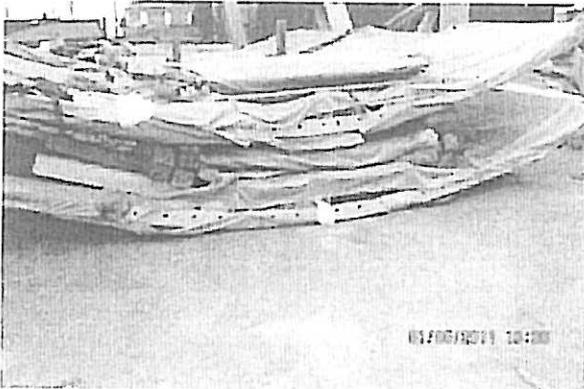
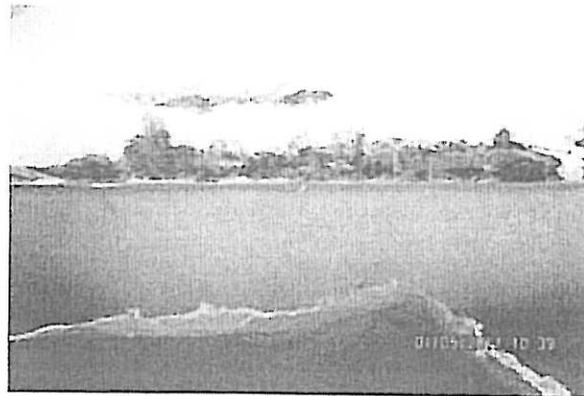
During random in-process visual inspection of Tower sub-assemblies (Facades), Caltrans Quality Assurance (QA) Inspector discovered the following issue:

- Facades have been accepted by CT after paint inspection in the Paint Shop.
- Paint damaged during transportation from Paint Shop to Ship Zhenhua #18 for Tower Shipment 4. Protective softeners were found detached/damaged.
- The façades are identified as ND1-SPSA4-336-131m, ND1-SPSA4-335-139m.
