Contract #: 04-0120F4
 Cty: SF/ALA Rte: 80 PM: 13.2/13.9
 File #: 69.25B

QUALITY ASSURANCE -- NON-CONFORMANCE REPORT

Report No: NCR-000965

Reference Description: Unspecified welding of Tower Walkway Support Beam to Sea Fastener

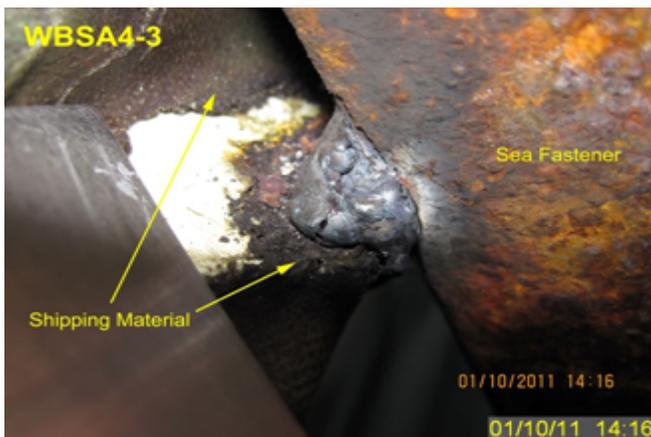
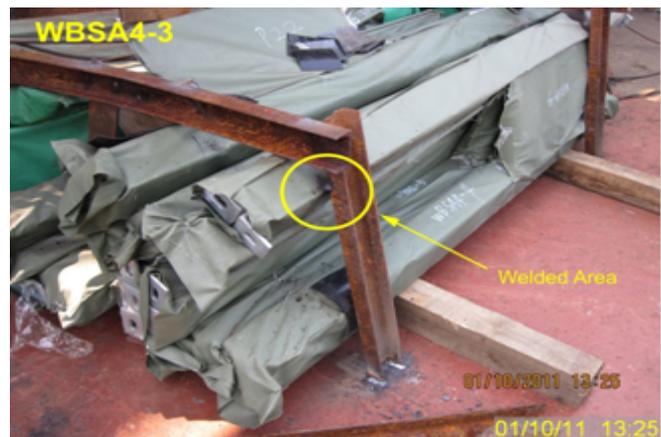
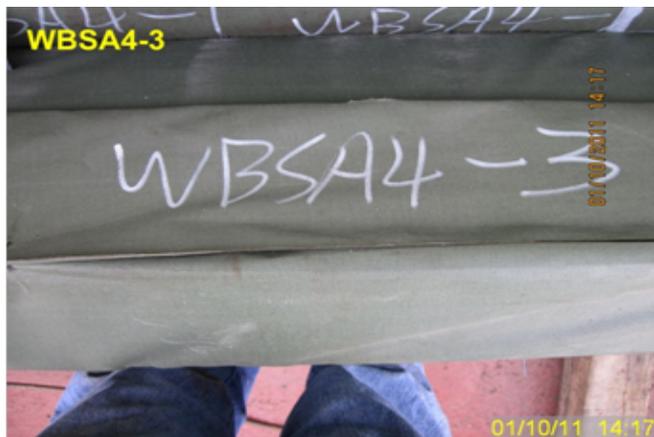
During the Quality Assurance (QA) random visual inspection of Tower Components being loaded on Ship (Zhen Hua vessel #18), this QA Inspector discovered the following issues:

- ZPMC has welded a ship sea fastener to a Walkway Support Beam.
- The approved shop drawings do not specify any welds in these areas.
- The member is identified as WBSA4-3.
- The additional material and welding was not approved by the engineer
- This QA also noted that ZPMC did not appear to have preheated the area welded.
- It appears that ZPMC personnel welded through the shipping material.

AWS D1.5-2002 Section 6.5.1: "The Inspector shall make certain that the size, length, and location of all welds conform to the requirements of this code and to the detail drawings and that no unspecified welds have been added without approval".

AWS D1.5-2002 Section 3.3.8 Temporary welds: "Temporary welds shall be subject to the same WPS requirements as final welds." "Temporary welds at other locations shall be shown on the shop drawings." "They shall be removed unless approved by the engineer"

Reference Resolution: "ZPMC has removed the tack weld and repaired the surface by grinding and re applied the paint under the supervision of the Department's representative which was acceptable.

Contractor removed the tack welds between sea fasteners to Walkway beams and ground flush. MT was performed with acceptable MT results. Paint repairs were performed in accordance with the approved PQWP and are acceptable.

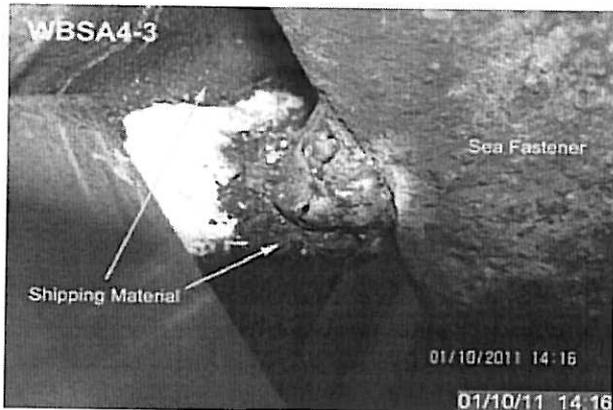
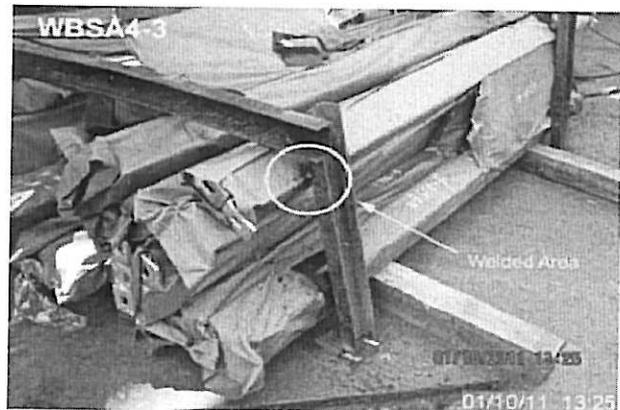
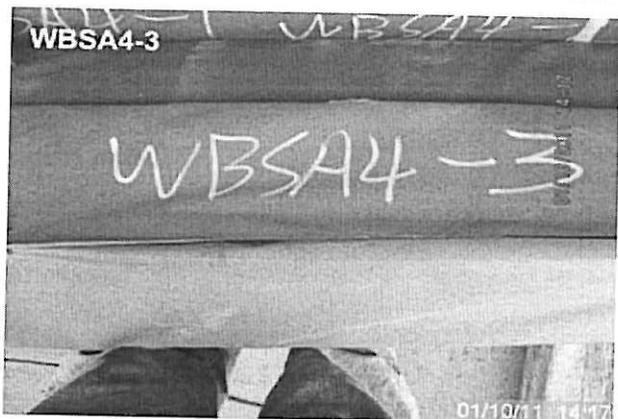
During the Quality Assurance (QA) random visual inspection of Tower Components being loaded on Ship (Zhen Hua vessel #18), this QA Inspector discovered the following issues:

- ZPMC has welded a ship sea fastener to a Walkway Support Beam.
- The approved shop drawings do not specify any welds in these areas.
- The member is identified as WBSA4-3.
- The additional material and welding was not approved by the engineer
- This QA also noted that ZPMC did not appear to have preheated the area welded.
- It appears that ZPMC personnel welded through the shipping material.

AWS D1.5-2002 Section 6.5.1: "The Inspector shall make certain that the size, length, and location of all welds conform to the requirements of this code and to the detail drawings and that no unspecified welds have been added without approval".

AWS D1.5-2002 Section 3.3.8 Temporary welds: "Temporary welds shall be subject to the same WPS requirements as final welds." "Temporary welds at other locations shall be shown on the shop drawings." "They shall be removed unless approved by the engineer"

Reference Resolution: ZPMC is providing the MT report after the tack weld was removed to show the base metal is acceptable after grinding, and the paint applied was acceptable.

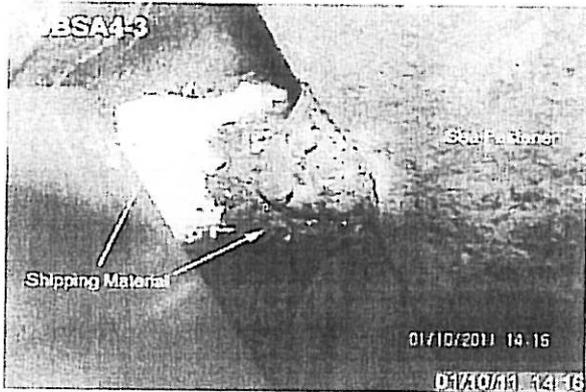
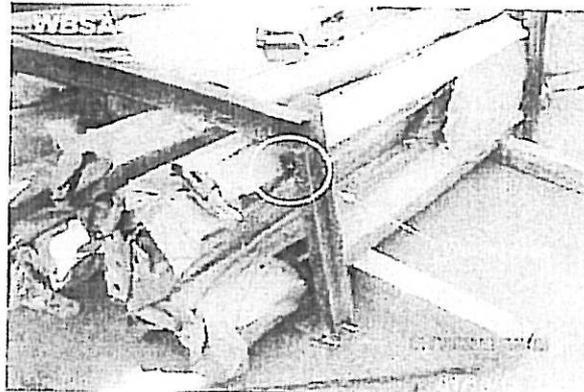
During the Quality Assurance (QA) random visual inspection of Tower Components being loaded on Ship (Zhen Hua vessel #18), this QA Inspector discovered the following issues:

- ZPMC has welded a ship sea fastener to a Walkway Support Beam.
- The approved shop drawings do not specify any welds in these areas.
- The member is identified as WBSA4-3.
- The additional material and welding was not approved by the engineer
- This QA also noted that ZPMC did not appear to have preheated the area welded.
- It appears that ZPMC personnel welded through the shipping material.

AWS D1.5-2002 Section 6.5.1: "The Inspector shall make certain that the size, length, and location of all welds conform to the requirements of this code and to the detail drawings and that no unspecified welds have been added without approval".

AWS D1.5-2002 Section 3.3.8 Temporary welds: "Temporary welds shall be subject to the same WPS requirements as final welds." "Temporary welds at other locations shall be shown on the shop drawings." "They shall be removed unless approved by the engineer"

Contractor will remove the tack weld between sea fasteners to Walkway Support Beams. MT report will be provided to prove the base metal is acceptable. Contractor will inspect paint repaired areas. The loading supervision will increase to prevent the future incidents.
