DEPARTMENT OF TRANSPORTATION

Contract #: 04-0120F4Cty: SF/ALA Rte: 80 PM: 13.2/13.9File #: 69.25B**QUALITY ASSURANCE -- NON-CONFORMANCE REPORT****Location:** Changxing Island, Shanghai, P.R. China**Report No:** NCR-000966**Prime Contractor:** American Bridge/Fluor Enterprises, a JV**Date:** 11-Jan-2011**Submitting Contractor:** Zhenhua Port Machinery Company, Ltd (ZPMC), Changxing Island**NCR #:** ZPMC-0925**Type of problem:****Welding****Concrete****Other****Welding****Curing****Procedural****Bridge No:** 34-0006**Joint fit-up****Coating****Other****Component:** Bikepath BK4A and BK6A**Procedural****Procedural****Description:**

Reference Description: The dimension and location of the slotted holes were not built per the approved shop drawings on the Bikepath bearing plates

Dear: Mr. Charles Kanapicki
Job Name: SAS Superstructure

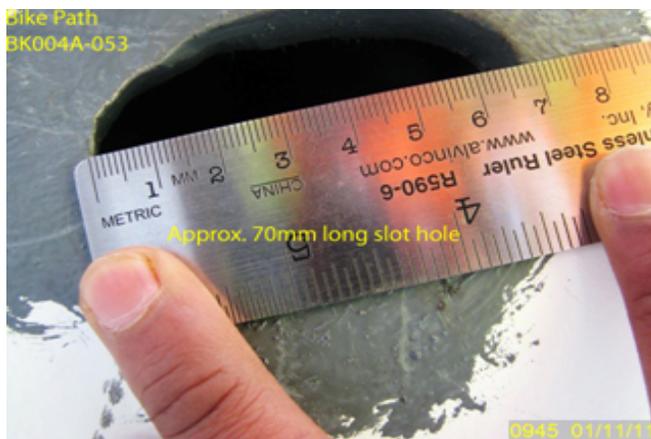
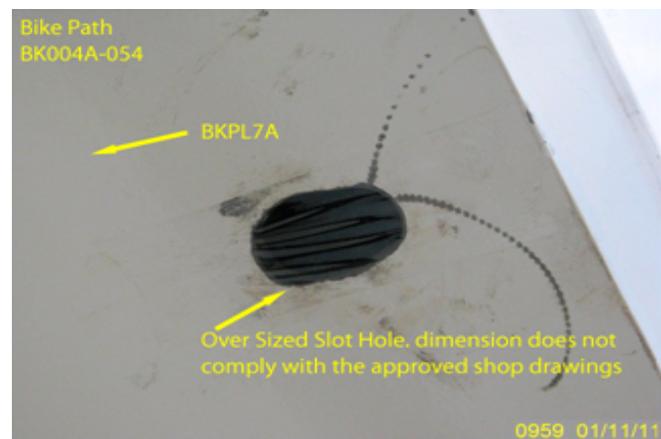
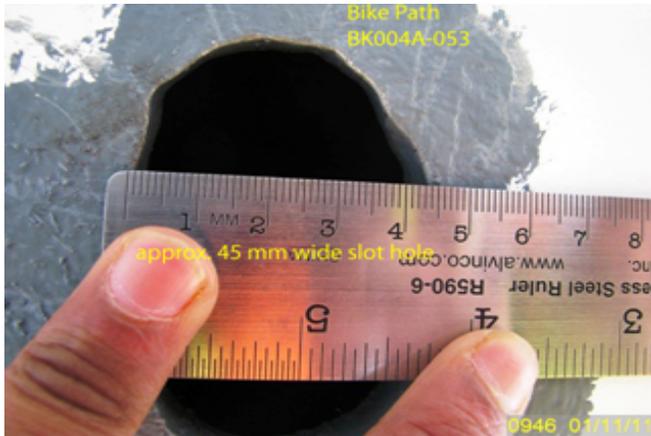
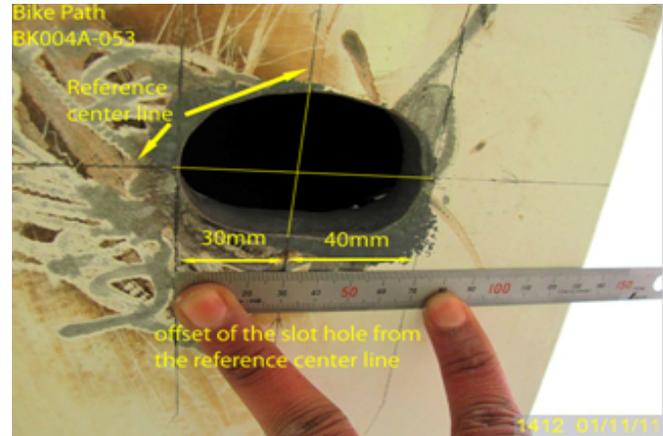
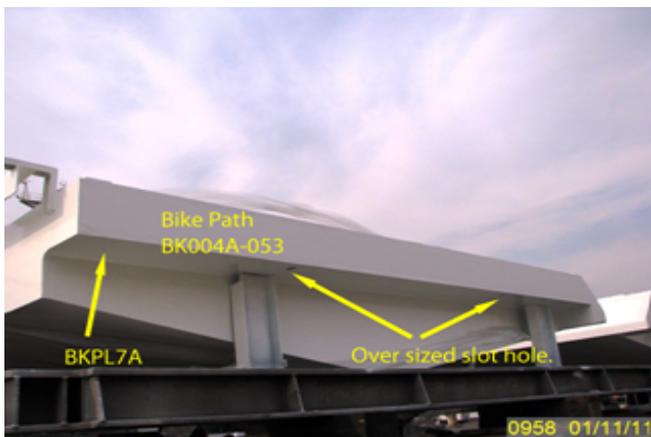
During Quality Assurance (QA) dimensional check of the bearing plate slotted holes on the Bikepath for final Green Tag Procedure, this QA inspector discovered the following issues:

- The measured slotted holes dimensions on the bearing plates (BKPL7A for BK4A and BKPL14A for BK6A) of the Bikepaths do not comply with the approved shop drawings.
- The affected Bikepath components are identified as: BK004A-001, BK004A-003, BK004A-004, BK004A-005, BK004A-008, BK004A-009, BK004A-010, BK004A-012, BK004A-017, BK004A-019, BK004A-020, BK004A-021, BK004A-026, BK004A-053, BK004A-054, BK004A-056, and BK006A-002.
- The slotted holes dimensions measured approx. 68~72 mm long and 40~45mm wide.
- Some slotted holes are offset from the correct locations (see the identified reference line in one of the pictures below)

Contractor will submit a TC-RFI to the Department to accept the as built holes as Fit-for-Purpose.

Contractor submitted TC-RFI 314R0. The Department accepted the as built over-sized holes as Fit-for-Purpose.
