Contract #: 04-0120F4Cty: SF/ALA Rte: 80 PM: 13.2/13.9File #: 69.25B**QUALITY ASSURANCE -- NON-CONFORMANCE REPORT****Location:** Changxing Island, Shanghai, P.R. China**Report No:** NCR-000968**Prime Contractor:** American Bridge/Fluor Enterprises, a JV**Date:** 12-Jan-2011**Submitting Contractor:** Zhenhua Port Machinery Company, Ltd (ZPMC), Changxing Island**NCR #:** ZPMC-0927**Type of problem:**

**Reference Description:** QA found 1 missed MT crack in Segment 13BW that has been tested and accepted by the Contractor's QC

**Subject:** NCR No. ZPMC-0927

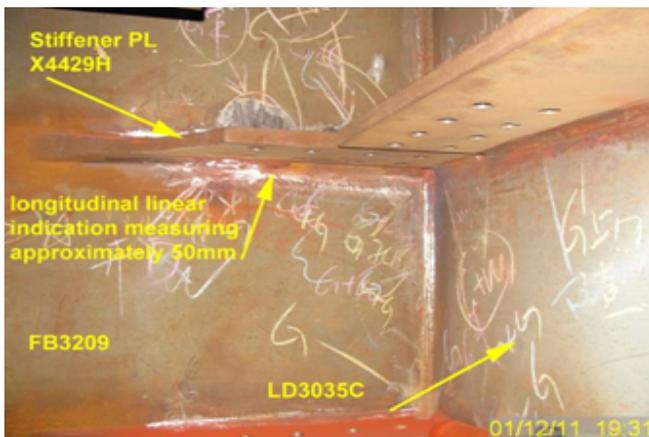
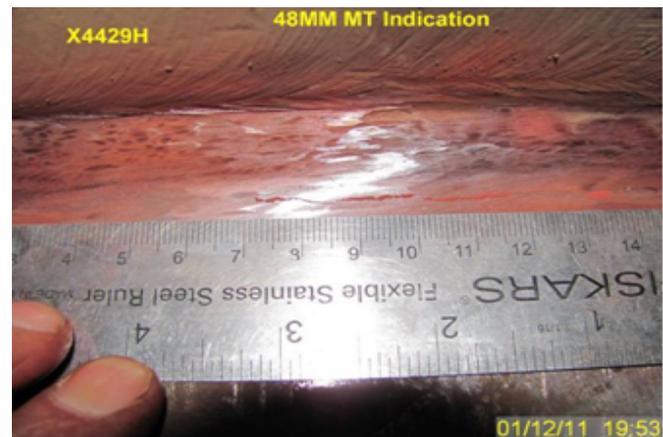
-One (1) Longitudinal Crack measuring approximately 50mm in length at the toe of the weld identified as FB3209-001-115.

-This weld is fillet weld joining horizontal floor beam stiffener (X4429H) to the floor beam web (X4475A).

-This OBG floor beam is located in Bay 14.

-The Contractor's Quality Control (QC) personnel performed 100% MT of these welds. The crack is located within an area that has been previously tested and accepted by the QC personnel.

**Reference Resolution:** ZPMC has repaired the indication noted in the NCR and is providing NDT documentation after the repair to show the indication has been removed.

Contractor will remove the indication and repair the weld. NDT will be performed on the repaired area and report will be submitted. ZPMC will issue an internal NCR to the QC personnel involved and will monitor his performance. Disciplinary action will be taken if he continues missing indications.

Contractor removed the indication and complete the weld repair. NDT testing was performed and the NDT report submitted confirmed the welds are acceptable. Contractor issued an internal NCR to the QC personal.

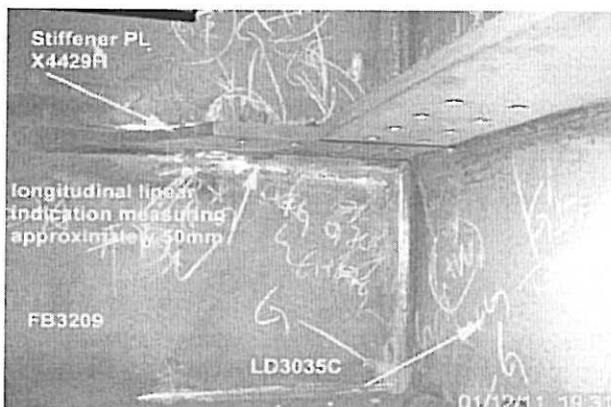
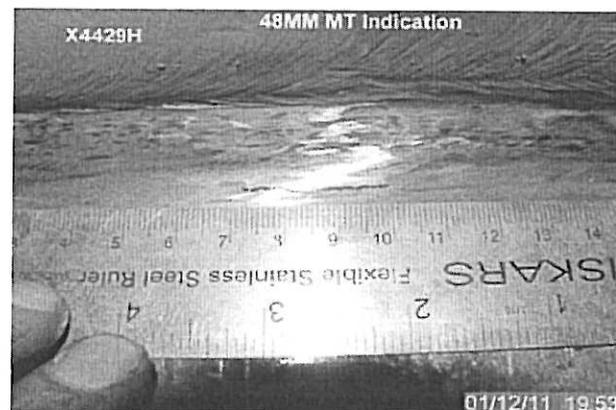
-One (1) Longitudinal Crack measuring approximately 50mm in length at the toe of the weld identified as FB3209-001-115.

-This weld is fillet weld joining horizontal floor beam stiffener (X4429H) to the floor beam web (X4475A).

-This OBG floor beam is located in Bay 14.

-The Contractor's Quality Control (QC) personnel performed 100% MT of these welds. The crack is located within an area that has been previously tested and accepted by the QC personnel.
