DEPARTMENT OF TRANSPORTATION
 DIVISION OF ENGINEERING SERVICES
 Office of Structural Materials
 Quality Assurance and Source Inspection

QUALITY ASSURANCE -- NON-CONFORMANCE REPORT

Report No: NCR-000969

Reference Description: QA found missed VT discontinuities near the cope hole termination in Segment 13AE at 4 locations after QC has accepted the welds

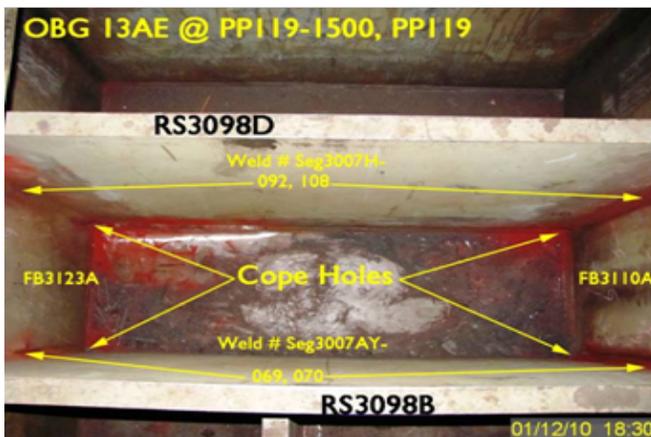
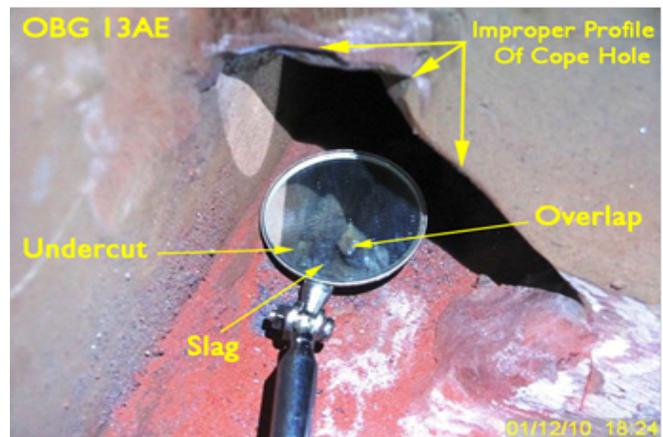
During Quality Assurance (QA) Visual Testing (VT) review of welds located on segment 13AE, this Caltrans (CT) QA Inspector discovered the following issue:

- Cope hole weld terminations were not built to be in compliance with the contract documents.
 - Non compliant discontinuities (slag, undercut and overlap) were observed at the end of the welds and inside the cope holes at 4 locations.
 - The affected weld joints are identified as SEG3007H-092 & 108 and SEG3007AY-069 & 070.
 - The welds are Partial Joint Penetration (PJP) welds joining built up plate stiffeners identified as RS3098B and RS3098B to the web plates of floor beams identified as FB3123A and FB3110A.
- The Notice of Witness Inspection Number (NWIT) is 08153. The discontinuities are located within the areas that were previously tested and accepted by ZPMC Quality Control (QC) personnel. As per the contract documents, ZPMC's QC personnel are required to perform 100% VT inspection of these welds.

AWS D1.5 (02) Section 3.12.3 ...the ends of the welds shall be made smooth and flush with the edges of the abutting parts.

AWS D1.5 (02) Section 3.12.1 Welds shall be terminated at the end of a joint in a manner that will ensure sound welds.

Contractor proposes to remove the indications and repair the welds. Contractor will provide the NWIT for VT re-inspection to prove the welds are acceptable. ZPMC will issue an internal NCR to the QC personnel responsible.

Contractor removed the indications, and repaired the welds. Provided the NWIT for VT re-inspection to confirm the welds have been accepted. Contractor also issued an internal NCR to the QC personnel involved.

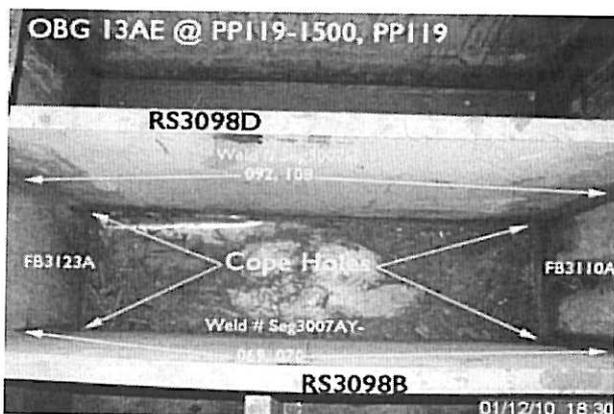
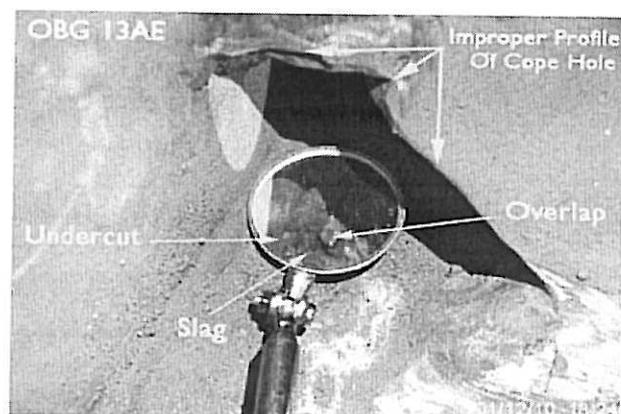
During Quality Assurance (QA) Visual Testing (VT) review of welds located on segment 13AE, this Caltrans (CT) QA Inspector discovered the following issue:

-Cope hole weld terminations were not built to be in compliance with the contract documents.

-Non compliant discontinuities (slag, undercut and overlap) were observed at the end of the welds and inside the cope holes at 4 locations.

-The affected weld joints are identified as SEG3007H-092 & 108 and SEG3007AY-069 & 070.

-The welds are Partial Joint Penetration (PJP) welds joining built up plate stiffeners identified as RS3098B and RS3098B to the web plates of floor beams identified as FB3123A and FB3110A.

The Notice of Witness Inspection Number (NWIT) is 08153. The discontinuities are located within the areas that were previously tested and accepted by ZPMC Quality Control (QC) personnel. As per the contract documents, ZPMC's QC personnel are required to perform 100% VT inspection of these welds.
