**DEPARTMENT OF TRANSPORTATION**

Contract #: 04-0120F4Cty: SF/ALA Rte: 80 PM: 13.2/13.9File #: 69.25B**QUALITY ASSURANCE -- NON-CONFORMANCE REPORT****Location:** Changxing Island, Shanghai, China**Report No:** NCR-000972**Prime Contractor:** American Bridge/Fluor Enterprises, a JV**Date:** 19-Jan-2011**Submitting Contractor:** Zhenhua Port Machinery Company, Ltd (ZPMC), Changxing Island**NCR #:** ZPMC-0931**Type of problem:**

**Reference Description:** Missed Class "A" (UT) Indications on Lift 14W weld numbers SEG3020Q-058 and SEG3020K-026 discovered by QA

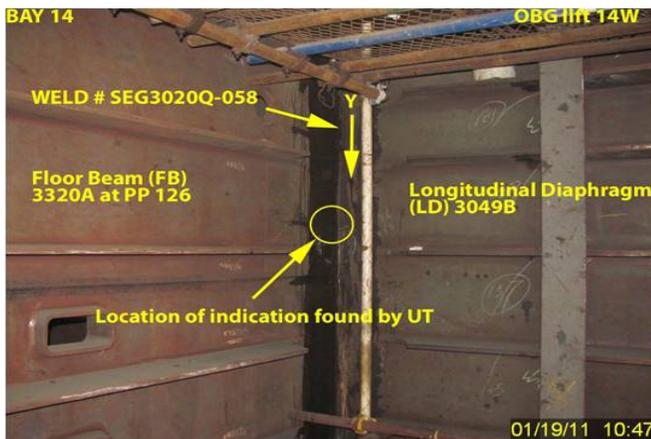
- One Class "A" longitudinal indication measuring approximately 20mm in length.
- The depth of the indication is 21mm from face A.
- The db rating is +4.
- The material thickness is 30mm.
- The weld is identified as: SEG3020Q-058.
- The Weld is a Complete Joint Penetration (CJP), Tee-joint, joining the Floorbeam (FB3320A) to the Longitudinal Diaphragm (LD3049A) at Panel Point (PP126).
- The "Y" location of the indication is 1575mm from the top end of the weld as shown in the attached photograph.
- The indication is clearly marked on the component.
- The material is identified as Seismic Performance Critical Member (SPCM) and the weld is identified as Fracture Critical Weld (FCW).
- The member is located in Bay 14.

- The “Y” location of the indication is 450mm from the Longitudinal Diaphragm (LD3050A) as shown in the attached photograph.
- The indication is clearly marked on the component.
- The material is identified as Seismic Performance Critical Member (SPCM) and the weld is identified as Fracture Critical Weld (FCW).
- The member is located in Bay 14.

Contractor repaired the indications. NDT report was provided which shows the welds are acceptable. Contractor identified the inspector responsible and his performance is being monitored

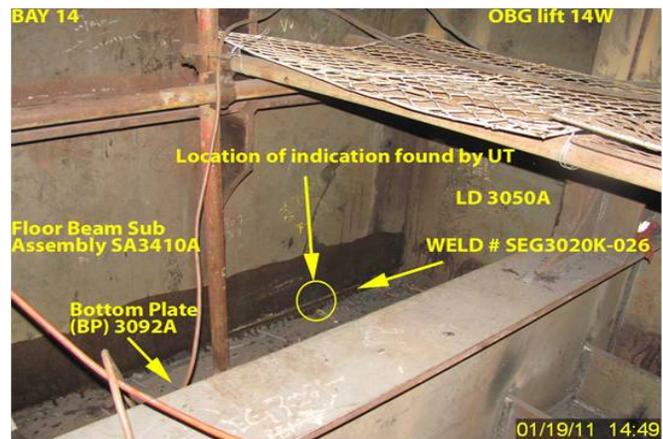
- One Class "A" longitudinal indication measuring approximately 20mm in length.
- The depth of the indication is 23mm from face A.
- The db rating is +6.
- The material thickness is 25mm.
- The weld is identified as: SEG3020K-026.
- The Weld is a Complete Joint Penetration (CJP), Tee-joint, joining the Floor Beam Sub Assembly (SA3410A) to the Bottom Plate (BP3092A) at Panel point (PP127.3).

The Notice of Witness Inspection Number (NWIT) is 08220. The indication is located inside the area that has been previously tested and accepted by ZPMC Quality Control (QC) personnel. As per the contract documents, ZPMC’s QC personnel are required to perform 100% UT inspection of these welds. Attached photographs provide additional location details.
