QUALITY ASSURANCE -- NON-CONFORMANCE REPORT

Location: Changxing Island, Shanghai, P.R. China**Report No:** NCR-000974**Prime Contractor:** American Bridge/Fluor Enterprises, a JV**Date:** 21-Jan-2011**Submitting Contractor:** Zhenhua Port Machinery Company, Ltd (ZPMC), Changxing Island**NCR #:** ZPMC-0933**Type of problem:**

Welding	Concrete	Other	
Welding	Curing	Procedural	Bridge No: 34-0006
Joint fit-up	Coating	Other	Component: OBG Segment 12BW to 12CW Deck Panel
Procedural	Procedural	Description:

Reference Description: The weld repair was performed without following the approved repair WPS and WRR

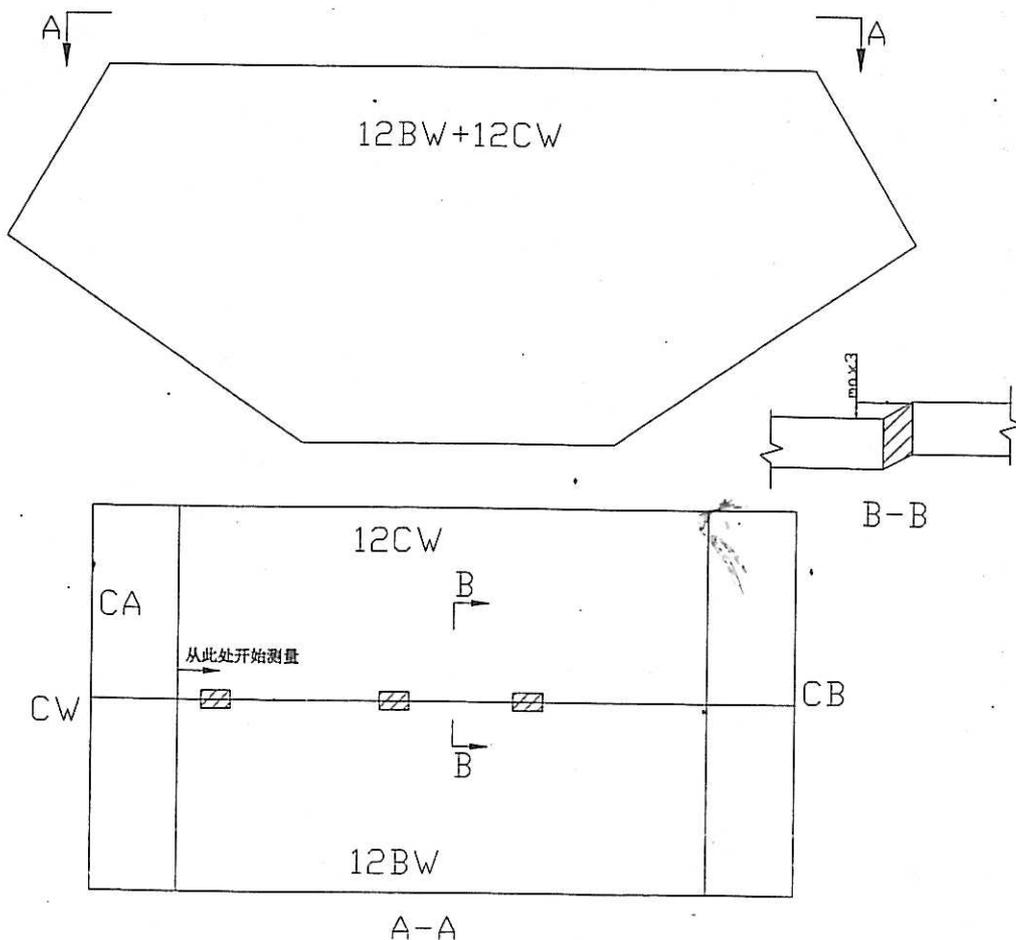
Draft of welding discontinuity

After inspection 12BW and 12CW deck plate butt weld, it was maximum 3mm misalignment at weld OBW12A-001, the position is 1070~1670、6570~7070、13150~13620 from the weld, and needs to cut to adjust.

Weld distortion and fabricate error.

1. Remove the welds by the way of gouging or Oxygen Preheat according to the WPS prior to gouging.
2. Perform 100%VT and 100%MT inspection to the metal cutting area to ensure no defects exist.
3. Adjust the misalignment and the straightness to meet the tolerance by extra force and ensure the stiff ener to meet the tolerance, and then perform tack weld.
4. Preheat and weld according to the approved repair WPS with check the line degree sometime.
5. Grind the weld flush to the adjacent weld or base metal.
6. Perform NDT inspection of the weld according to the working drawings.
