Contract #: 04-0120F4
 Cty: SF/ALA Rte: 80 PM: 13.2/13.9
 File #: 69.25B

QUALITY ASSURANCE -- NON-CONFORMANCE REPORT

Report No: NCR-000976

Reference Description: Transverse Crack Discovered by QA on Lift 13AW Deck Panel Weld # DP3118-001-052

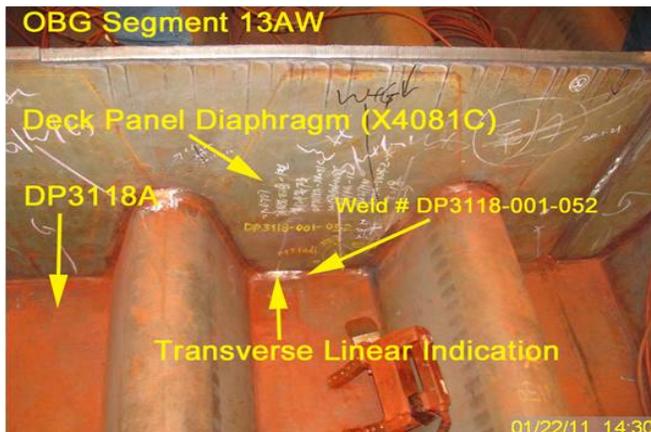
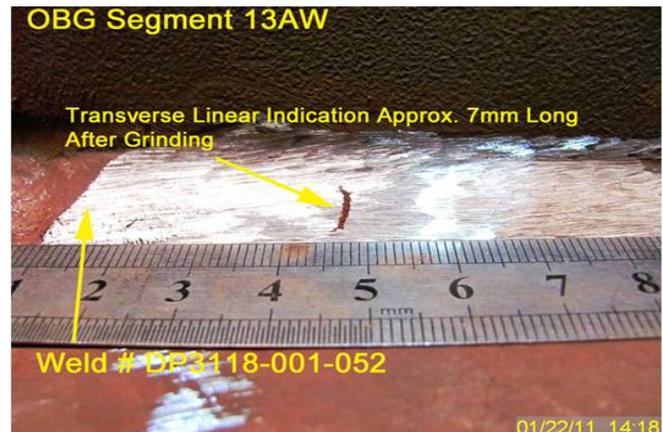
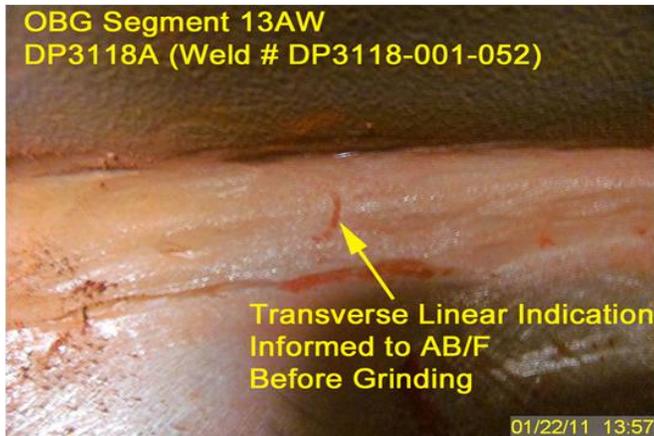
- One (1) Transverse crack measuring approximately 7 mm in length.
- The indication is clearly marked on the material near the weld.
- The weld is identified as DP3118-001-052.
- Weld is an 8mm Fillet Weld joining the Deck Panel Diaphragm To Deck Plate.
- Deck Panel Diaphragm is identified as X4081C (SPCM)
- Deck Plate is identified as DP3118A/PL3314A (SPCM).
- The weld is designated as Seismic Performance Critical Material (SPCM).
- OBG segment 13AW is located inside OBG Bay 14.
- ZPMC Quality Control Personnel have performed 100% Magnetic Particle Testing of these welds.

For further information, see the attached pictures below.

AWS D1.5 (02) Section 6.26.2 - "Welds that are subject to RT or MT in addition to visual inspection shall have no cracks..."

AWS D1.5 (02) Figure 6.8 – Specifies the maximum length of discontinuity allowed in an 8mm weld is approximately 3mm.

Propose a resolution for this non-conformance and provide documentation that the deficiency has been brought into compliance with the contract requirements. Propose a resolution that addresses the apparent failure of Quality Control to identify the indication. Additionally, provide documentation of the steps taken by the Quality Control Manager to prevent future occurrences.

ZPMC has repaired the indication noted in the NCR and is providing NDT documentation after the repair to show the indication has been removed. ABFJV has noted which inspector was responsible for this missed indication and is monitoring his performance as well as all inspector performance, if he continues to miss indications disciplinary action will be undertaken. Based on these actions, ZPMC requests closure of this NCR.

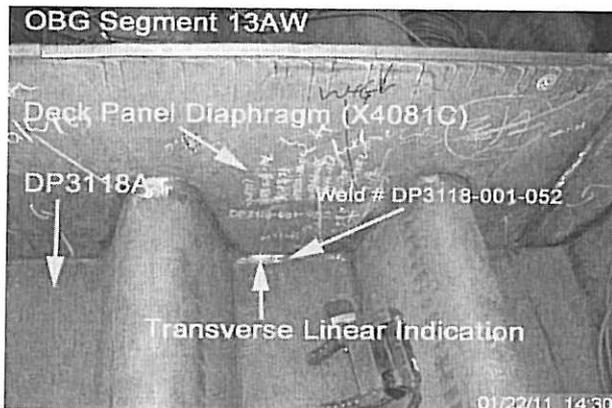
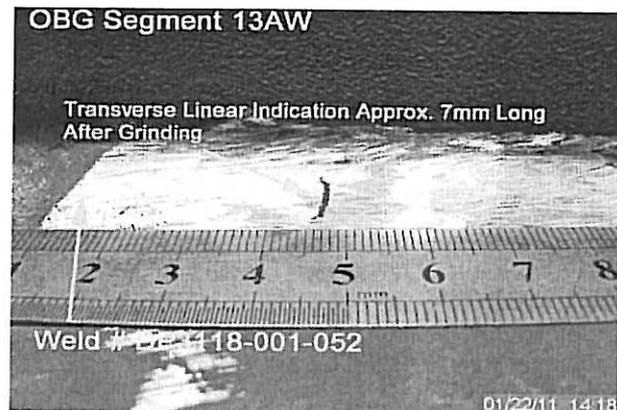
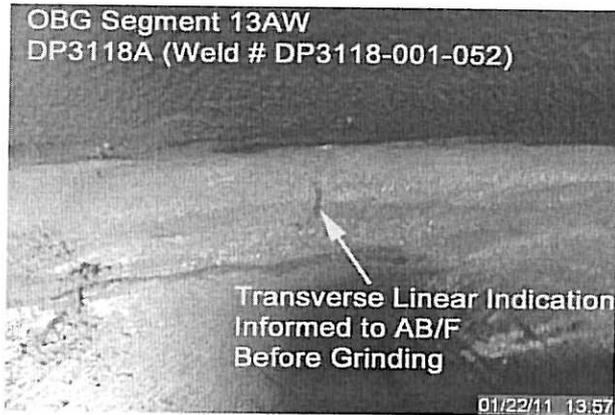
- One (1) Transverse crack measuring approximately 7 mm in length.
- The indication is clearly marked on the material near the weld.
- The weld is identified as DP3118-001-052.
- Weld is an 8mm Fillet Weld joining the Deck Panel Diaphragm To Deck Plate.
- Deck Panel Diaphragm is identified as X4081C (SPCM)
- Deck Plate is identified as DP3118A/PL3314A (SPCM).
- The weld is designated as Seismic Performance Critical Material (SPCM).
- OBG segment 13AW is located inside OBG Bay 14.
- ZPMC Quality Control Personnel have performed 100% Magnetic Particle Testing of these welds.

For further information, see the attached pictures below.

AWS D1.5 (02) Section 6.26.2 - "Welds that are subject to RT or MT in addition to visual inspection shall have no cracks..."

AWS D1.5 (02) Figure 6.8 – Specifies the maximum length of discontinuity allowed in an 8mm weld is approximately 3mm.

Contractor will repair the indication noted in the NCR and will provide the NDT report to prove the weld is acceptable after repairing. Contractor will monitor the inspector's performance. Disciplinary action will be taken if he misses indication continuously.

Contractor removed the weld indication. NDT report was provided showing the welds are acceptable. The inspector's performance was being monitored.
