Contract #: 04-0120F4  
 Cty: SF/ALA Rte: 80 PM: 13.2/13.9  
 File #: 69.25B

## QUALITY ASSURANCE -- NON-CONFORMANCE REPORT

**Report No:** NCR-000981

**Reference Description:** Missed Longitudinal Crack Discovered by QA for Lift 13CE Fit Lug

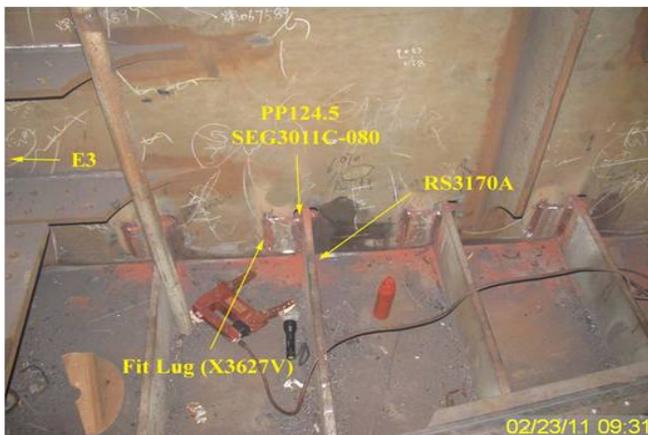
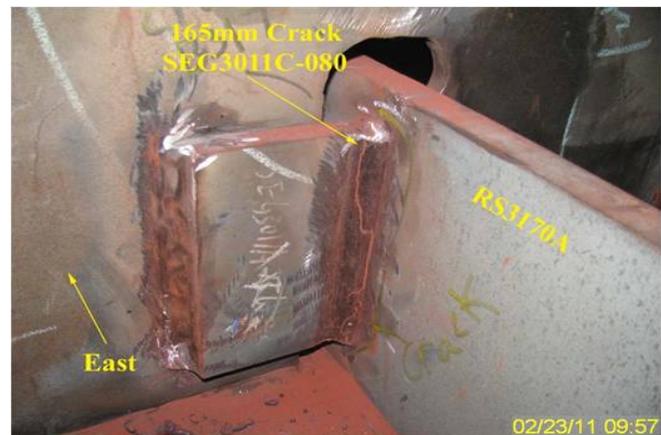
During the Quality Assurance Magnetic Particle Testing (MT) review of welds located on OBG segment 13CE this Quality Assurance Inspector discovered the following issue:

- One longitudinal crack measuring 165mm in length in the fit lug (X3627V), fillet attachment weld to the I-rail stiffener (RS3170A), at panel point 124.5 at E3.
- The weld is identified as SEG3011C-080.
- The crack is clearly marked on the material near the weld.
- OBG Segment 13CE is located in fabrication bay 14.

The Notice of Inspection Witness Number (NWIT) is 08367. The indication is located within an area previously tested and accepted by ZPMC Quality Control (QC) personnel. As per the contract documents, ZPMC's QC personnel are required to perform 25% inspection of this weld.

AWS D1.5 (02) Section 6.26.1.1 – “The weld shall have no cracks.”

ZPMC has repaired the indication noted in the NCR and is providing NDT documentation after the repair to show the indication has been removed. ABFJV has noted which inspector was responsible for this missed indication and is monitoring his performance, if he continues to miss indications disciplinary action will be undertaken. Based on these actions, ZPMC requests closure of this NCR.

This proposed resolution is acceptable. The documentation received is sufficient and the Department concurs that Non-Conformance ZPMC-0939 is closed.

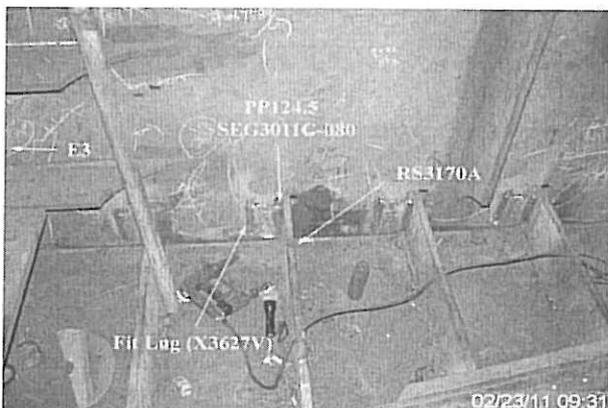
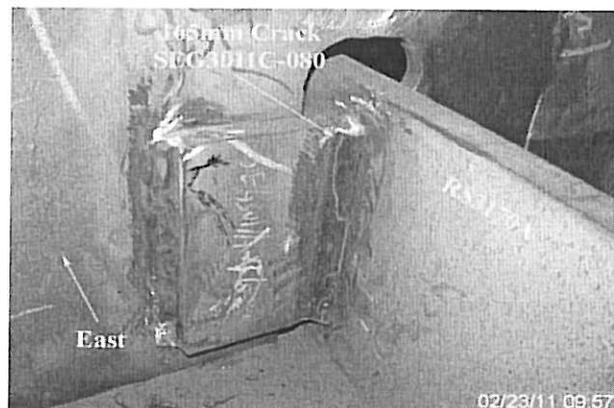
During the Quality Assurance Magnetic Particle Testing (MT) review of welds located on OBG segment 13CE this Quality Assurance Inspector discovered the following issue:

- One longitudinal crack measuring 165mm in length in the fit lug (X3627V), fillet attachment weld to the I-rib stiffener (RS3170A), at panel point 124.5 at E3.
- The weld is identified as SEG3011C-080.
- The crack is clearly marked on the material near the weld.
- OBG Segment 13CE is located in fabrication bay 14.

The Notice of Inspection Witness Number (NWIT) is 08367. The indication is located within an area previously tested and accepted by ZPMC Quality Control (QC) personnel. As per the contract documents, ZPMC's QC personnel are required to perform 25% inspection of this weld.

AWS D1.5 (02) Section 6.26.1.1 – “The weld shall have no cracks.”

Contractor to repair the indication, and provide the NDT report to prove the weld is acceptable. The performance of the inspector responsible will be monitored and will be disciplined if he continues to miss indications.

Contractor repaired the weld. NDT report was provided which shows the weld is acceptable. The inspector responsible was identified and internal NCR issued.
