Contract #: 04-0120F4Cty: SF/ALA Rte: 80 PM: 13.2/13.9File #: 69.25B**QUALITY ASSURANCE -- NON-CONFORMANCE REPORT****Location:** Changxing Island, Shanghai, China**Report No:** NCR-000985**Prime Contractor:** American Bridge/Fluor Enterprises, a JV**Date:** 02-Mar-2011**Submitting Contractor:** Zhenhua Port Machinery Company, Ltd (ZPMC), Changxing Island**NCR #:** ZPMC-0943**Type of problem:**

Reference Description: Missed UT Indications Discovered by QA on Lift 14E Vertical Shear Plate to Anchor Plate Weld

Job Name: SAS Superstructure

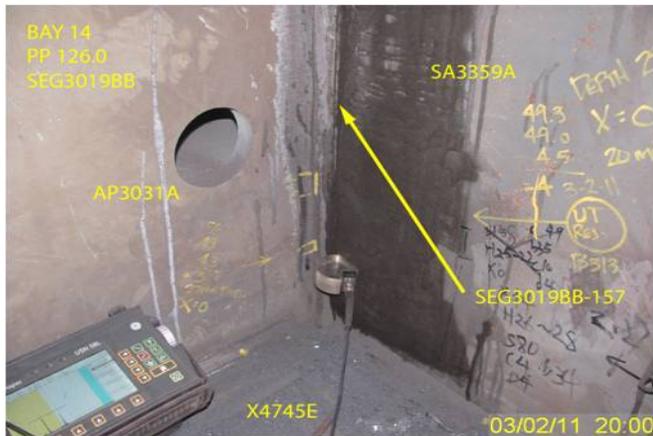
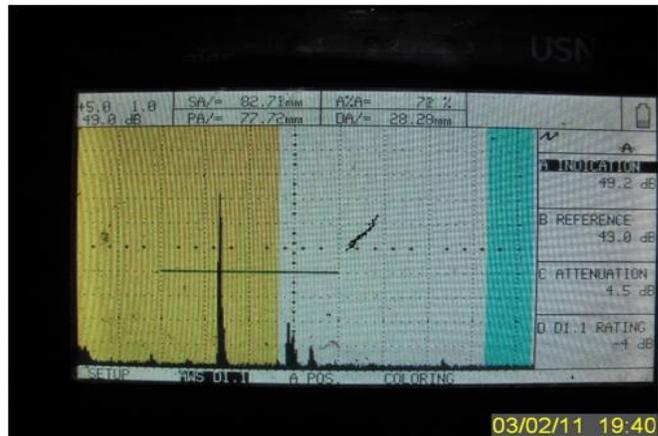
- A total of two (2) Class "A" rejectable indications measuring approximately 15 and 20mm in length.
- The weld is a Complete Joint Penetration (CJP) Tee Joint, joining the vertical shear plate (SA3364A) to the anchor plate (AP3031A) and is identified as SEG3019BB-157.
- The material thickness is 40mm and the weld is designated as a (FCW) Fracture Critical Weld.
- The depth of the indications are approximately 27 and 29mm.
- The indication db ratings are +3 and -4 respectively.
- The "Y" locations are approximately 1200mm and 1300mm from the termination of the weld at the bottom plate.
- The indication is clearly marked near the weld.
- OBG Segment 14AE located in East Side of fabrication Bay 14.

The Notice of Witness Inspection Number (NWIT) is 08430. The indication is located within the area that has been previously tested and accepted by ZPMC Quality Control (QC) personnel and was found in an area that has been previously rejected and repaired. As per the contract documents, ZPMC's QC personnel are required to perform 100% UT inspection of these welds.

AWS D1.5-2002, Section 6, Table 6.3; “Specifies a class A indication as having a dbS rating of +4 and lower for weld thicknesses 38mm through 60mm.”

Class” A”: Any indication in this category shall be rejected (regardless of length).

ZPMC has repaired the indication noted in the NCR and is providing NDT documentation after the repair to show the indication has been removed. ABFJV has noted which inspector was responsible for this missed indication and is monitoring his performance, if he continues to miss indications disciplinary action will be undertaken. Based on these actions, ZPMC requests closure of this NCR.

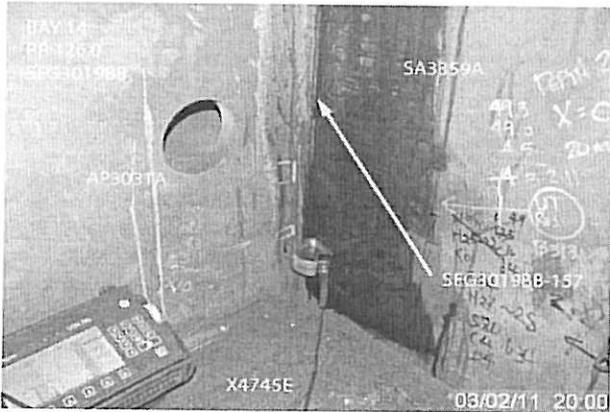
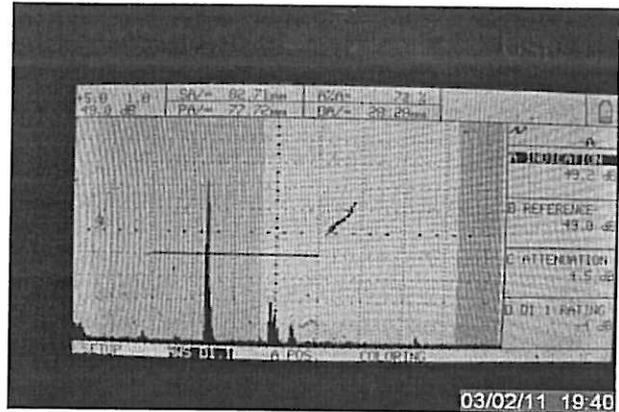
- A total of two (2) Class "A" rejectable indications measuring approximately 15 and 20mm in length.
- The weld is a Complete Joint Penetration (CJP) Tee Joint, joining the vertical shear plate (SA3364A) to the anchor plate (AP3031A) and is identified as SEG3019BB-157.
- The material thickness is 40mm and the weld is designated as a (FCW) Fracture Critical Weld.
- The depth of the indications are approximately 27 and 29mm.
- The indication db ratings are +3 and -4 respectively.
- The "Y" locations are approximately 1200mm and 1300mm from the termination of the weld at the bottom plate.
- The indication is clearly marked near the weld.
- OBG Segment 14AE located in East Side of fabrication Bay 14.

The Notice of Witness Inspection Number (NWIT) is 08430. The indication is located within the area that has been previously tested and accepted by ZPMC Quality Control (QC) personnel and was found in an area that has been previously rejected and repaired. As per the contract documents, ZPMC's QC personnel are required to perform 100% UT inspection of these welds.

AWS D1.5-2002, Section 6, Table 6.3; "Specifies a class A indication as having a dbS rating of +4 and lower for weld thicknesses 38mm through 60mm."

Class "A": Any indication in this category shall be rejected (regardless of length).

Contractor repaired the weld, and NDT report was provided. The NDT report shows the weld is acceptable. The inspector responsible was identified and internal NCR issued.

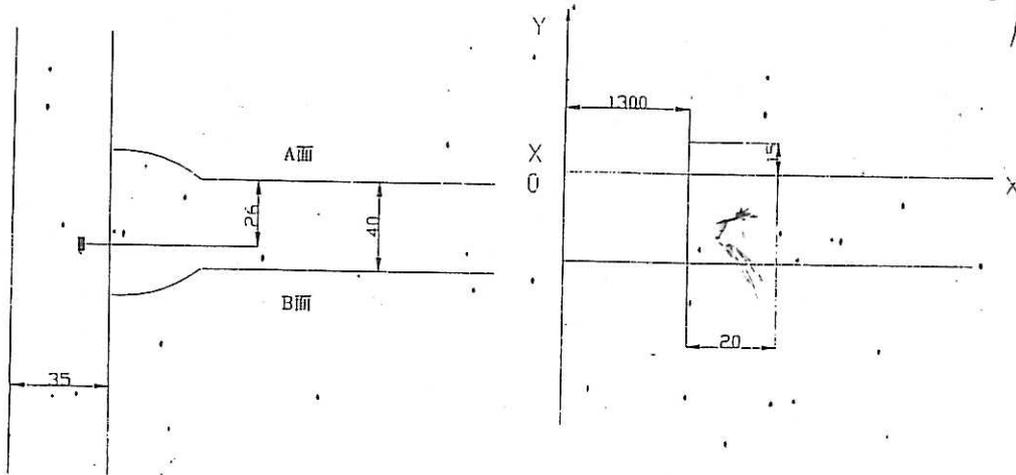
WELD NUMBER: SEG3019BB-157

(Description of welding discontinuity): Rejected indication found by ultrasonic inspection is less than the maximum allowance aggregate length.

1. 焊道未及时处理干净。
1. Did not clear the weld pass completely in time.

1. 从缺陷距离端面较近一侧 ($D \leq 0.65T$, D为缺陷深度, T为板厚) 采用碳刨或打磨的方法去除焊缝缺陷;
 2. 参照返修焊接工艺规程 (WPS) 准备正确的接头型式, 预热和焊接;
 3. 将修补区域打磨到与母材或邻近焊缝平齐;
 4. 根据批准的车间图纸检查焊缝.
-
1. Gouge or grind from nearer side from metal edge ($D \leq 0.65T$, "D" is depth of defects, "T" is thickness of metal) to remove all defects;
 2. Follow repair WPS for joint preparation, preheat, and weld deposit;
 3. Grind the repaired area flush with base metal or the adjacent weld;
 4. Check the welds according to the working drawings.

1. 加强焊接监控和道间清理。
1. Improve monitoring of welding and interpass cleaning.
