QUALITY ASSURANCE -- NON-CONFORMANCE REPORT

Location: Changxing Island, Shanghai, P.R. China**Report No:** NCR-000987**Prime Contractor:** American Bridge/Fluor Enterprises, a JV**Date:** 11-Mar-2011**Submitting Contractor:** Zhenhua Port Machinery Company, Ltd (ZPMC), Changxing Island**NCR #:** ZPMC-0945**Type of problem:**

Reference Description: QA found an UT indication after ZPMC had tested and accepted the weld in the Bikepath Cantilever Beam at PP113 (Lift 12)

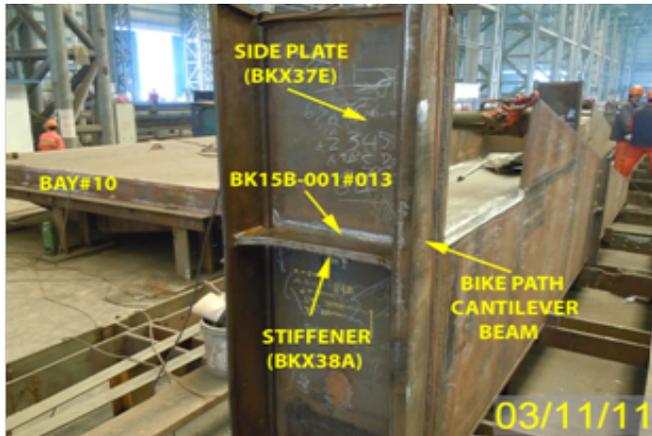
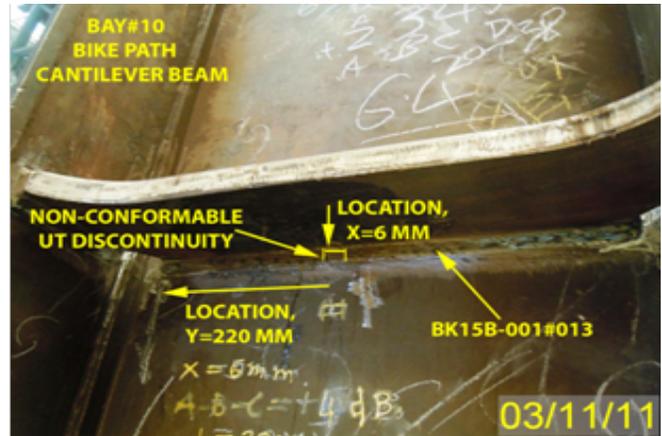
- One (1) Class "A" non conforming longitudinal indication in a weld.
- UT discontinuity rating was +4 db; Class "A" non-conformable indication.
- Depth of the discontinuity from face "B" is approximately 25 mm.

- Length of the discontinuity is approximately 25 mm in length.
- Y location is approximately 220 mm from left side of the joint.
- Weld is a double groove, complete joint penetration (CJP) T- joint, joining the side plate (BKX37E) to the stiffener (BKX38A).

- The weld is identified as BK15B-001-013.
- Scanning was performed from face "A" and "B" to cover the full volumetric scan of the weld.
- The material thickness is 32 mm.

- Component located at fabrication Bay#10.
- The Notice of Witness Inspection Number (NWIT) is 08509. The indication is located inside the area that has been previously tested and accepted by ZPMC Quality Control (QC) personnel. ZPMC's QC personnel performed 100% UT inspection of this weld.

ZPMC has repaired the indication noted in the NCR and is providing NDT documentation after the repair to show the indication has been removed.

ABFJV has noted which inspector was responsible for this missed indication and is monitoring his performance, if he continues to miss indications disciplinary action will be undertaken. Based on these actions, ZPMC requests closure of this NCR.

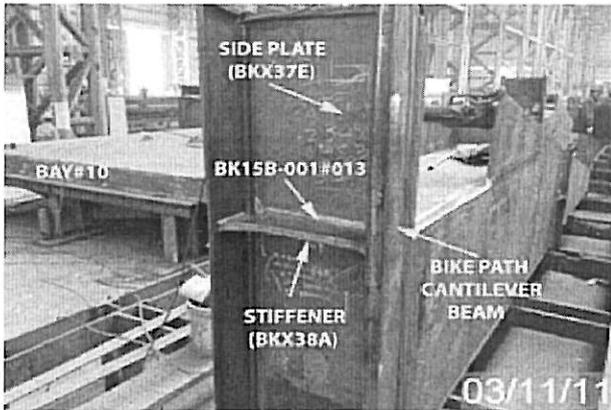
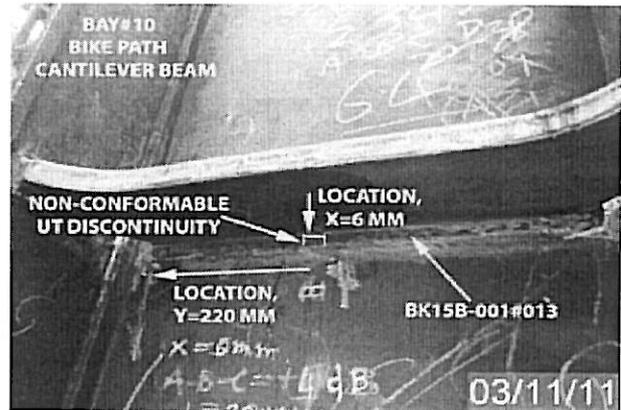
- One (1) Class "A" non conforming longitudinal indication in a weld.
- UT discontinuity rating was +4 db; Class "A" non-conformable indication.
- Depth of the discontinuity from face "B" is approximately 25 mm.

- Length of the discontinuity is approximately 25 mm in length.
- Y location is approximately 220 mm from left side of the joint.
- Weld is a double groove, complete joint penetration (CJP) T- joint, joining the side plate (BKX37E) to the stiffener (BKX38A).

- The weld is identified as BK15B-001-013.
- Scanning was performed from face "A" and "B" to cover the full volumetric scan of the weld.
- The material thickness is 32 mm.

- Component located at fabrication Bay#10.
- The Notice of Witness Inspection Number (NWIT) is 08509. The indication is located inside the area that has been previously tested and accepted by ZPMC Quality Control (QC) personnel. ZPMC's QC personnel performed 100% UT inspection of this weld.

Contractor will repair the weld, and provide the NDT report to prove the weld is acceptable. Contractor will identify and monitor the inspector responsible. If the inspector continues miss indications, disciplinary action will be taken.

Contractor repaired the weld. NDT report was provided showing the weld is acceptable. ZPMC identified the inspector and issued internal NCR. The inspector's performance is being monitored.

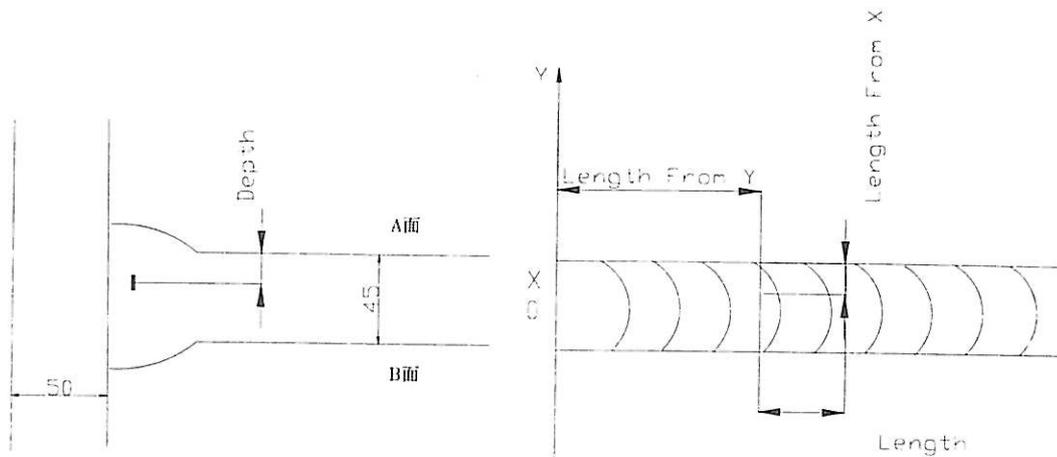
焊缝编号为： BK15B-001-013

(Description of welding discontinuity): Rejected indication found by ultrasonic inspection is less than the maximum allowance aggregate length.

1. 焊道未及时处理干净。
1. Did not clear the weld pass completely in time.

1. Gouge or grind from nearer side from metal edge ($D \leq 0.65T$, "D" is depth of defects, "T" is thickness of metal) to remove all defects;
2. Follow repair WPS for joint preparation, preheat, and weld deposit;
3. Grind the repaired area flush with base metal or the adjacent weld;
4. Check the welds according to the working drawings.

1. Improve monitoring of welding and interpass cleaning.
