Contract #: 04-0120F4
 Cty: SF/ALA Rte: 80 PM: 13.2/13.9
 File #: 69.25B

QUALITY ASSURANCE -- NON-CONFORMANCE REPORT

Report No: NCR-000988

Reference Description: QA found an UT indication after ZPMC had tested and accepted the weld at Traveler Rail 20TR2-039

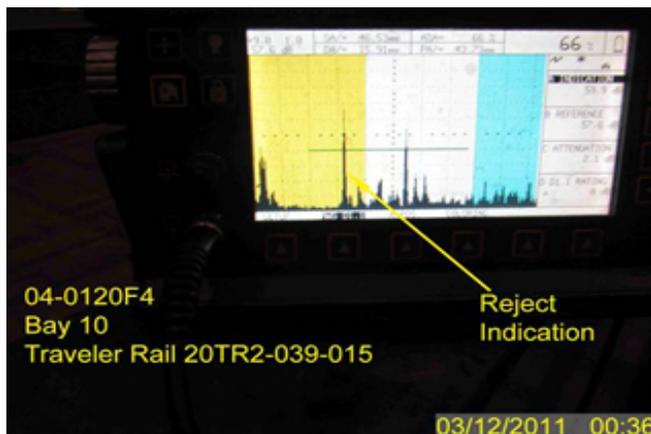
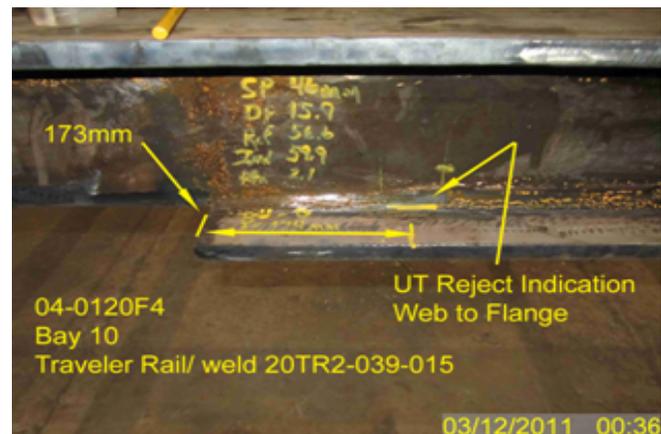
During the Quality Assurance (QA) Ultrasonic Testing (UT) verification of weld located on traveler rail 20TR2-039-015, this QA Inspector discovered the following issue:

- One (1) Class "A" indication measuring approximately 25mm in length.
- The Indication rating is +0dB.
- The thickness of the plate is 20mm and depth of the indication approximately 15.9mm.
- The indication is located on the weld joint identified as 20TR2-039-015.
- The "Y" location for this indication is approximately 173mm from weld termination point.
- The weld is a Complete Joint Penetration (CJP) T-Joint joining web to flange
- The indication is clearly marked by QA on/near the weld.
- Traveler Rail is located inside bay 10.
- The Notice of Witness Inspection Number (NWIT) is 08518. The indication is located within the area that has been previously tested and accepted by ZPMC Quality Control (QC) personnel. As per the contract documents, ZPMC's QC personnel are required to perform 100% UT inspection of this weld.

AWS D1.5-2002, Section 6, Table 6.3. Specifies a class A indication as having a dB rating of +10 and lower for weld thicknesses 8mm through 20mm.

Propose a resolution for this non-conformance and provide documentation that the deficiency has been brought into compliance with the contract requirements. Propose a resolution that addresses the apparent failure of Quality Control to identify the indication. Additionally, provide documentation of the steps taken by the Quality Control Manager to prevent future occurrences.

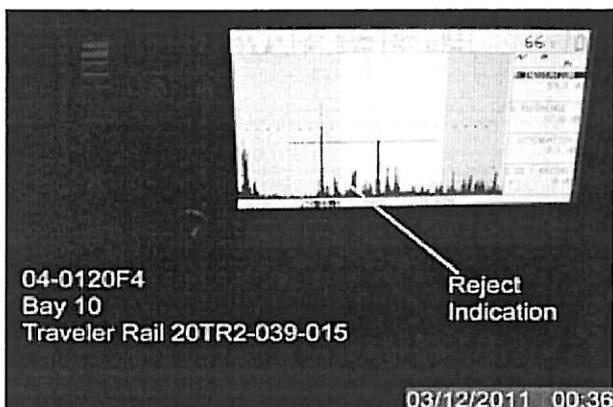
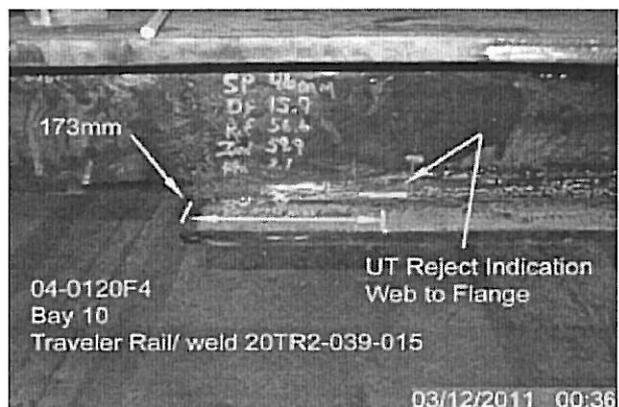
During the Quality Assurance (QA) Ultrasonic Testing (UT) verification of weld located on traveler rail 20TR2-039-015, this QA Inspector discovered the following issue:

- One (1) Class "A" indication measuring approximately 25mm in length.
- The Indication rating is +0dB.
- The thickness of the plate is 20mm and depth of the indication approximately 15.9mm.
- The indication is located on the weld joint identified as 20TR2-039-015.
- The "Y" location for this indication is approximately 173mm from weld termination point.
- The weld is a Complete Joint Penetration (CJP) T-Joint joining web to flange
- The indication is clearly marked by QA on/near the weld.
- Traveler Rail is located inside bay 10.
- The Notice of Witness Inspection Number (NWIT) is 08518. The indication is located within the area that has been previously tested and accepted by ZPMC Quality Control (QC) personnel. As per the contract documents, ZPMC's QC personnel are required to perform 100% UT inspection of this weld.

AWS D1.5-2002, Section 6, Table 6.3. Specifies a class A indication as having a dB rating of +10 and lower for weld thicknesses 8mm through 20mm.

Contractor repaired the weld. NDT report was provided which shows the weld is acceptable. ZPMC issued internal NCR and the inspector performance is being monitored.

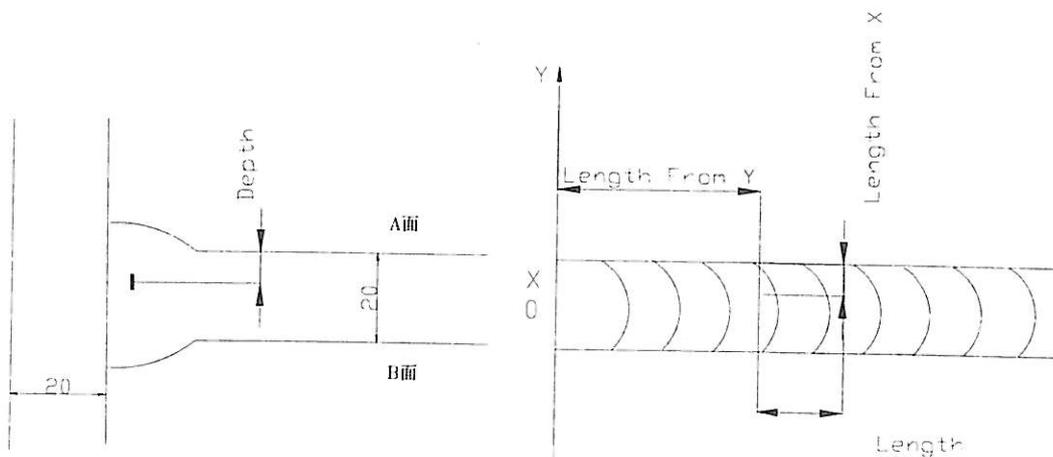
Draft of welding discontinuity:

(Description of welding discontinuity): Rejected indication found by ultrasonic inspection is less than the maximum allowance aggregate length.

焊缝编号为： 20TR2-030-015,20TR2-039-015

1. Did not clear the weld pass completely in time.

返修(碳刨)前预热温度 Preheat temperature before gouging	<u>NA</u>	返修的缺陷 Description of discontinuity	<u>slag.</u>
---	-----------	---------------------------------------	--------------

1. Gouge or grind from nearer side from metal edge ($D \leq 0.65T$, "D" is depth of defects, "T" is thickness of metal) to remove all defects;
2. Follow repair WPS for joint preparation, preheat, and weld deposit;
3. Grind the repaired area flush with base metal or the adjacent weld;
4. Check the welds according to the working drawings.

1. Improve monitoring of welding and interpass cleaning.
