## QUALITY ASSURANCE -- NON-CONFORMANCE REPORT

**Report No:** NCR-000991

**Component:** East Anchorage Bearing Blocks - APBB1

**Reference Description:** Missed VT Indications Discovered by QA on Lift 14 East Anchorage Bearing Blocks

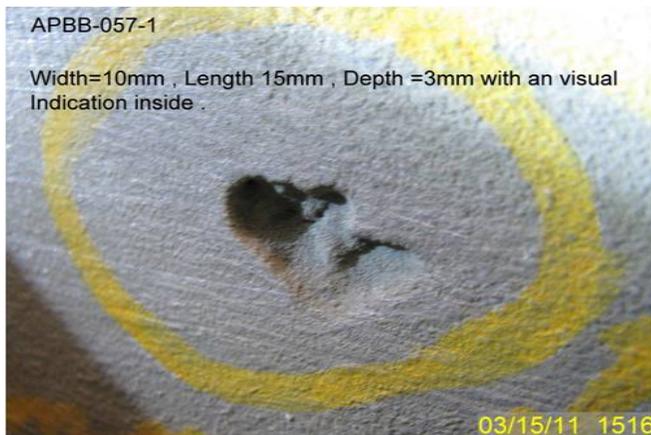
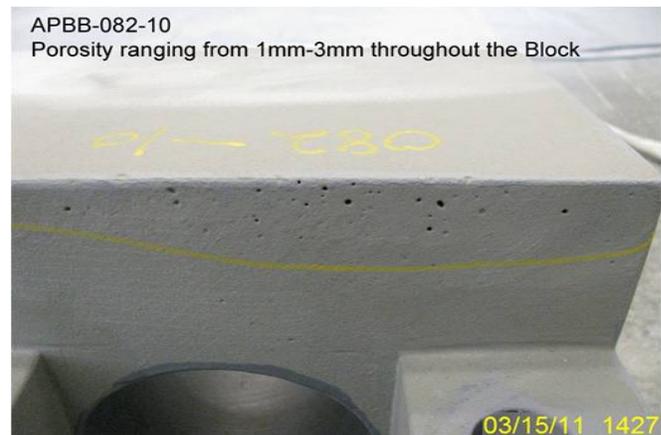
- The machined surfaces of seven of the APBBs, did not appear to comply with the contract documents.
- The surfaces exhibited excessive porosity.
- The discontinuities range from 1mm to 15mm in diameter.
- The material type is cast steel in accordance with ASTM A148 GR 550-345.
- The parts are identified as APBB1-082-10, 083-2, 057-1, 082-2, 082-1, 121-11 and 121-3.
- The APBBs have been visually tested and accepted by ZPMC QC. According to the contract documents, all castings shall be visually tested 100% on all surfaces.

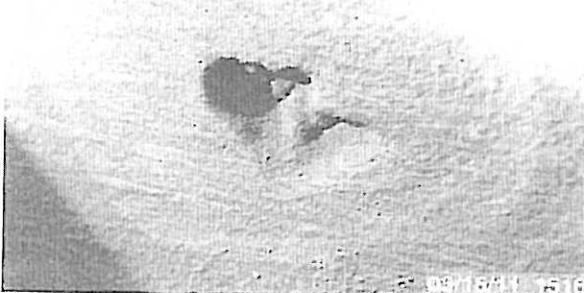
APBB-057-1

- The machined surfaces of seven of the APBBs, did not appear to comply with the contract documents.
- The surfaces exhibited excessive porosity.
- The discontinuities range from 1mm to 15mm in diameter.
- The material type is cast steel in accordance with ASTM A148 GR 550-345.
- The parts are identified as APBB1-082-10, 083-2, 057-1, 082-2, 082-1, 121-11 and 121-3.
- The APBBs have been visually tested and accepted by ZPMC QC. According to the contract documents, all castings shall be visually tested 100% on all surfaces.

Width=10mm, Length 15mm, Depth =3mm with a visual indication inside.

Contractor will repair the damaged areas, offer for re-inspection and submit NDT reports to prove the repair is acceptable. The QC personnel involved will be reminded to ensure visual inspection must be carried out thoroughly.

ZPMC repaired the damaged area and re-inspected and accepted by QA. NDT reports were submitted showing the repair is acceptable. Internal NCR issued to the QC involved.

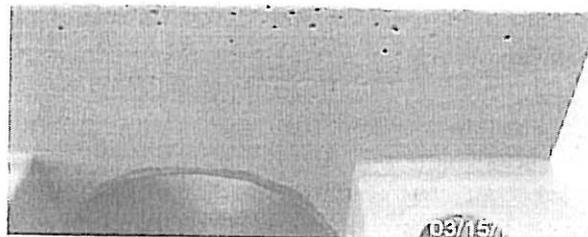
APBB-082-10

Porosity ranging from 1mm-3mm throughout the Block
