## QUALITY ASSURANCE -- NON-CONFORMANCE REPORT

**Report No:** NCR-000993

<b>Welding</b>	<b>Concrete</b>	<b>Other</b>	
<b>Welding</b>	<b>Curing</b>	<b>Procedural</b>	<b>Bridge No:</b> 34-0006
<b>Joint fit-up</b>	<b>Coating</b>	<b>Other</b>	<b>Component:</b> APBB1 Bearing Blocks, OBG 14E/14W
<b>Procedural</b>	<b>Procedural</b>	<b>Description:</b>

**Reference Description:** Damaged Bearing Blocks (VT) were discovered installed on Lift 14 East Anchorage prior to repairs being performed

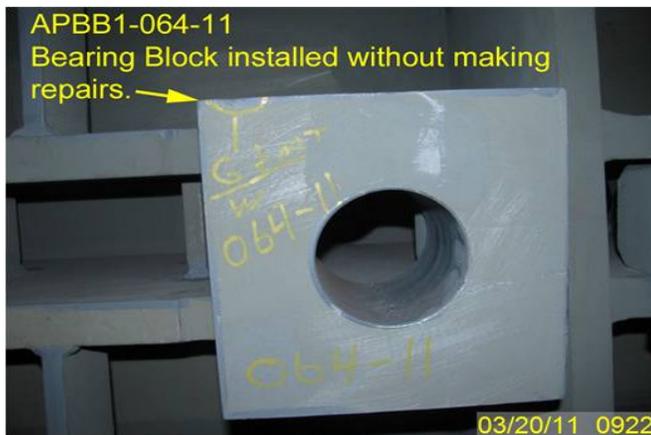
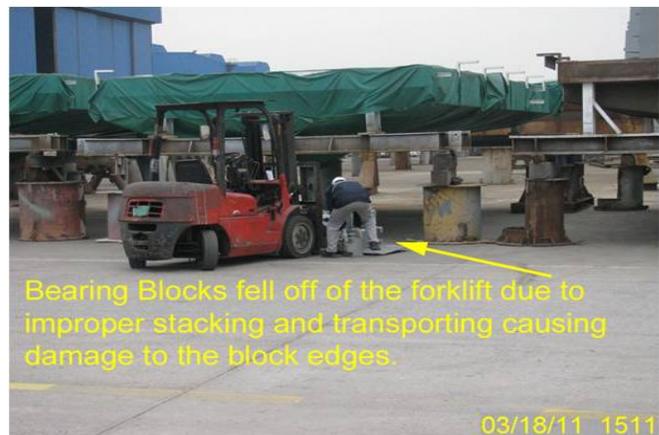
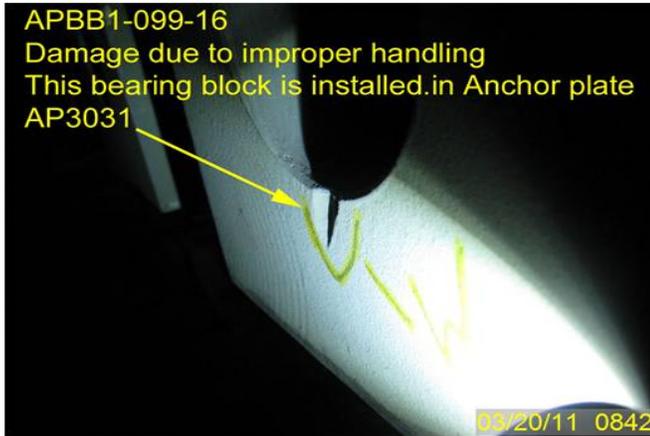
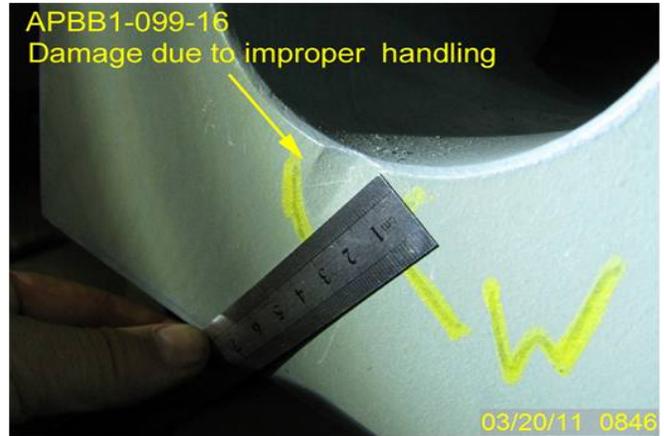
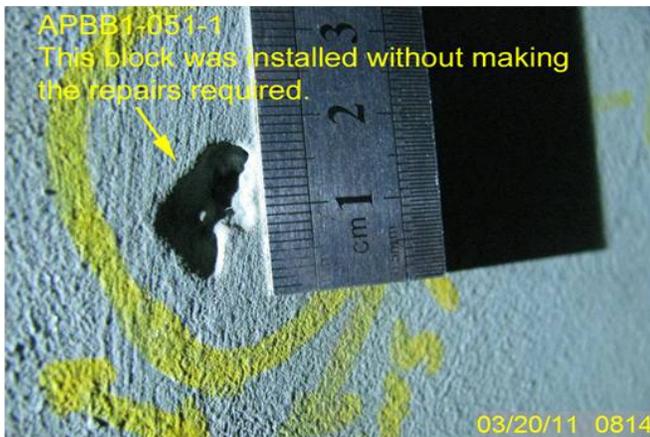
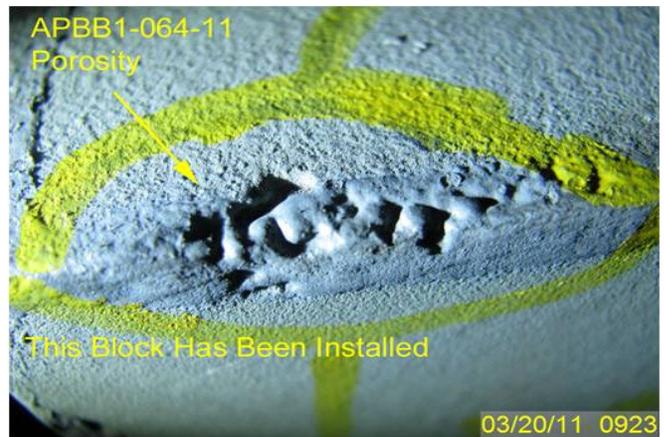
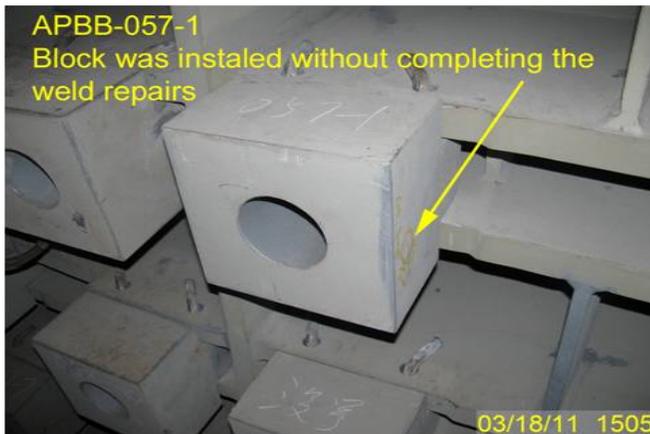
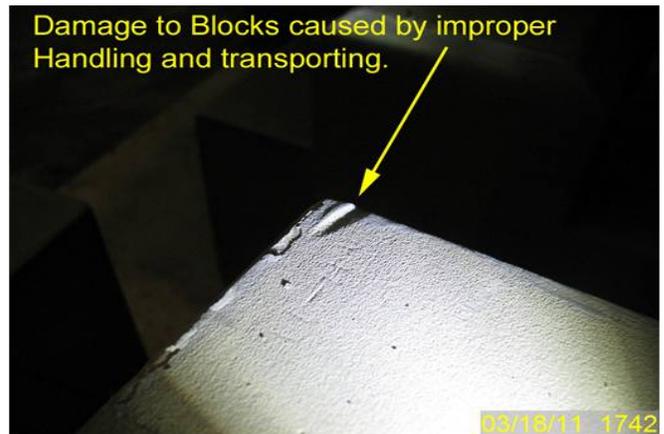
- 1) - This QA visually observed multiple bearing blocks with damage to the edge of the blocks due to poor handling. See pictures below.
- 2) - This QA visually observed Bearing Block 057-1 placed into position on Anchor Plate Assembly AP3031A before all the weld repairs have been completed.
- 3) - This QA visually observed Bearing Block 057-1 placed into position on Anchor Plate Assembly AP3031A prior to this Anchor Plate Assembly being affixed with a Green Tag due to items that required corrective action (outstanding cope hole issues). This occurs also for West Line (AP3032A).

1)- In Section 55-1.04; In handling and shipping of the steel work, every care shall be taken to avoid bending, scraping or overstressing the pieces. All pieces bent or otherwise injured will be rejected.

ZPMC acknowledged this problem and has issued an internal NCR. ZPMC QA personnel have talked with the floor CWI to address this issue. These damaged locations have been repaired and been inspected to be acceptable. ZPMC is providing the NDT report to show these areas have been accepted by department's inspector. Based on this, please consider closure of this NCR.

Contractor repaired the damaged location. NDT report is provided and acceptable. Contractor also issued the NCR to the QA personnel.

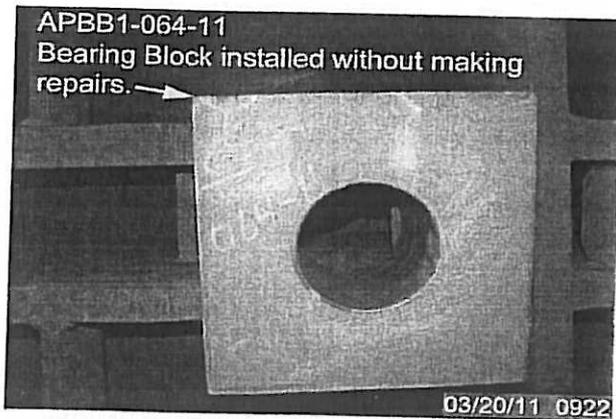
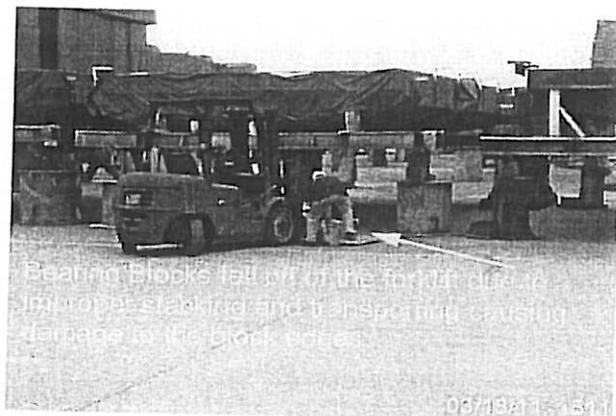
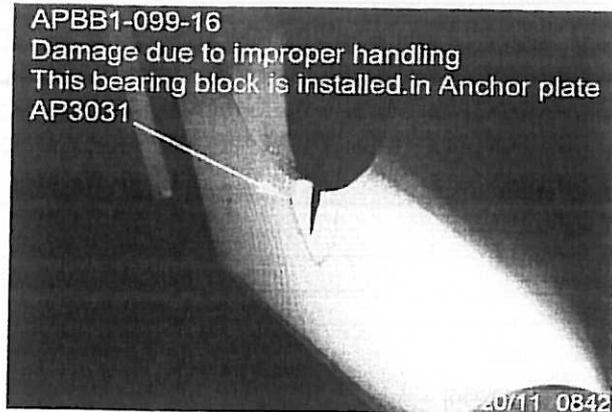
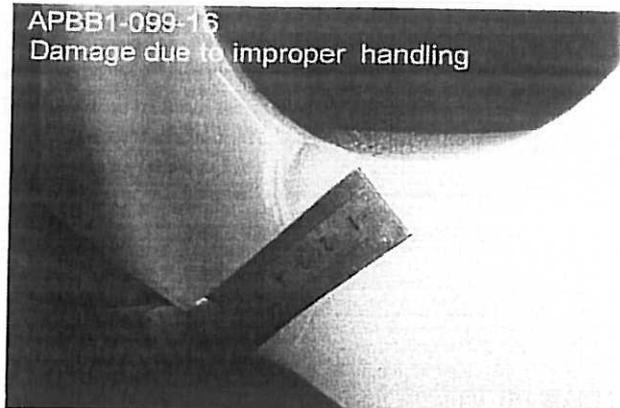
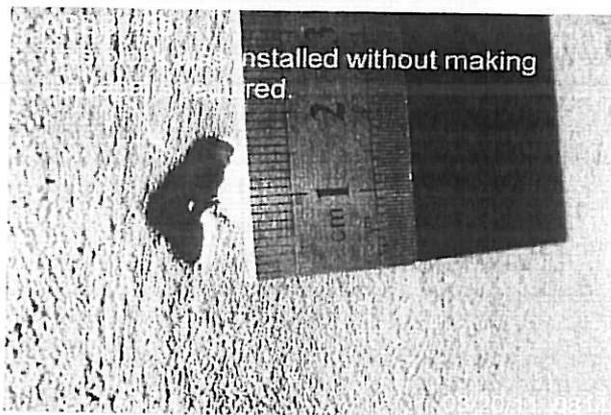
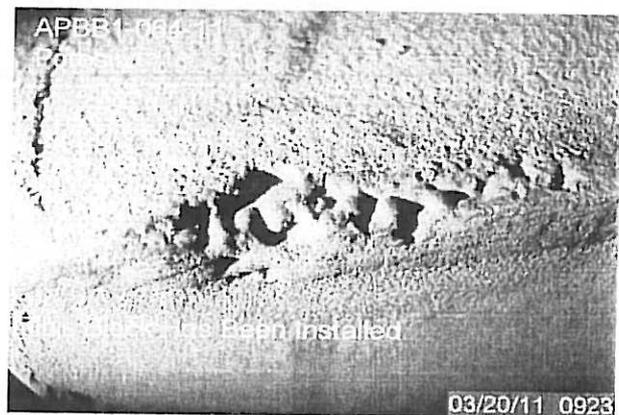
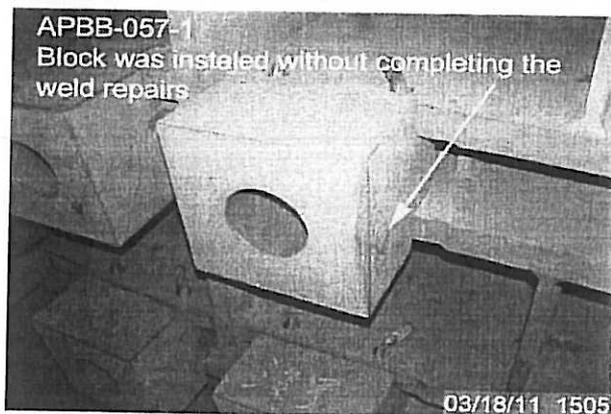
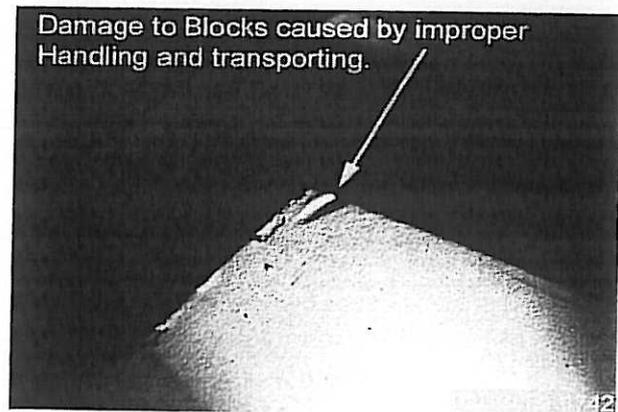
- 1) - This QA visually observed multiple bearing blocks with damage to the edge of the blocks due to poor handling. See pictures below.
- 2) - This QA visually observed Bearing Block 057-1 placed into position on Anchor Plate Assembly AP3031A before all the weld repairs have been completed.
- 3) - This QA visually observed Bearing Block 057-1 placed into position on Anchor Plate Assembly AP3031A prior to this Anchor Plate Assembly being affixed with a Green Tag due to items that required corrective action (outstanding cope hole issues). This occurs also for West Line (AP3032A).

1)- In Section 55-1.04; In handling and shipping of the steel work, every care shall be taken to avoid bending, scraping or overstressing the pieces. All pieces bent or otherwise injured will be rejected.

Contractor will repair the damaged location, and provide the NDT report. Contractor will issue an internal NCR to the QA personnel regarding this issue.
