QUALITY ASSURANCE -- NON-CONFORMANCE REPORT

Location: Changxing Island, Shanghai, China**Report No:** NCR-000994**Prime Contractor:** American Bridge/Fluor Enterprises, a JV**Date:** 07-Apr-2011**Submitting Contractor:** Zhenhua Port Machinery Company, Ltd (ZPMC), Changxing Island**NCR #:** ZPMC-0952**Type of problem:**

Reference Description: Missed UT indications discovered by QA for RS Stiffener to Floorbeam connections on Lift 13CW

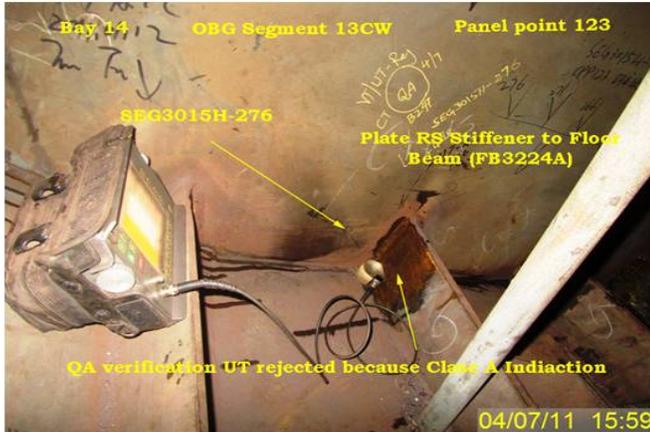
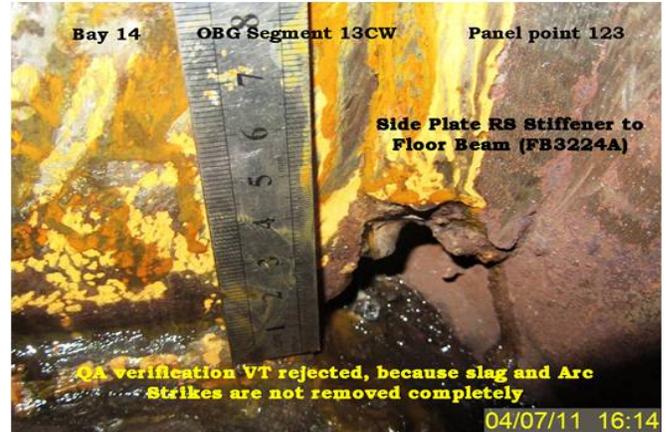
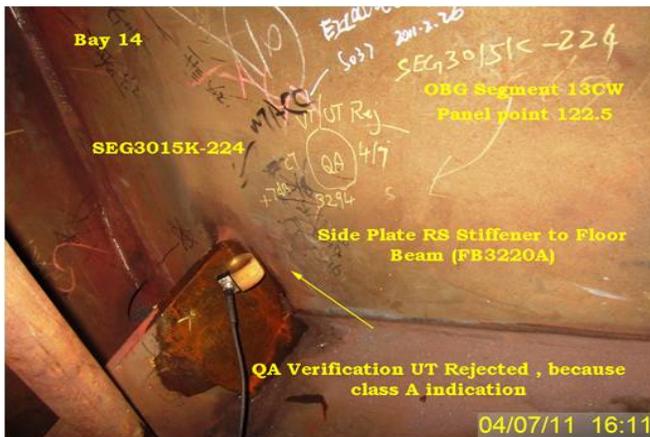
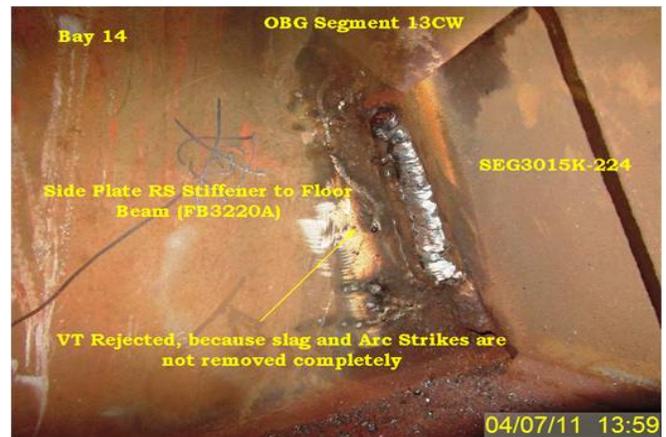
1. The Indication rating is +4dB and length approximately 20mm.

The Thickness of the plate is 22mm and depth of the indication approximately 16mm.

The indication is located on the weld joint identified as SEG3015H-276.

The "Y" location for this indication is approximately 145mm from top edge of this RS Stiffener.

The weld is a Complete Joint Penetration (CJP) "T" weld joint joining Side Plate RS Stiffener to Floor Beam (FB3224A) at panel point 123.

This weld did not meet the Visual Testing (VT) requirements of the contract documents due to incomplete welding at the cope hole.

2. The Indication rating is +7dB and length approximately 25mm.

The Thickness of the plate is 22mm and depth of the indication approximately 19mm.

The indication is located on the weld joint identified as SEG3015K-224.

The "Y" location for this indication is approximately 35mm from top edge of this RS Stiffener.

The weld is a Complete Joint Penetration (CJP) "T" weld joint joining Side Plate RS Stiffener to Floor Beam (FB3220A) at panel point 122.5.

This weld did not meet the Visual Testing (VT) requirements of the contract documents due to visible slag and

Arc Strikes present on the accepted weld.

- The indications are clearly marked by QA near the weld.
- OBG Segment 13CW is located in West Side of fabrication Bay 14.

The Notice of Witness Inspection Number (NWIT) is 008757. The indication is located within the area that has been previously tested and accepted by ZPMC Quality Control (QC) personnel. As per the contract documents, ZPMC's QC personnel are required to perform 100% UT inspection of this weld.

Reference Resolution: ZPMC has repaired the indications noted in the NCR and providing WR & NDT documentation after the repair to show the indication has been removed.

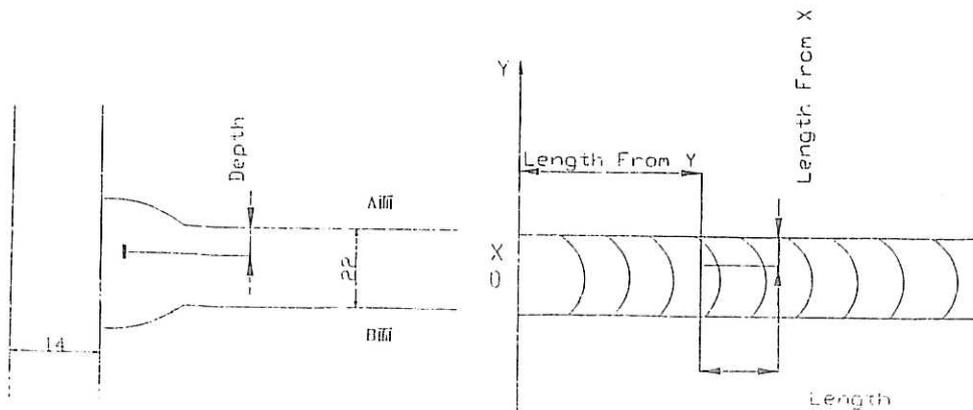
Draft of welding discontinuity:

(Description of welding discontinuity): Rejected indication found by ultrasonic inspection is less than the maximum allowance aggregate length.

焊缝编号为：SEG3015H-271, SEG3015K-224

Caused:

- 1、焊道未及时处理干净。
1. Did not clear the weld pass completely in time.

1. 从缺陷距离端面较近一侧 ($D \leq 0.65T$, D为缺陷深度, T为板厚) 采用碳刨或打磨的方法去除焊缝缺陷;
 2. 参照返修焊接工艺规程 (WPS) 准备正确的接头型式, 预热和焊接;
 3. 将修补区域打磨到与母材或邻近焊缝平齐;
 4. 根据批准的车间图纸检查焊缝.
-
1. Gouge or grind from nearer side from metal edge ($D \leq 0.65T$, "D" is depth of defects, "T" is thickness of metal) to remove all defects;
 2. Follow repair WPS for joint preparation, preheat, and weld deposit;
 3. Grind the repaired area flush with base metal or the adjacent weld;
 4. Check the welds according to the working drawings.

1. Improve monitoring of welding and interpass cleaning.

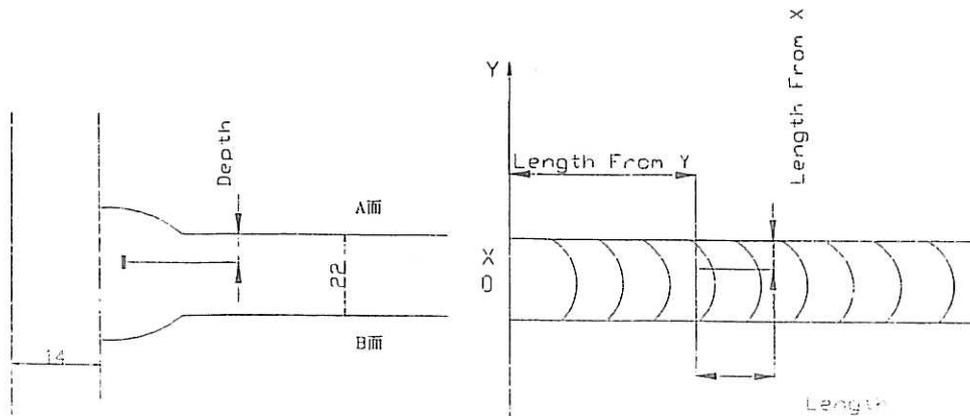
Draft of welding discontinuity:

(Description of welding discontinuity): Rejected indication found by ultrasonic inspection is less than the maximum allowance aggregate length.

焊缝编号为: SEG3015H-276, SEG3015K-224

- 1、焊道未及时处理干净。
1. Did not clear the weld pass completely in time.

1. Gouge or grind from nearer side from metal edge ($D \leq 0.65T$, "D" is depth of defects, "T" is thickness of metal) to remove all defects;
2. Follow repair WPS for joint preparation, preheat, and weld deposit;
3. Grind the repaired area flush with base metal or the adjacent weld;
4. Check the welds according to the working drawings.

1. Improve monitoring of welding and interpass cleaning.
