Contract #: 04-0120F4Cty: SF/ALA Rte: 80 PM: 13.2/13.9File #: 69.25B**QUALITY ASSURANCE -- NON-CONFORMANCE REPORT****Location:** Changxing Island, Shanghai, P.R. China**Report No:** NCR-000995**Prime Contractor:** American Bridge/Fluor Enterprises, a JV**Date:** 13-Apr-2011**Submitting Contractor:** Zhenhua Port Machinery Company, Ltd (ZPMC), Changxing Island**NCR #:** ZPMC-0953**Type of problem:****Welding****Concrete****Other****Welding****Curing****Procedural****Bridge No:** 34-0006**Joint fit-up****Coating****Other****Component:** Service Platform #4 Railing**Procedural****Procedural****Description:** Shipping and Handling Damage

Reference Description: QA Inspector observed handling and shipping damage on the OBG Service Platform #4 railing

Job Name: SAS Superstructure

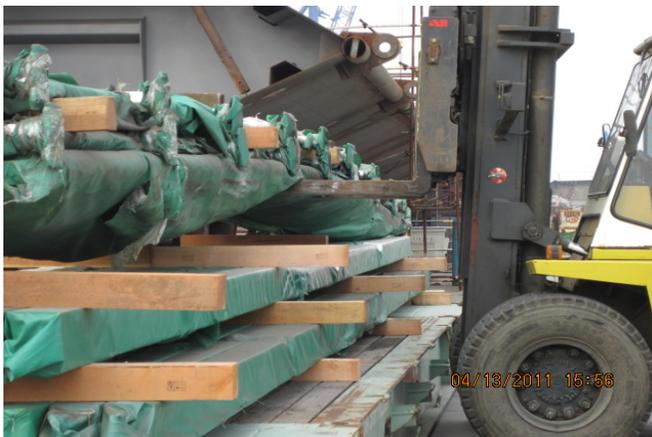
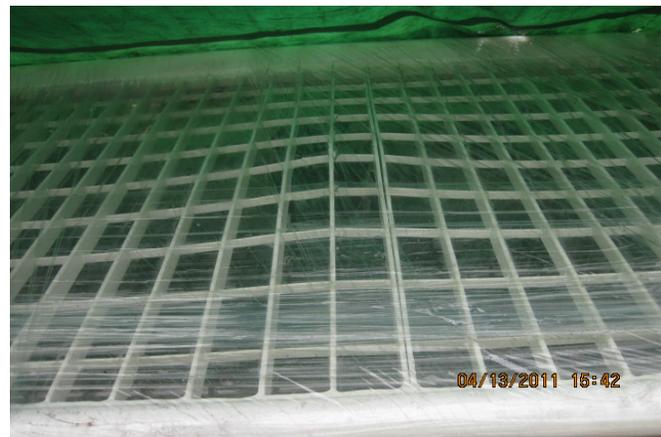
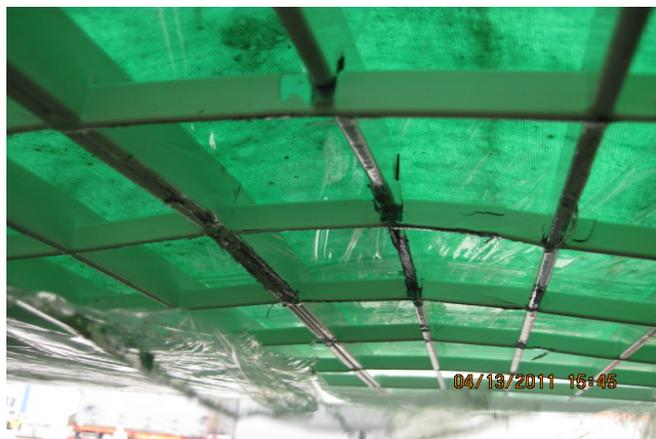
- The previously inspected and accepted Railing of the Service Platform SP#4 has been damaged.
- The damage noted is on the grating section of the service platform railing.
- It appears that the railing was damaged during loading and handling.
- The 40' Collapsible End Flat Rack Container on which the service platform is placed is identified as CCLU940000, model 40'FR4/03A.

Standard Specifications July, 1999 Section 55-1.04 Shipping, Handling and Storing Materials; "In handling and shipping of the steel work, every care shall be taken to avoid bending, scraping or overstressing the pieces. All pieces bent or otherwise injured will be rejected.

Contractor will repair the damaged part on the grating and request QA for re-inspection and issue visual inspection report. ZPMC will remind workers to handle carefully.

ZPMC repaired the damaged part and have the repair re-inspected by QA. Provided the visual inspection report which shows the repair is acceptable. ZPMC issued an internal NCR to the personnel involved.

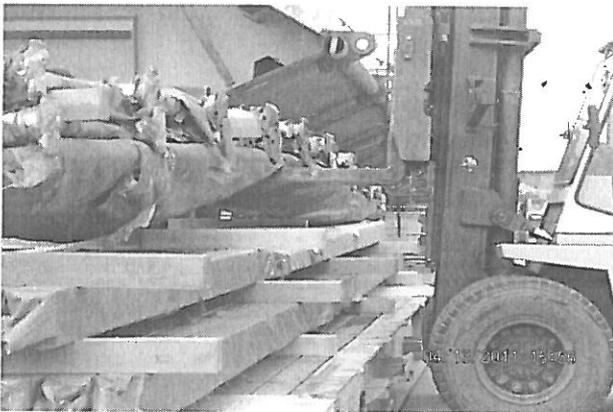
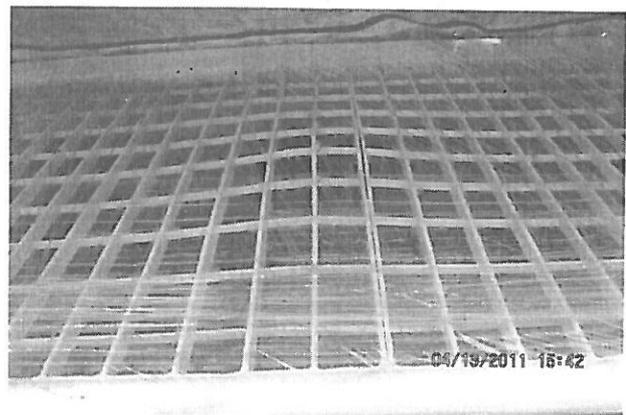
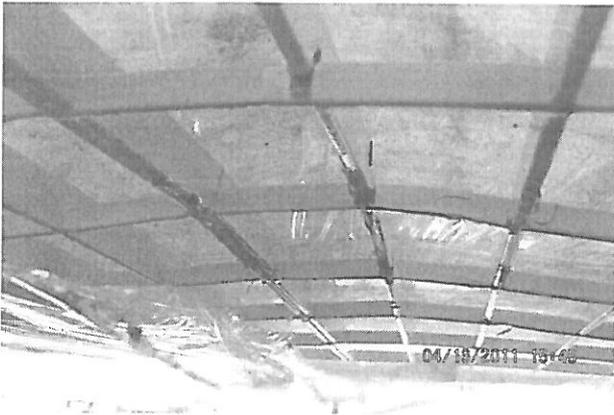
- The previously inspected and accepted Railing of the Service Platform SP#4 has been damaged.
- The damage noted is on the grating section of the service platform railing.
- It appears that the railing was damaged during loading and handling.
- The 40' Collapsible End Flat Rack Container on which the service platform is placed is identified as CCLU940000, model 40'FR4/03A.

Standard Specifications July, 1999 Section 55-1.04 Shipping, Handling and Storing Materials: "In handling and shipping of the steel work, every care shall be taken to avoid bending, scraping or overstressing the pieces. All pieces bent or otherwise injured will be rejected.
