Contract #: 04-0120F4Cty: SF/ALA Rte: 80 PM: 13.2/13.9File #: 69.25B**QUALITY ASSURANCE -- NON-CONFORMANCE REPORT****Location:** Changxing Island, Shanghai, China**Report No:** NCR-000997**Prime Contractor:** American Bridge/Fluor Enterprises, a JV**Date:** 21-Apr-2011**Submitting Contractor:** Zhenhua Port Machinery Company, Ltd (ZPMC), Changxing Island**NCR #:** ZPMC-0955**Type of problem:**

**Reference Description:** Longitudinal Toe Crack Discovered by QA on Segment 13CE Longitudinal Diaphragm to Stiffener Fillet Weld

# QUALITY ASSURANCE -- NON-CONFORMANCE REPORT

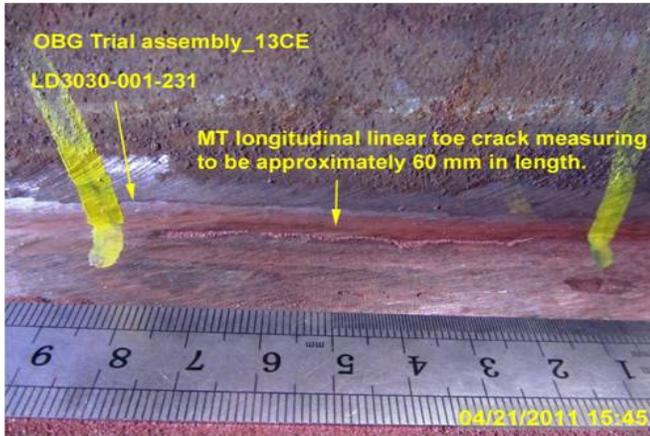
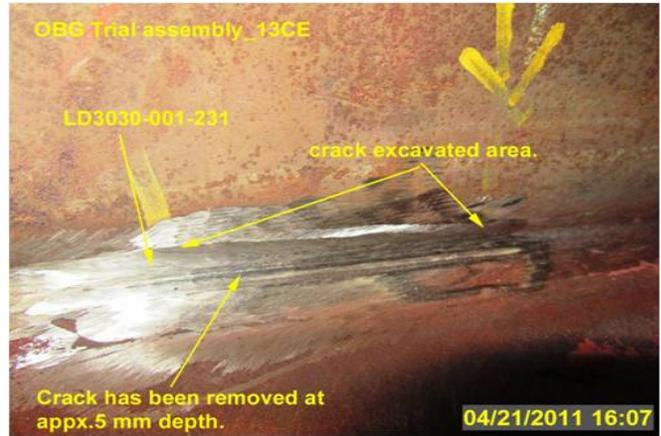
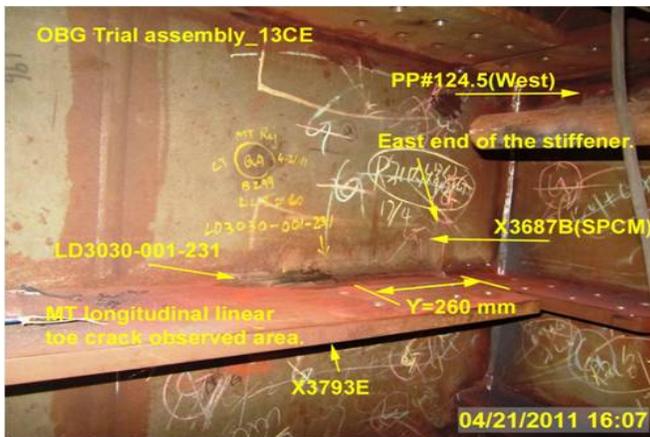
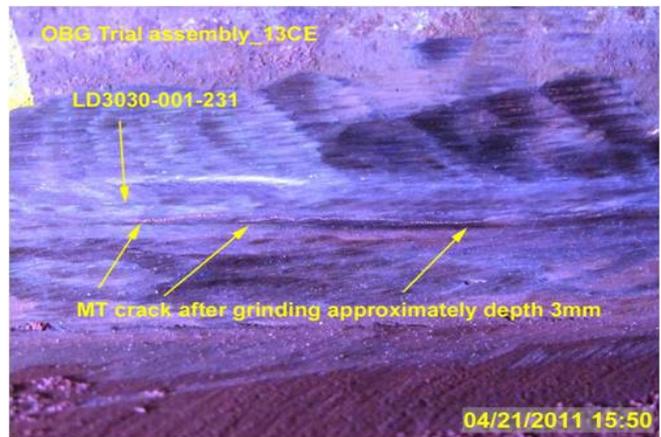
During Quality Assurance Magnetic Particle Testing (MT) review of welds located on Orthotropic Box Girder (OBG) Longitudinal diaphragm (LD) LD3030A, this Quality Assurance Inspector (QA) discovered the following issue:

- One Longitudinal Linear toe crack measuring approximately 60 mm in length.
- The weld is identified as: LD3030-001-231.
- This weld is a fillet weld joining LD base plate (X3687B) to "I" Stiffener plate (X3793E).
- The LD base plate is designated as Seismic Performance Critical Material (SPCM) on approved shop drawing.
- The "Y" location is approximately 260 mm from East side of the weld termination (as shown on picture below).
- Both LD base plate and stiffener plate thickness is 25 mm.
- The crack is clearly marked on the material near the weld.
- Segment 13CE is currently located in the OBG Trial assembly area.
- The crack has been shown to ZPMC MT Technician prior to grinding process.
- This crack has been removed to an approximate depth of 5 mm.

The Notice of Witness Inspection Number (NWIT) is 08891. The indication is located within an area that has been previously tested and accepted by ZPMC Quality Control (QC) personnel. As per the contract documents, The contractors personnel are required to perform 100% MT inspection of this weld.

AWS D1.5 (02) Section 6.26.2 – “Welds that are subject to MT in addition to visual inspection shall have no cracks”.

ZPMC acknowledged this problem and has issued an internal NCR. This indication has been removed, repaired and re-tested to be acceptable. ZPMC is providing the NDT record and is requesting closure of this NCR.

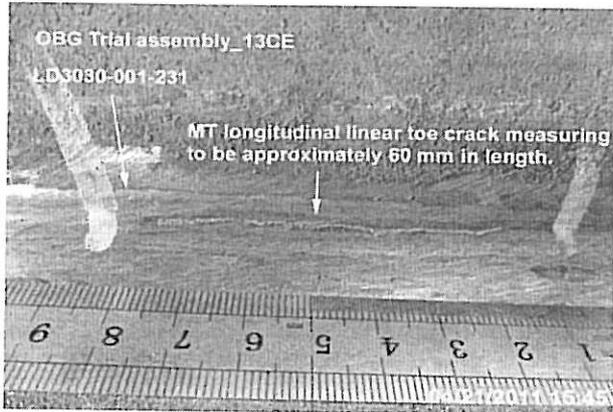
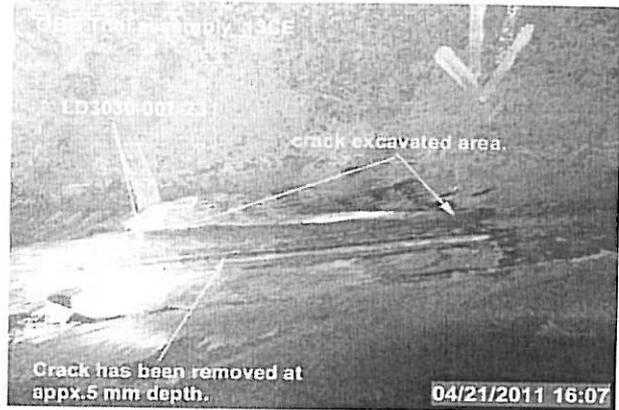
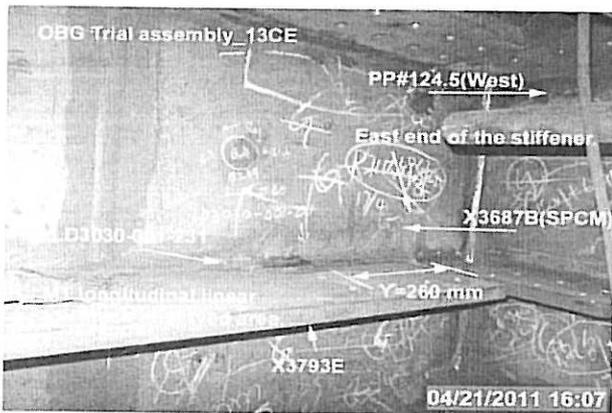
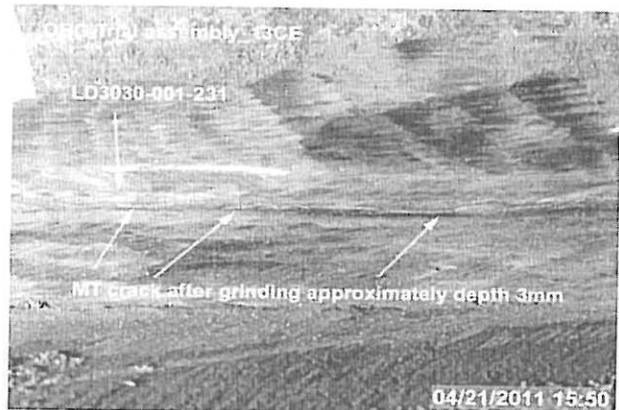
During Quality Assurance Magnetic Particle Testing (MT) review of welds located on Orthotropic Box Girder (OBG) Longitudinal diaphragm (LD) LD3030A, this Quality Assurance Inspector (QA) discovered the following issue:

- One Longitudinal Linear toe crack measuring approximately 60 mm in length.
- The weld is identified as: LD3030-001-231.
- This weld is a fillet weld joining LD base plate (X3687B) to "I" Stiffener plate (X3793E).
- The LD base plate is designated as Seismic Performance Critical Material (SPCM) on approved shop drawing.
- The "Y" location is approximately 260 mm from East side of the weld termination (as shown on picture below).
- Both LD base plate and stiffener plate thickness is 25 mm.
- The crack is clearly marked on the material near the weld.
- Segment 13CE is currently located in the OBG Trial assembly area.
- The crack has been shown to ZPMC MT Technician prior to grinding process.
- This crack has been removed to an approximate depth of 5 mm.

The Notice of Witness Inspection Number (NWIT) is 08891. The indication is located within an area that has been previously tested and accepted by ZPMC Quality Control (QC) personnel. As per the contract documents, The contractors personnel are required to perform 100% MT inspection of this weld.

AWS D1.5 (02) Section 6.26.2 – “Welds that are subject to MT in addition to visual inspection shall have no cracks”.

Contractor will repair the indication, and provide the NDT report to prove the weld is acceptable.

Contractor repaired the weld indication. The NDT report proved the repaired weld is acceptable. Internal NCR issued.
