## QUALITY ASSURANCE -- NON-CONFORMANCE REPORT

**Report No:** NCR-000998

<b>Welding</b>	<b>Concrete</b>	<b>Other</b>	
<b>Welding</b>	<b>Curing</b>	<b>Procedural</b>	<b>Bridge No:</b> 34-0006
<b>Joint fit-up</b>	<b>Coating</b>	<b>Other</b>	<b>Component:</b> OBG Suspender Bracket 110E
<b>Procedural</b>	<b>Procedural</b>	<b>Description:</b> Missed MT transverse indication

**Reference Description:** QA found a missed MT transverse indication after ZPMC had tested and accepted the weld at Suspender Bracket 110 East

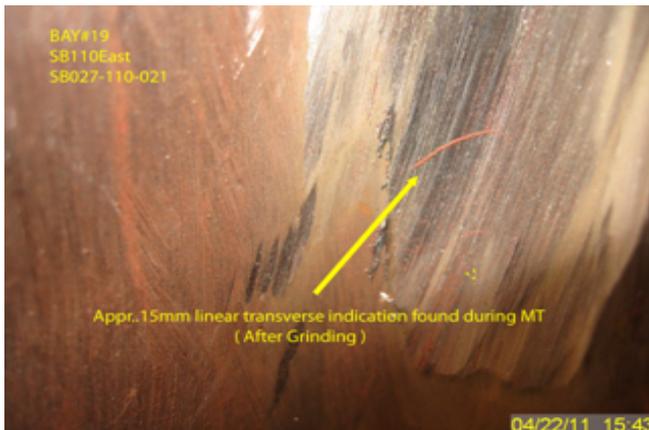
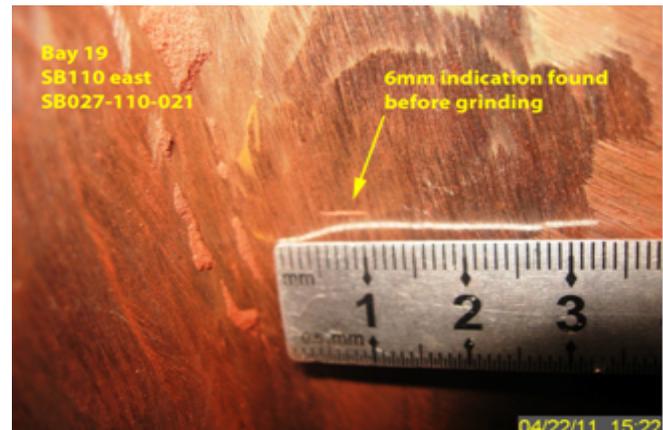
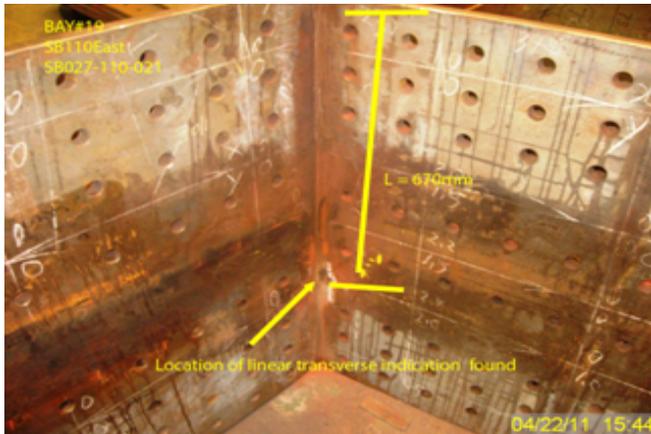
During the Quality Assurance (QA) Magnetic particle Testing (MT) review of welds located on OBG Suspender bracket SB110 East, this QA Inspector discovered the following issues:

- One transverse indication measuring approximately 6mm was found in weld ID SB027-110-021.
- In grinding the surface of the weld, the transverse indication is also present, measuring about 15mm.
- The weld is a 12mm Partial joint penetration (PJP) T joint, joining the Edge plate (X65W) to the Side plate (X64DD).
- The Y Location is 670mm from the edge of side plate
- The OBG Suspender bracket is located in BAY#19.
- This indication is clearly marked on the material on/near the weld.
- This weld joint is Non-Seismic performance critical (Non-SPCM).
- The Notice of Witness Inspection Number (NWIT) is 8899.
- The indication is located within an area that has been previously tested and accepted by ZPMC Quality Control (QC).

AWS D1.5 (02) Table 6.8 – Specifies the maximum length indication allowed is approximately 3mm for a 12mm weld.

- The OBG Suspender bracket is located in BAY#19.
  - This indication is clearly marked on the material on/near the weld.
  - This weld joint is Non-Seismic performance critical (Non-SPCM).

- The Notice of Witness Inspection Number (NWIT) is 8899.
  - The indication is located within an area that has been previously tested and accepted by ZPMC Quality Control (QC).

Propose a resolution for this non-conformance and provide documentation that the deficiency has been brought into compliance with the contract requirements. Propose a resolution that addresses the apparent failure of Quality Control to identify the indication. Additionally, provide documentation of the steps taken by the Quality Control Manager to prevent future occurrences.

ZPMC acknowledged this problem and has issued an internal NCR. This indication has been removed, repaired and re-tested to be acceptable. ZPMC is providing the NDT record and is requesting closure of this NCR.

Contractor will repair the weld indication and provide the NDT report to prove the weld is acceptable.

Contractor repaired the weld, and provided the NDT report. The NDT report proved the weld is acceptable. Internal NCR issued.

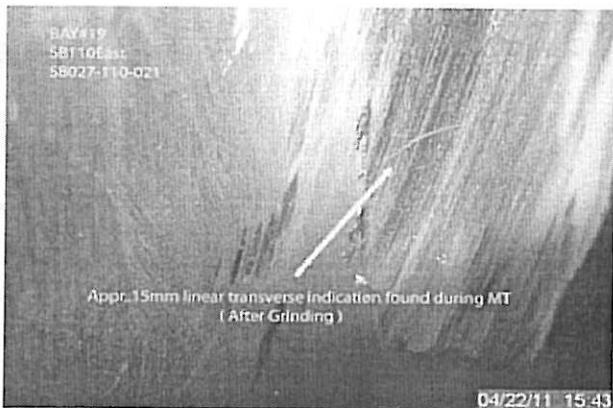
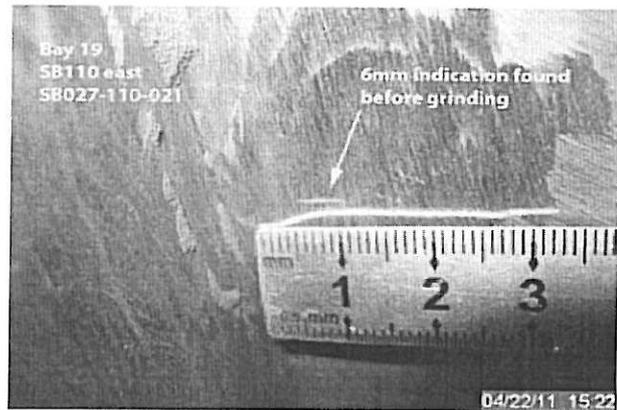
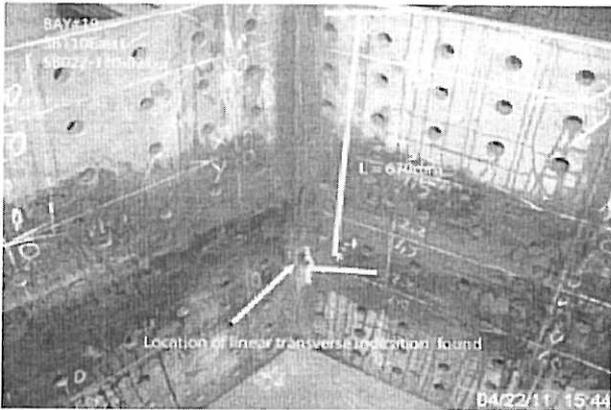
During the Quality Assurance (QA) Magnetic particle Testing (MT) review of welds located on OBG Suspender bracket SB110 East, this QA Inspector discovered the following issues:

- One transverse indication measuring approximately 6mm was found in weld ID SB027-110-021.
- In grinding the surface of the weld, the transverse indication is also present, measuring about 15mm.
- The weld is a 12mm Partial joint penetration (PJP) T joint, joining the Edge plate (X65W) to the Side plate (X64DD).
- The Y Location is 670mm from the edge of side plate
- The OBG Suspender bracket is located in BAY#19.
- This indication is clearly marked on the material on/near the weld.
- This weld joint is Non-Seismic performance critical (Non-SPCM).
- The Notice of Witness Inspection Number (NWIT) is 8899.
- The indication is located within an area that has been previously tested and accepted by ZPMC Quality Control (QC).

AWS D1.5 (02) Table 6.8 – Specifies the maximum length indication allowed is approximately 3mm for a 12mm weld.
