QUALITY ASSURANCE -- NON-CONFORMANCE REPORT

Location: Changxing Island, Shanghai, P.R. China**Report No:** NCR-000999**Prime Contractor:** American Bridge/Fluor Enterprises, a JV**Date:** 24-Apr-2011**Submitting Contractor:** Zhenhua Port Machinery Company, Ltd (ZPMC), Changxing Island**NCR #:** ZPMC-0957**Type of problem:**

Reference Description: A joint in Cable Bracket SA6529 was being welded without conforming to the approved WPS root gap opening tolerance

Subject: NCR No. ZPMC-0957

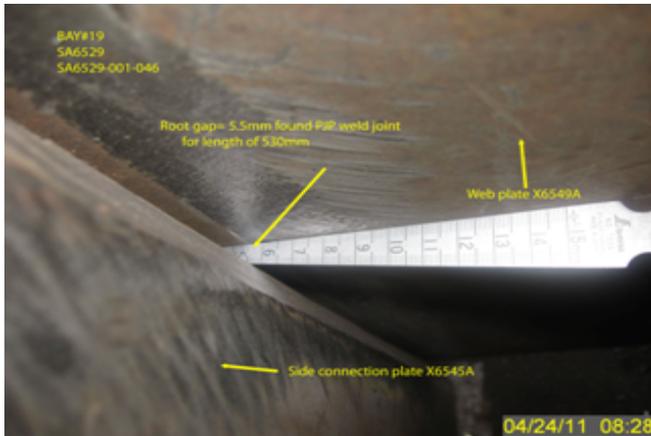
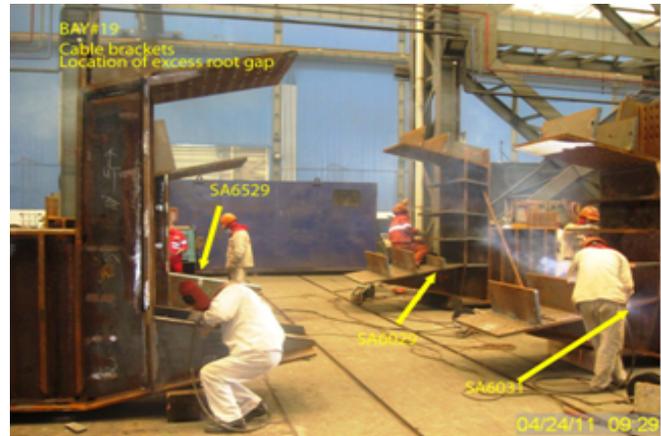
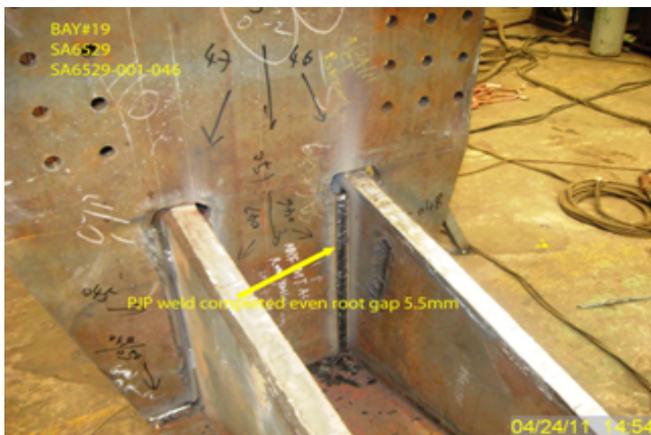
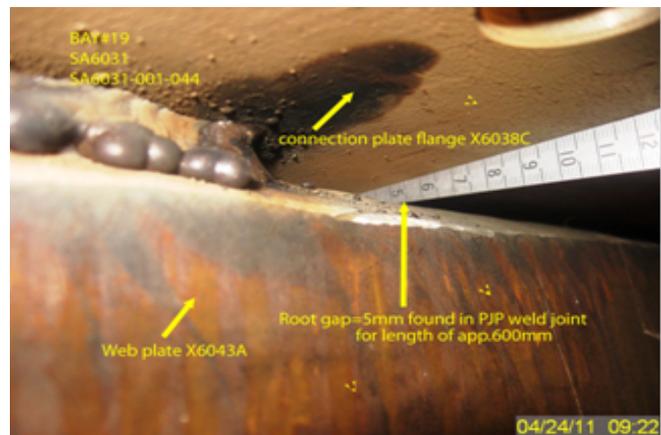
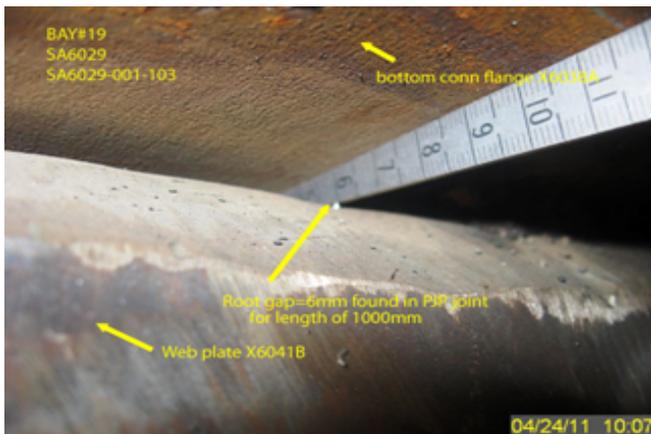
- The fit-up of 3 Partial Joint Penetration (PJP) welds had excessive root openings as described below.
- ZPMC personnel proceeded with welding one of these PJP welds without conforming to the root opening tolerance as stated in the approved WPS.

- The PJP weld is identified as SA6529-001-046 (Welded the joint with excessive root opening).
- The Root gap was measured approximately 5.5mm for length of 530mm.
- Web plate (X6549A) connects to Side connection plate (X6545A).

- The PJP weld is identified as SA6031-001-044.
- The Root gap was measured approximately 5.0 mm for length of 600mm.
- Web plate (X6043A) connects to Bottom flange plate (X6038C).

- The PJP weld is identified as SA6029-001-103.
- The Root gap was measured approximately 6.0mm for length of 1000mm.
- Web plate (X6041B) connects to Bottom flange plate (X6038A)

Approved WPS: WPS-B-T-2233-ESAB / WPS-B-T-2232-ESAB indicated that the Root Gap fit-up shall be 0mm with a tolerance of (+3mm, -2mm)

AWSD1.5-2002, Sec.3.3.2: The root opening between parts to be joined by PJP groove welds parallel to the member length (bearing joints expected) shall be zero, or as small as practicable.

Based on TC-RFI-0411 Rev 0 acceptable response to leave this condition as is, ABFJV hereby requests closure of this NCR.

Contractor issued TC-RFI -0411R0 proposing remedial actions for cable bracket SA6029 but leaving SA6529 and SA6031 sa-is. proposes remedial actions for cable bracket SA6029 as well as leaving SA6529 and SA6031 as-is. Remedial action for SA6029 includes - root pass with SMAW as stated in AWS D1.5, clause 3.3.2.1, MT
