Contract #: 04-0120F4Cty: SF/ALA Rte: 80 PM: 13.2/13.9File #: 69.25B**QUALITY ASSURANCE -- NON-CONFORMANCE REPORT****Location:** Changxing Island, Shanghai, China**Report No:** NCR-001001**Prime Contractor:** American Bridge/Fluor Enterprises, a JV**Date:** 24-Apr-2011**Submitting Contractor:** Zhenhua Port Machinery Company, Ltd (ZPMC), Changxing Island**NCR #:** ZPMC-0959**Type of problem:**

Reference Description: Missed UT Indication Discovered by QA on an Channel Splice Plate that is not able to be identified

To:	AMERICAN BRIDGE/FLUOR, A JV 375 BURMA ROAD OAKLAND CA 95607	Date:	26-Apr-2011
Dear:	Mr. Charles Kanapicki	Contract No:	04-0120F4 04-SF-80-13.2 / 13.9
Attention:	Mr. Thomas Nilsson Project/Fabrication Manager	Job Name:	SAS Superstructure
Subject:	NCR No. ZPMC-0959	Document No:	05.03.06-000958

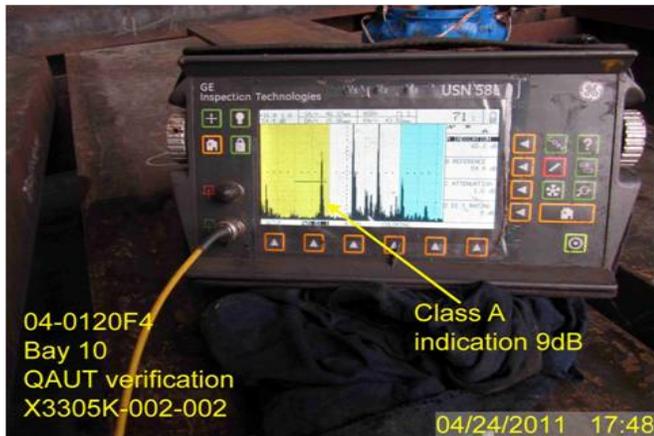
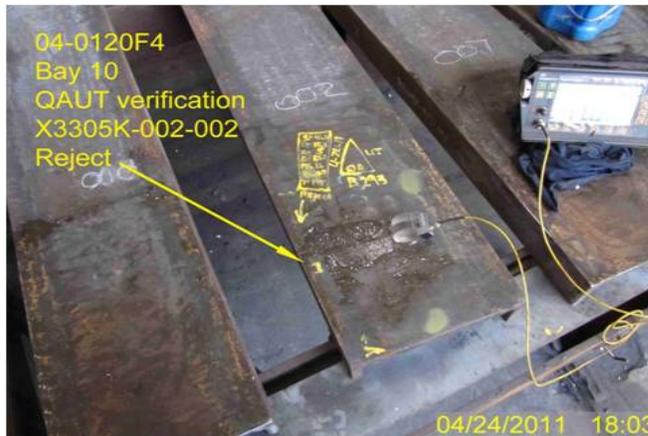
During the Quality Assurance Ultrasonic Testing (UT) verification of weld located on X3305K-002-002 weld, this Quality Assurance Inspector (QA) discovered the following issues:

- One (1) Class "A" indication measuring approximately 10mm in length.
- The Indication rating is +9dB.
- Piece Mark "X3305K" was not able to identified per the latest shop drawing.
- The thickness of the plate is 18mm and depth of the indication approximately 15.8mm.
- The "Y" location is approximately 195mm from weld termination.
- The weld is a Complete Joint Penetration (CJP) Corner-Joint joining flange to the web.
- The indication is clearly marked by CT QA on/near the weld.
- Fabricated channel assembly is located inside Bay 10.

The Notice of Witness Inspection Number (NWIT) is 08919, Item 3. The indication is located within the area that has been previously tested and accepted by ZPMC Quality Control (QC) personnel. As per the contract documents, ZPMC's QC personnel are required to perform 100% UT inspection of this weld.

For further information, please see the attached pictures.

AWS D1.5-2002, Section 6, Table 6.3; "Specifies a class A indication in this category shall be rejected (regardless of length).

Propose a resolution for this non-conformance and provide documentation that the deficiency has been brought into compliance with the contract requirements. Propose a resolution that addresses the apparent failure of Quality Control to identify the indication. Additionally, provide documentation of the steps taken by the Quality Control Manager to prevent future occurrences.

ZPMC acknowledged this problem and has issued an internal NCR. ZPMC has repaired the indications noted in the NCR and is providing WR & NDT documentation after the repair to show the indication has been removed. Based on these actions, ZPMC requests closure of this NCR.

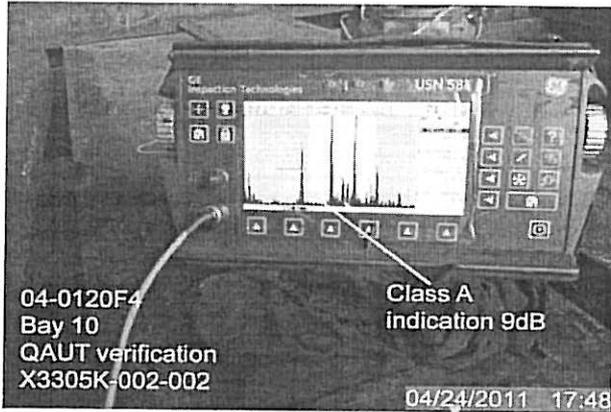
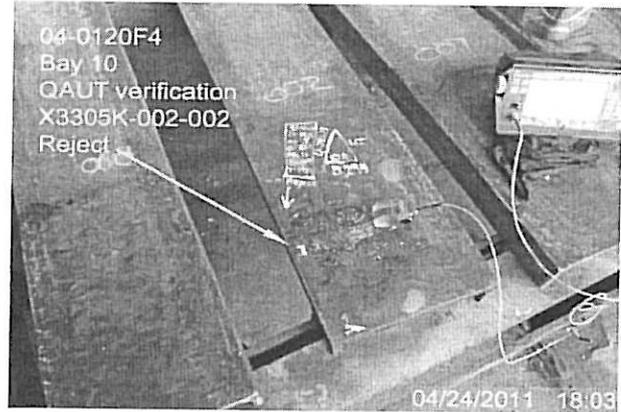
During the Quality Assurance Ultrasonic Testing (UT) verification of weld located on X3305K-002-002 weld, this Quality Assurance Inspector (QA) discovered the following issues:

- One (1) Class "A" indication measuring approximately 10mm in length.
- The Indication rating is +9dB.
- Piece Mark "X3305K" was not able to identified per the latest shop drawing.
- The thickness of the plate is 18mm and depth of the indication approximately 15.8mm.
- The "Y" location is approximately 195mm from weld termination.
- The weld is a Complete Joint Penetration (CJP) Corner-Joint joining flange to the web.
- The indication is clearly marked by CT QA on/near the weld.
- Fabricated channel assembly is located inside Bay 10.

The Notice of Witness Inspection Number (NWIT) is 08919, Item 3. The indication is located within the area that has been previously tested and accepted by ZPMC Quality Control (QC) personnel. As per the contract documents, ZPMC's QC personnel are required to perform 100% UT inspection of this weld.

For further information, please see the attached pictures.

AWS D1.5-2002, Section 6, Table 6.3; "Specifies a class A indication in this category shall be rejected (regardless of length).

Contractor will repair the weld indication. Contractor will provide the NDT report to prove the weld is acceptable after repair.

Contractor repaired the weld and submitted the NDT report showing the weld is sound. ZPMC issued an internal NCR to the personnel concerned.

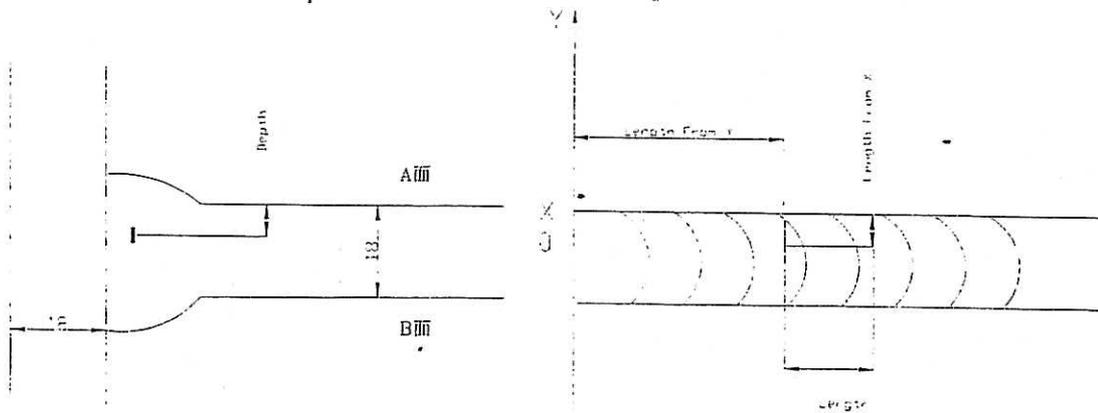
焊缝编号为 x3305k-002-002

(Description of welding discontinuity): Rejected indication found by ultrasonic inspection is less than the maximum allowance aggregate length.

Please see the detail data from UT report!

- 1、焊道未及时处理干净。
1. Did not clear the weld pass completely in time.

1. 从缺陷距离端面较近一侧 ($D \leq 0.65T$, D 为缺陷深度, T 为板厚) 采用碳刨或打磨的方法去除焊缝缺陷;
 2. 参照返修焊接工艺规程 (WPS) 准备正确的接头型式, 预热和焊接;
 3. 将修补区域打磨到与母材或邻近焊缝平齐;
 4. 根据批准的车间图纸检查焊缝.
-
1. Gouge or grind from nearer side from metal edge ($D \leq 0.65T$, "D" is depth of defects, "T" is thickness of metal) to remove all defects;
 2. Follow repair WPS for joint preparation, preheat, and weld deposit;
 3. Grind the repaired area flush with base metal or the adjacent weld;
 4. Check the welds according to the working drawings.

1. Improve monitoring of welding and interpass cleaning.
