Contract #: 04-0120F4Cty: SF/ALA Rte: 80 PM: 13.2/13.9File #: 69.25B**QUALITY ASSURANCE -- NON-CONFORMANCE REPORT****Location:** Changxing Island, Shanghai, P.R. China**Report No:** NCR-001007**Prime Contractor:** American Bridge/Fluor Enterprises, a JV**Date:** 08-May-2011**Submitting Contractor:** Zhenhua Port Machinery Company, Ltd (ZPMC), Changxing Island**NCR #:** ZPMC-0965**Type of problem:**

Reference Description: ZPMC performed base metal repair without prior Engineer's approval, repair documentation, preheat, and QC presence over 55 minutes

Dear: Mr. Charles Kanapicki
Job Name: SAS Superstructure

Subject: NCR No. ZPMC-0965

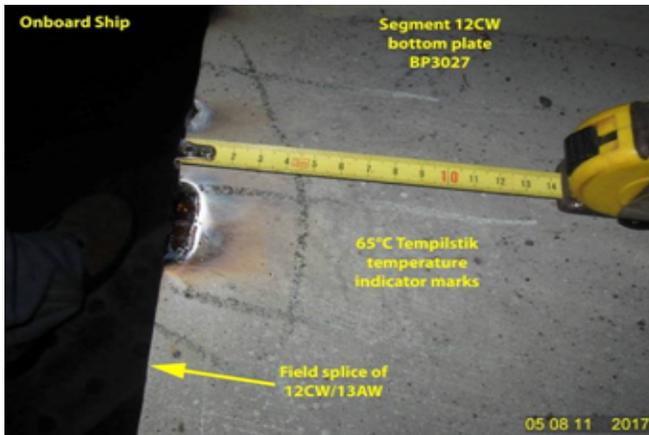
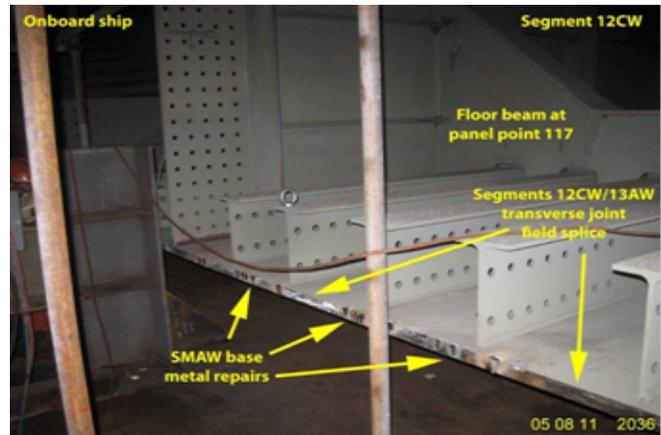
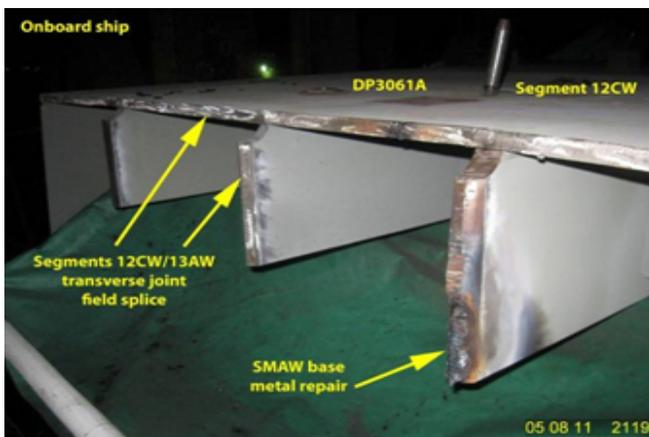
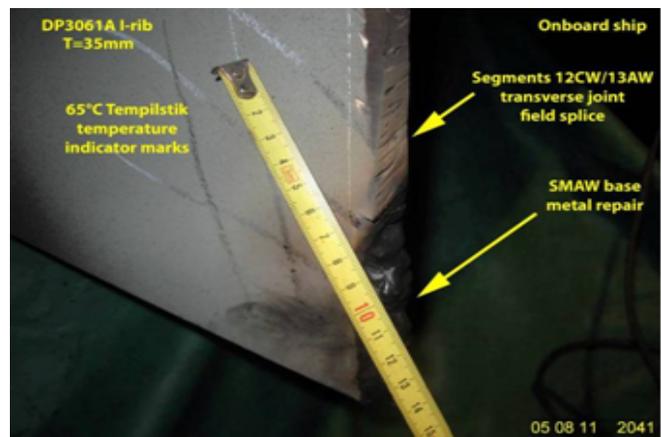
During Quality Assurance (QA) random in-process observations of the fabrication of OBG Lift 12CW, this Caltrans QA Inspector observed the following issues:

- ZPMC welding personnel was performing SMAW repair of deck plate base metal without prior Engineer's approval.
- Additionally, no contractor's QC monitored the repair process (55 minutes).
- The scope of the repair work is not known. No repair documentation or WPS are available.
- This QA observed that no preheat was performed prior to commencement of the repair.
- This QA was present in the area from 2015 hours to 2110 hours. Welding repair was being performed during this time.
- Caltrans QA lead inspector, Mr. Ken Riley notified ZPMC QA inspector Mr. Zhang Jiadi at approximately 2015 hours that no ZPMC QC CWI was present in the area. In the conversation, Mr. Zhang agreed to get a QC to look at this repair within 15 minutes.
- This QA departed the area at approximately 2110 hours after weld repairs stopped. The contractor's QC did not show up from 2015 to 2110 hours.

Area 1)

- The affected member is identified as DP3061A.
- The location of the repair area is at the east end of I-rib stiffener #RS3036F. Material thickness is 35mm. Material type is HPS-485WT2

Area 2)

- The affected member is identified as BP3027.
- The location of the repair area is at the east end of plate #PL3147B, between T-ribs identified as RS3060A and RS3060B. Material thickness is 28mm.

AWS D1.5 (2002), Section 4.2.7: requires the base metal temperature to be at or above the specified minimum temperature for a distance not less than 75mm in all directions from the point of welding.

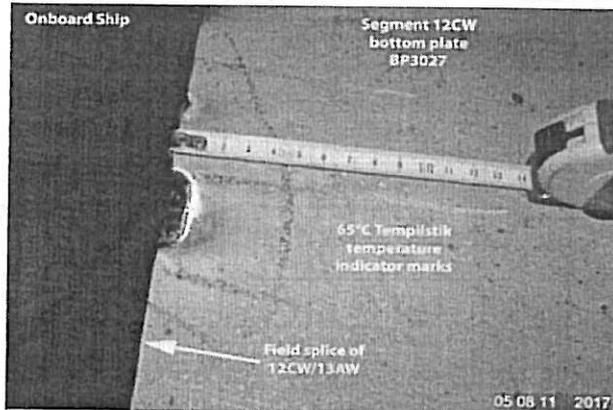
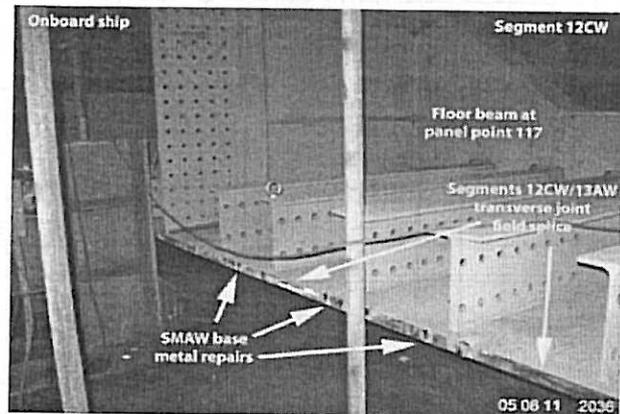
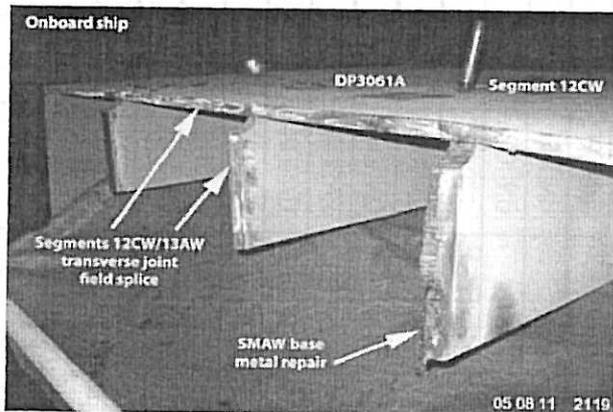
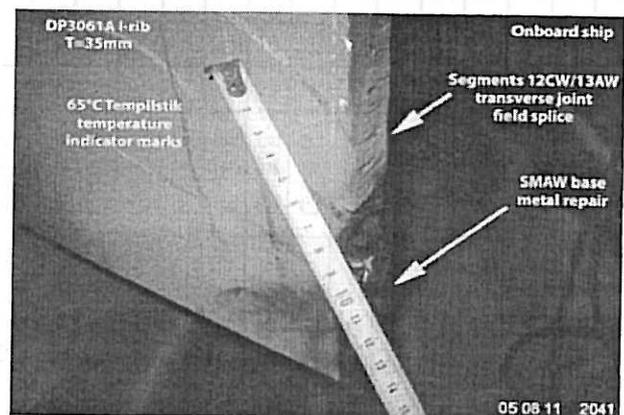
During Quality Assurance (QA) random in-process observations of the fabrication of OBG Lift 12CW, this Caltrans QA Inspector observed the following issues:

- ZPMC welding personnel was performing SMAW repair of deck plate base metal without prior Engineer's approval.
- Additionally, no contractor's QC monitored the repair process (55 minutes).
- The scope of the repair work is not known. No repair documentation or WPS are available.
- This QA observed that no preheat was performed prior to commencement of the repair.
- This QA was present in the area from 2015 hours to 2110 hours. Welding repair was being performed during this time.
- Caltrans QA lead inspector, Mr. Ken Riley notified ZPMC QA inspector Mr. Zhang Jiadi at approximately 2015 hours that no ZPMC QC CWI was present in the area. In the conversation, Mr. Zhang agreed to get a QC to look at this repair within 15 minutes.
- This QA departed the area at approximately 2110 hours after weld repairs stopped. The contractor's QC did not show up from 2015 to 2110 hours.

Area 1)

- The affected member is identified as DP3061A.
- The location of the repair area is at the east end of I-rib stiffener #RS3036F. Material thickness is 35mm. Material type is HPS-485WT2

Area 2)

- The affected member is identified as BP3027.
- The location of the repair area is at the east end of plate #PL3147B, between T-ribs identified as RS3060A and RS3060B. Material thickness is 28mm.

AWS D1.5 (2002), Section 4.2.7: requires the base metal temperature to be at or above the specified minimum temperature for a distance not less than 75mm in all directions from the point of welding.

ZPMC QA personnel have talked with the floor QC to enhance the welding control on site. ZPMC is providing the NDT record to show the acceptance of these repaired areas. The punchlist item has been verified by department's representative. Based on this, ZPMC is request closure of this NCR.
